Applied Report 84

RAAF ORION AIRCRAFT A9-300
OXYGEN FIRE(U)

This report summarizes the findings of the investigation into the nature and cause of the fire in RAAF Orion aircraft A9-300. This aircraft was destroyed by fire which initiated in the oxygen system as the result of an explosion caused by metal ignition.

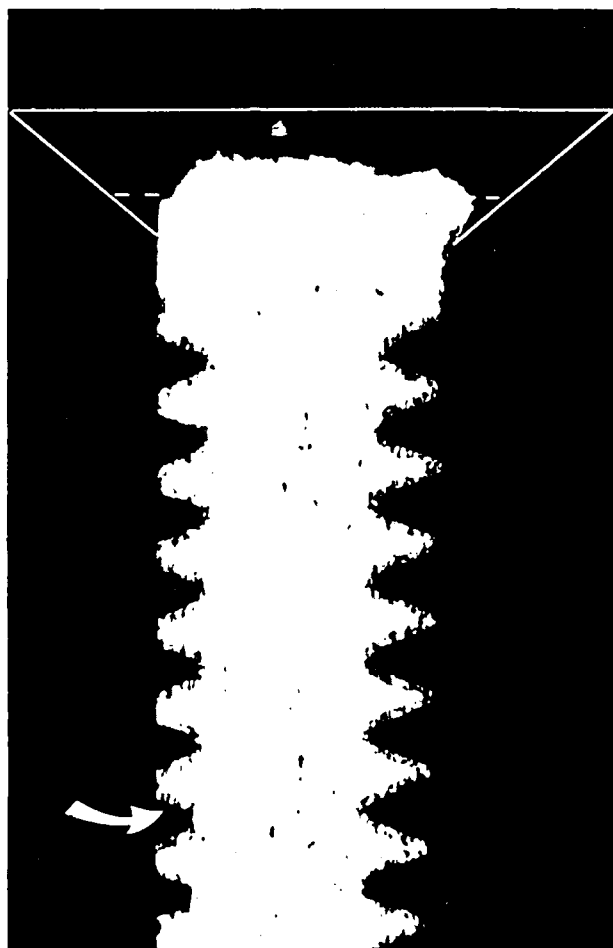
FIGURE 9a. SECTION THROUGH BRASS SCREW OF POPPET VALVE FROM No. 3 CHAMBER (FIGURE 3, DETAIL A, ITEM 5) SHOWING THE EXTENT OF DAMAGE TO THE COUNTERSUNK HEAD (THE ORIGINAL SHAPE IS OUTLINED). AN AREA OF THE CORRODED THREAD (ARROWED) IS SHOWN IN FIGURE 9b)

FIGURE 9b. AN ENLARGEMENT OF THE AREA ARROWED IN FIGURE 9a SHOWING THE EXTENT OF THE DEZINCIFICATION IN THE THREADS. THE GREY AREAS WHICH APPEAR TO PENETRATE THE MATRIX ARE ZINC OXIDE. AN EXAMPLE OF AN AREA OF PRECIPITATED COPPER IS ARROWED.

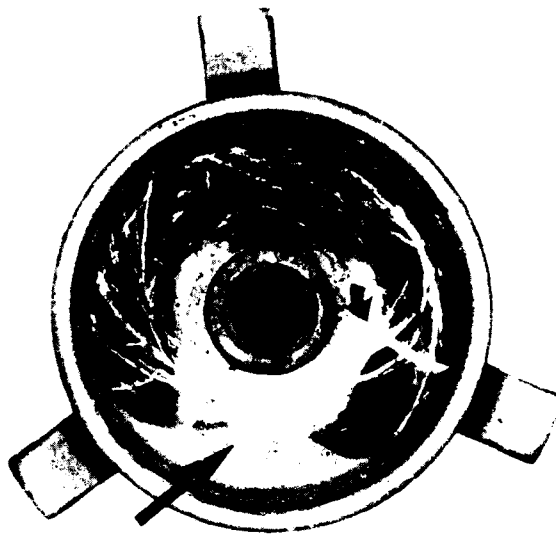
Inspection of the poppet valve seat from No.3 chamber showed evidence of score marks on the aluminium alloy face (Figure 12). These score marks were present prior to the fire and would have allowed a slow gas leakage under the silicone rubber washer (Figure 13). In combination with the defective brass screw the score marks

FIGURE 12. POPPET VALVE FROM No. 3 CHAMBER (FIGURE 3, DETAIL A, ITEM 5) WITH POPPET SEAL, SEAL RETAINER, AND SCREW REMOVED. NOTE LIGHT AREA (LONG ARROW) WHERE POPPET SEAL WAS NOT BONDED TO THE ALUMINIUM BODY AND THE NUMEROUS SCRATCH MARKS. (SHORT THICK SCRATCH ON RHS (CURVED ARROW) IS POST FIRE DAMAGE.)

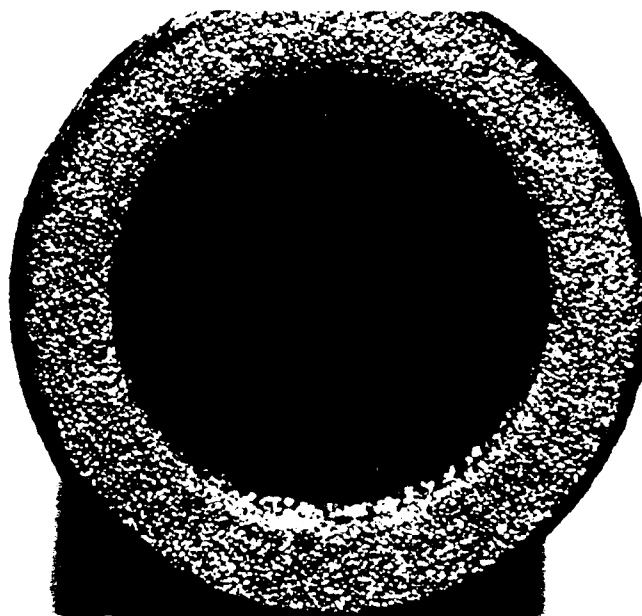
Filters from a number of Orion aircraft were examined. These were taken from the charging valve assemblies, and all showed signs of fretting, indicating that the element was not sealing properly and had oscillated during charging of the oxygen system. This movement had led to damage of the filter body, removal of material from the filter element and an imperfect seal between the filter body and the filter element. As a result the filters were incapable of effectively removing particles and

FIGURE 15 A FINE FILTER FROM AIRCRAFT A9 760 NOTE FRETTING
AROUND THE EDGE (ARROWED)
MAGNIFICATION: 9 APPROX

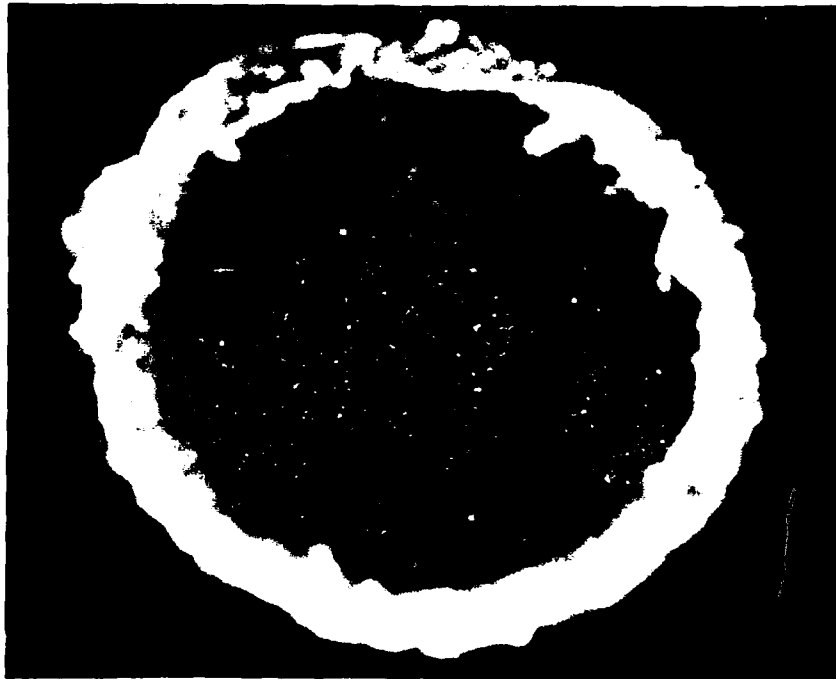
FIGURE 18 A SECTION THROUGH THE CENTRE OF THE STAINLESS
STEEL PIPE SHOWN IN FIGURE 17 SHOWING THE EXTENT
OF THE RUST DEPOSIT

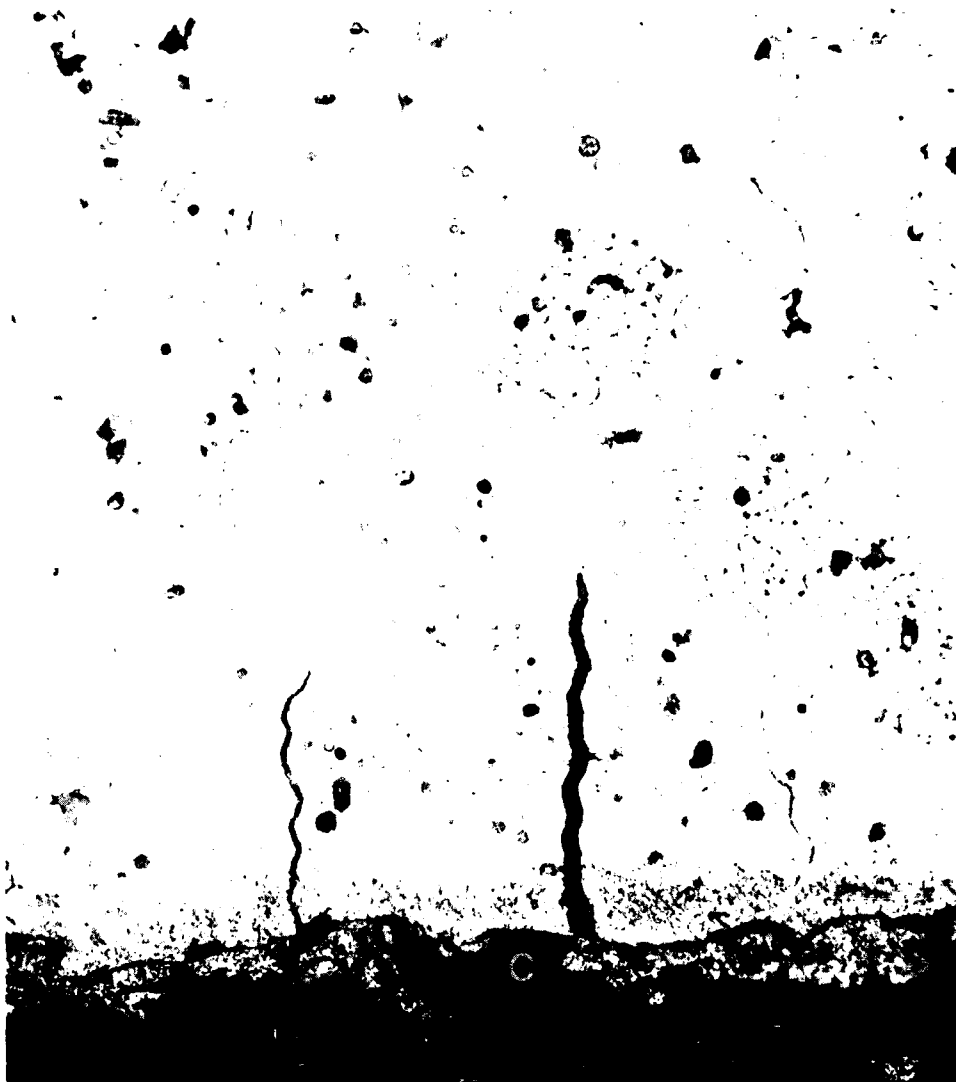
FIGURE 22. SECTION THROUGH THE FIRE DAMAGED BLOCK (A9-300) SHOWING THE COMBUSTION ZONE AREA (AREA C). THE HORIZONTAL LINE JUST ABOVE THE FIRE ZONE MARKS THE LIMIT OF RESOLIDIFIED ALUMINIUM ALLOY (ARROW). THE SHALLOW DEPTH OF THIS ZONE EMPHASISES THAT THE RATE OF COMBUSTION EXCEEDED THE RATE OF HEAT TRANSFER INTO THE INTERIOR OF THE BLOCK.

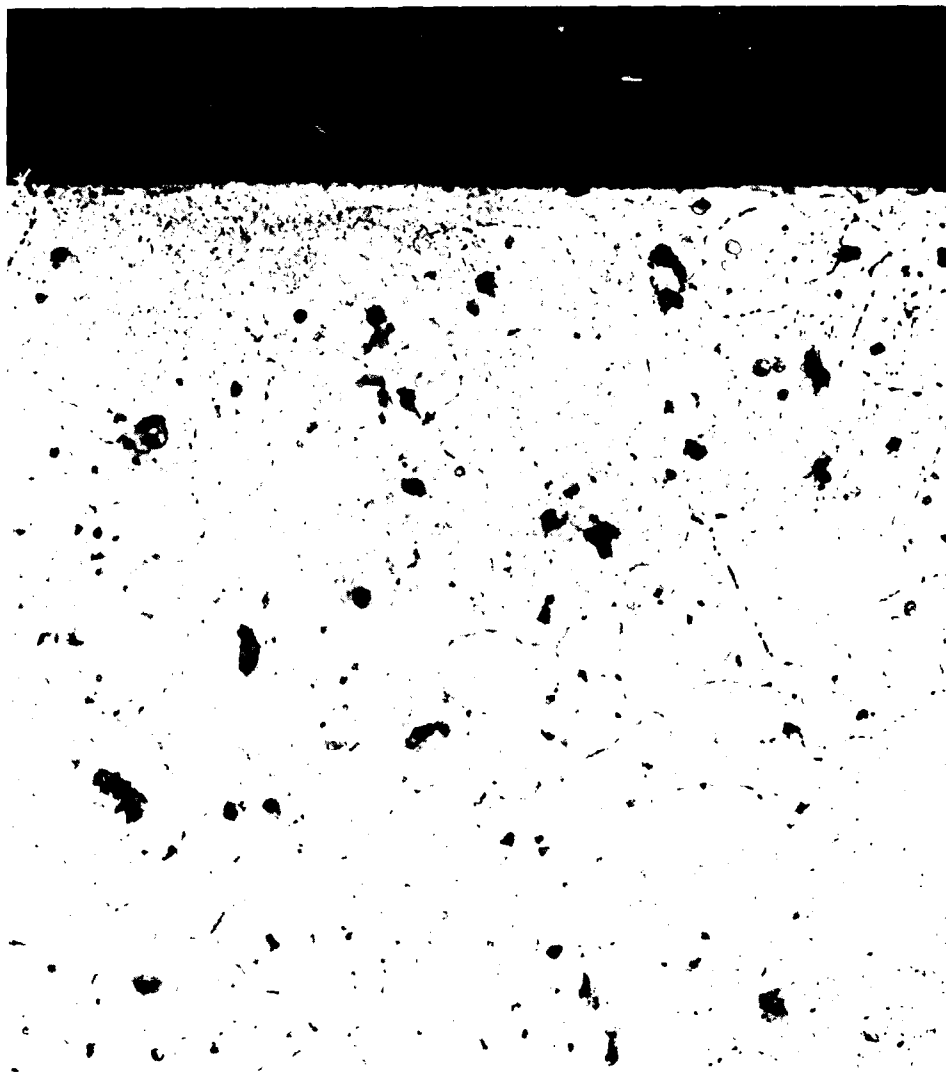
FIGURE 23. SECTION THROUGH THE FIRE-DAMAGED BLOCK (A9-300) SHOWING THE EXTERIOR FACE (TOP OF FIGURE). NOTE THE RELATIVELY UNDAMAGED SURFACE.
