# **Four Firefighters Injured In Lithium-Ion Battery Energy Storage System Explosion - Arizona**

Mark B. McKinnon  
Sean DeCrane  
Steve Kerber

UL Firefighter Safety Research Institute  
Columbia, MD 20145

July 28, 2020

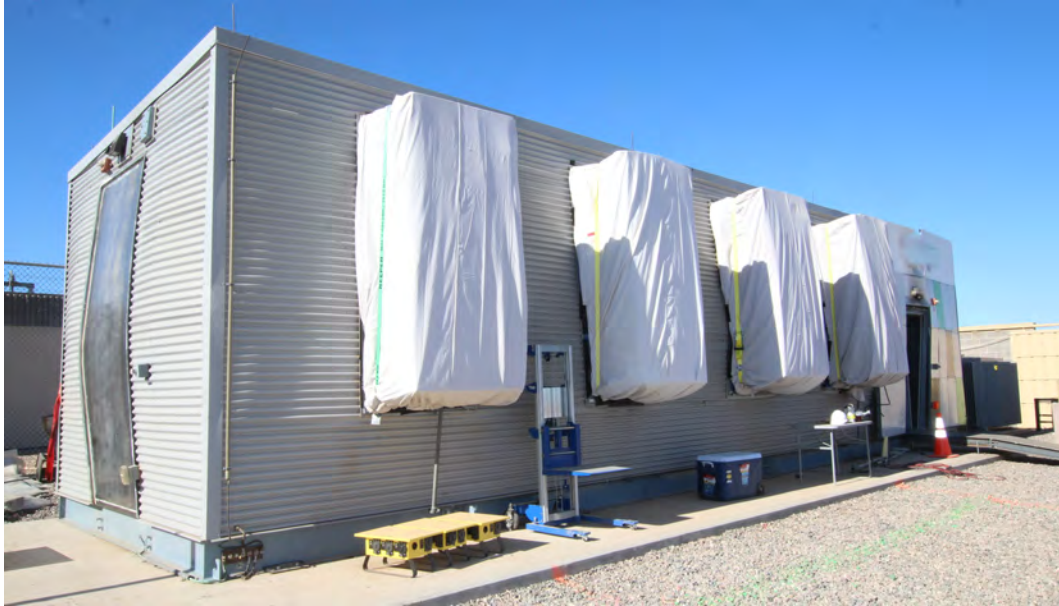
Figure 4.3: Photograph of the ESS after the incident from the southeast [13].

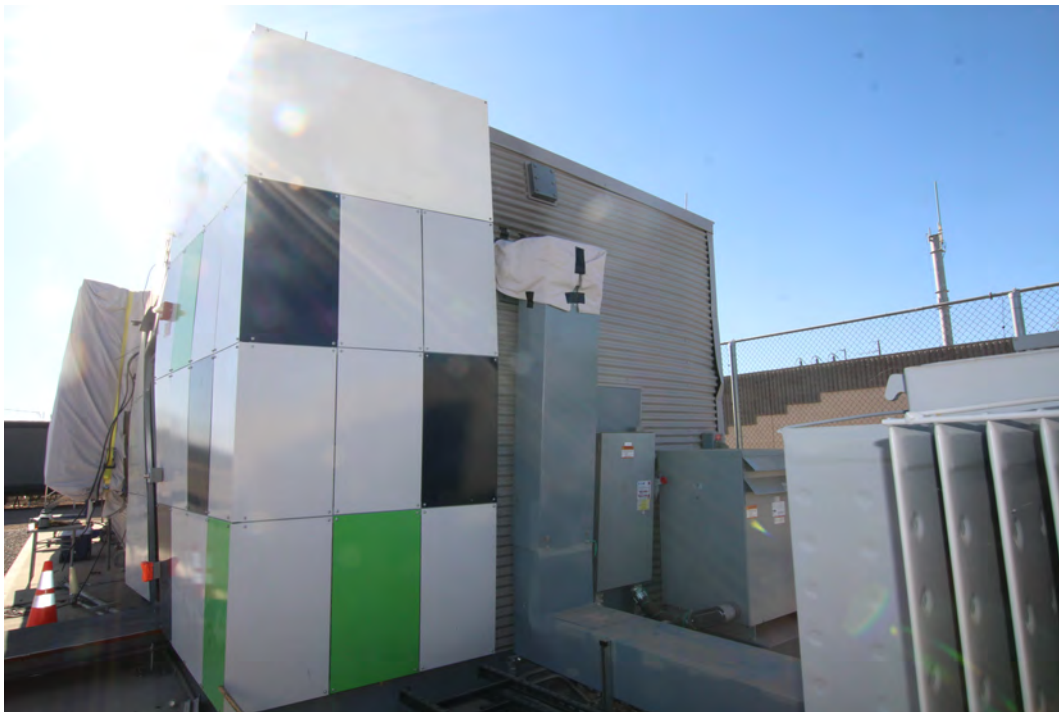
Figure 4.4: Photograph of the ESS after the incident from the northeast [13].

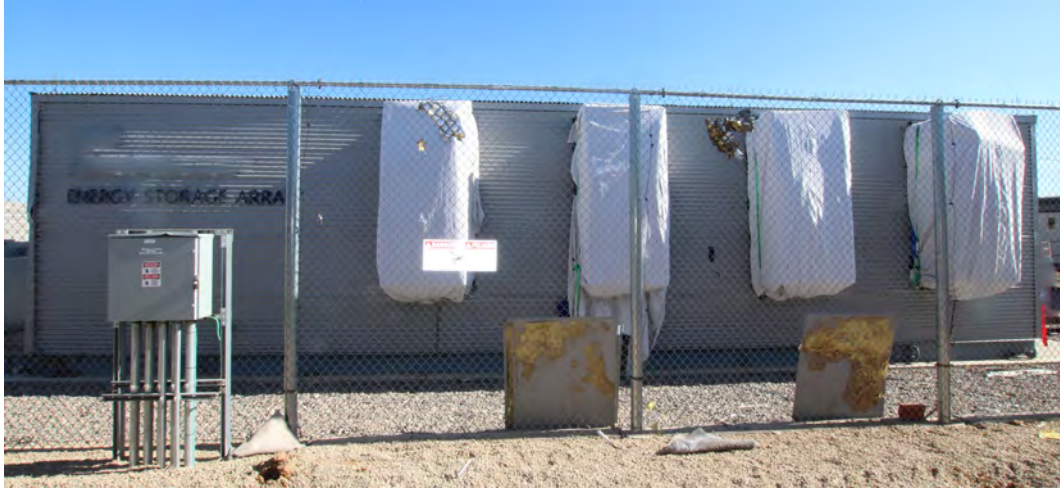
Figure 4.5: Photograph of the ESS after the incident from the northwest [13].

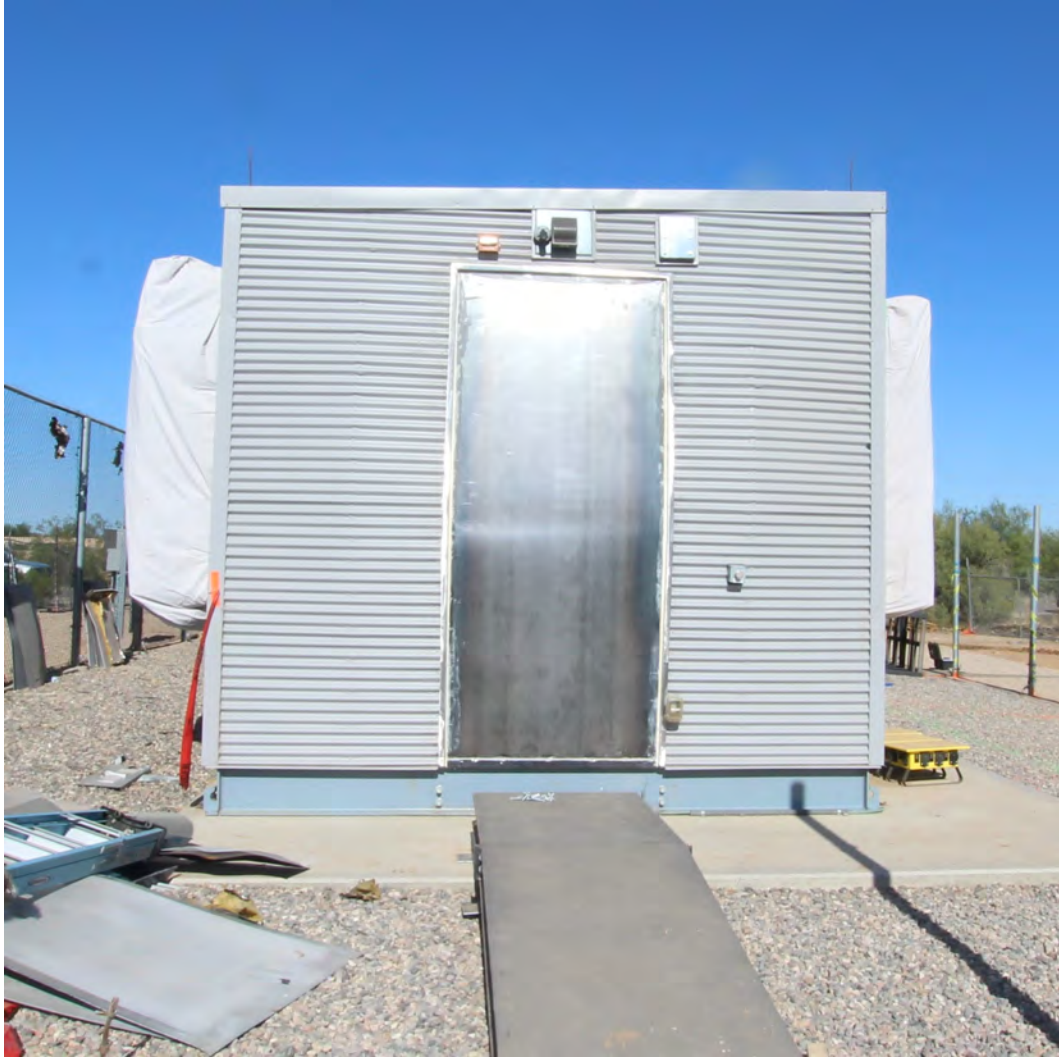
Figure 4.6: Photograph of the ESS after the incident from the southwest [13].

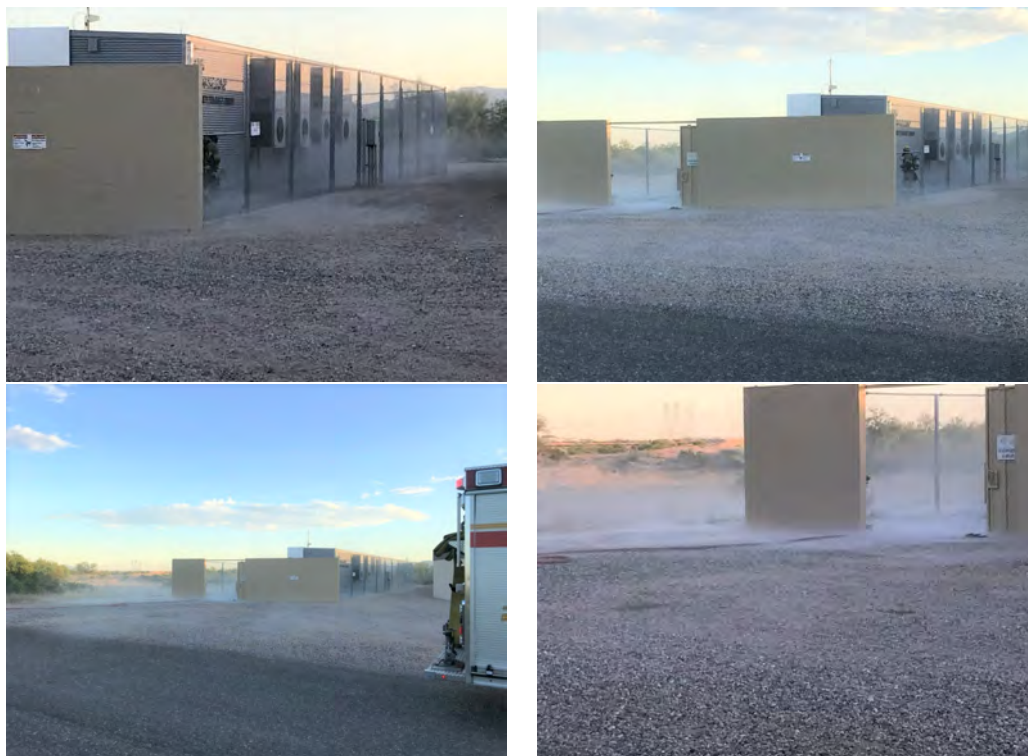
Figure 4.9: Photographs of the ESS scene taken by E193 FE upon the arrival of E193 [6].

Figure 4.9 indicates the ESS was actively leaking gases and vapors when the HAZMAT team arrived and performed a size-up approximately 100 minutes after the Novec 1230 was discharged. Based on a conservative estimate of the apparent area and depth of the vapor cloud in the photographs (100 ft x 60 ft, and a depth of 3 ft), as well as the estimated internal volume of the ESS, a volume of gas/vapor mixture sufficient for at least two complete volume changes had likely occurred. The continual leakage of a mixture of air, gases and vapors produced during thermal runaway, and Novec 1230 over time caused the concentration of the clean agent to fall below the design concentration. It is unlikely the concentration of Novec 1230 remaining in the ESS at the time the door was opened provided meaningful protection against the ignition of flammable gases and vapors that had accumulated in the ESS.

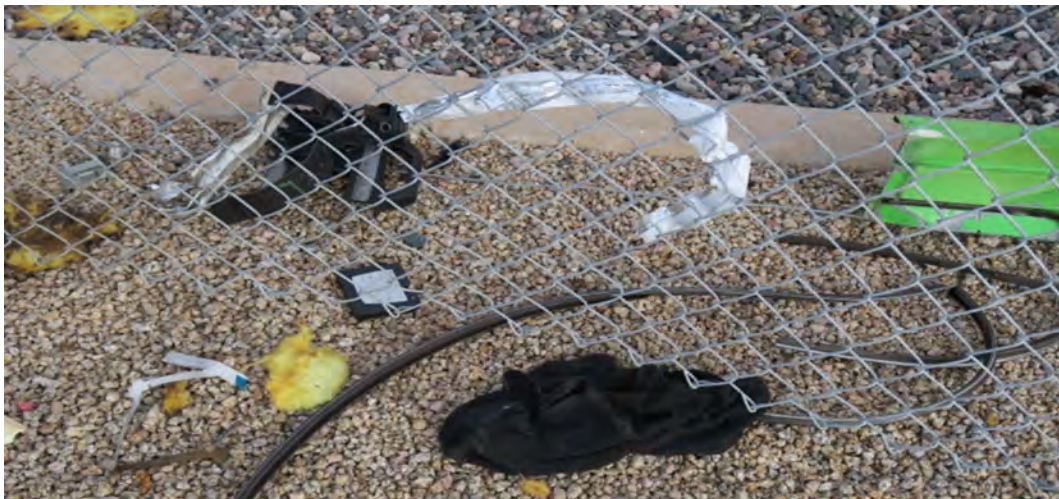
Figure 4.17: Photograph of firefighter equipment removed by the fence during the deflagration [6].

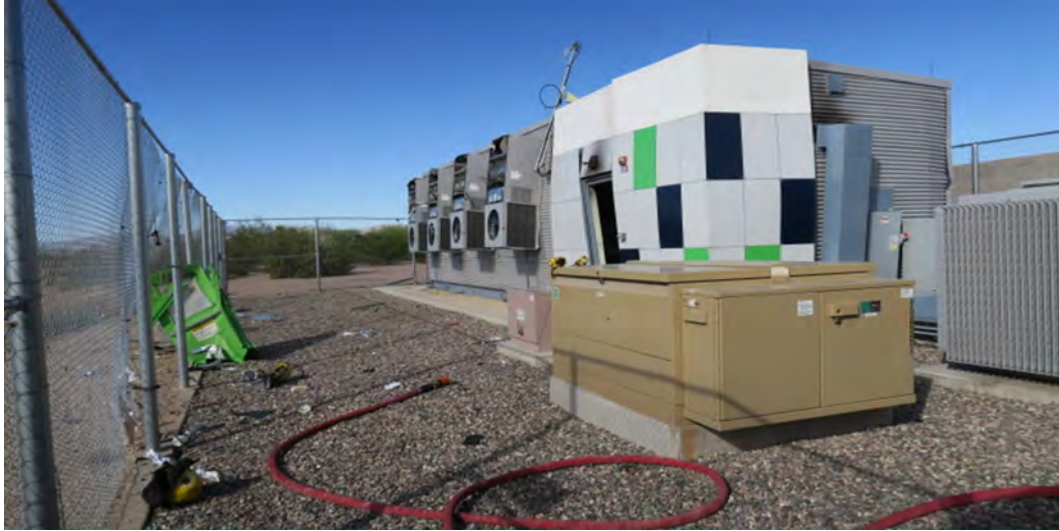
Figure 4.18: Photograph of firefighter helmets and the door to ESS removed during the deflagration [6].

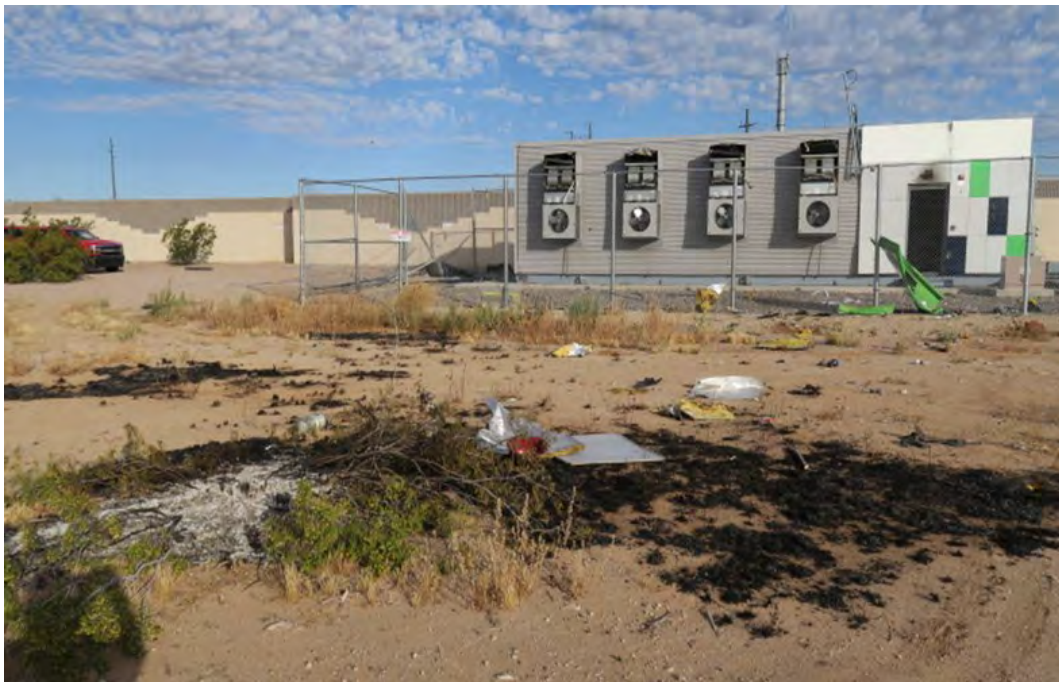
Figure 4.19: Photograph of burned bush, E193 Capt's helmet, and SCBA tank removed during the deflagration [6].

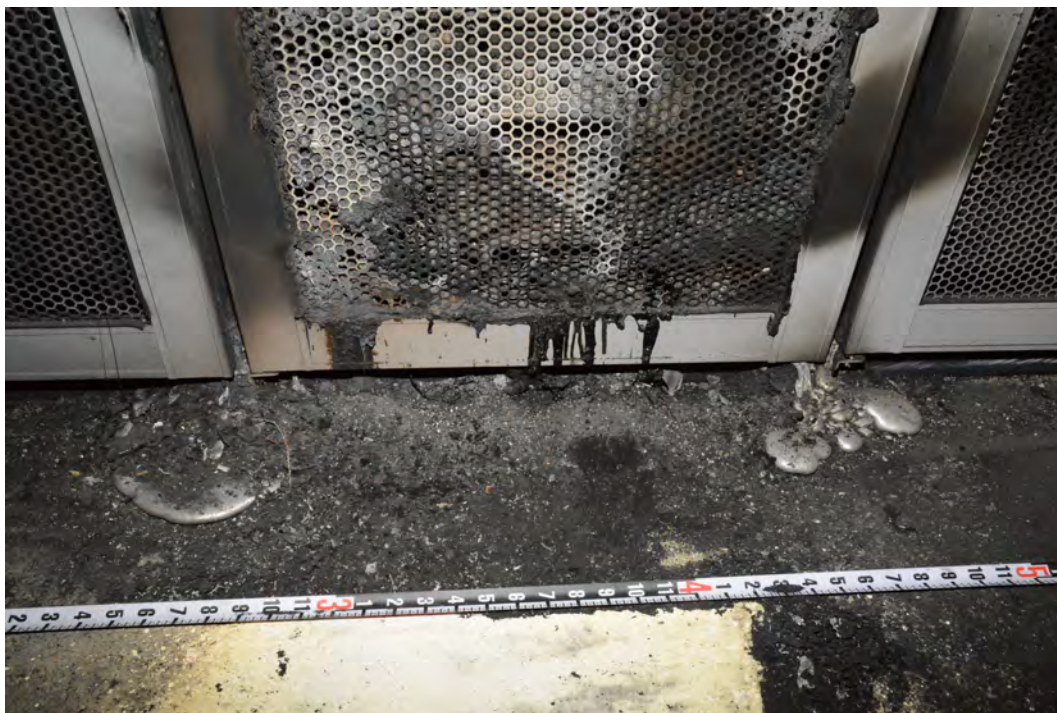
A photograph of the floor in front of Rack 15 taken during decommissioning is provided in Figure A.1. The photograph shows solidified pools of molten aluminum that apparently flowed down along the sides of the front of the rack during the incident. The melting temperature of aluminum is 1,220°F [22]. Studies conducted by the American Petroleum Institute suggest that a surface temperature approximately 360°F above the autoignition temperature is required to facilitate ignition [36]. Hydrogen as well as most hydrocarbons, which are major components of the gas mixture expected to be released from lithium-ion batteries undergoing thermal runaway, have autoignition temperatures below 860°F [37]. It has also been observed that the exothermic reactions that are a key contributor to propagation of the thermal runaway process produce temperatures that are capable of causing hot surface ignition of flammable mixtures [22].

Figure A.1: Photograph taken during decommissioning of the ESS shows a pool of solidified aluminum on the floor in front of Rack 15 [11].

Lithium-ion battery cells have been observed to eject molten metal during thermal runaway [19, 22]. These metal droplets are likely to be at a sufficient temperature to act as a competent ignition source for a flammable gas and vapor mixture.
