**Snitz Creek 18 and Upper 19 Stream and Floodplain Restoration  
Existing Conditions Photographs**

## Reach 18 - Existing Conditions

## Reach Upper 19 Existing Conditions

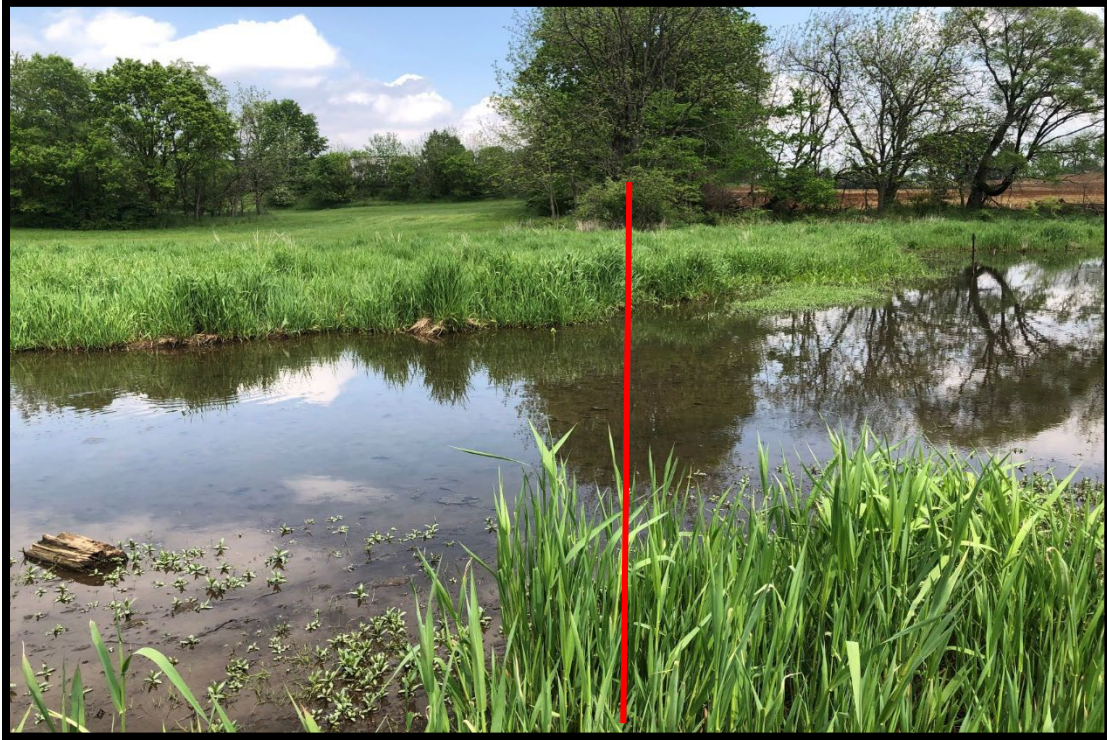
Permanently flooded emergent wetland along right floodplain at upstream boundary of Reach 18

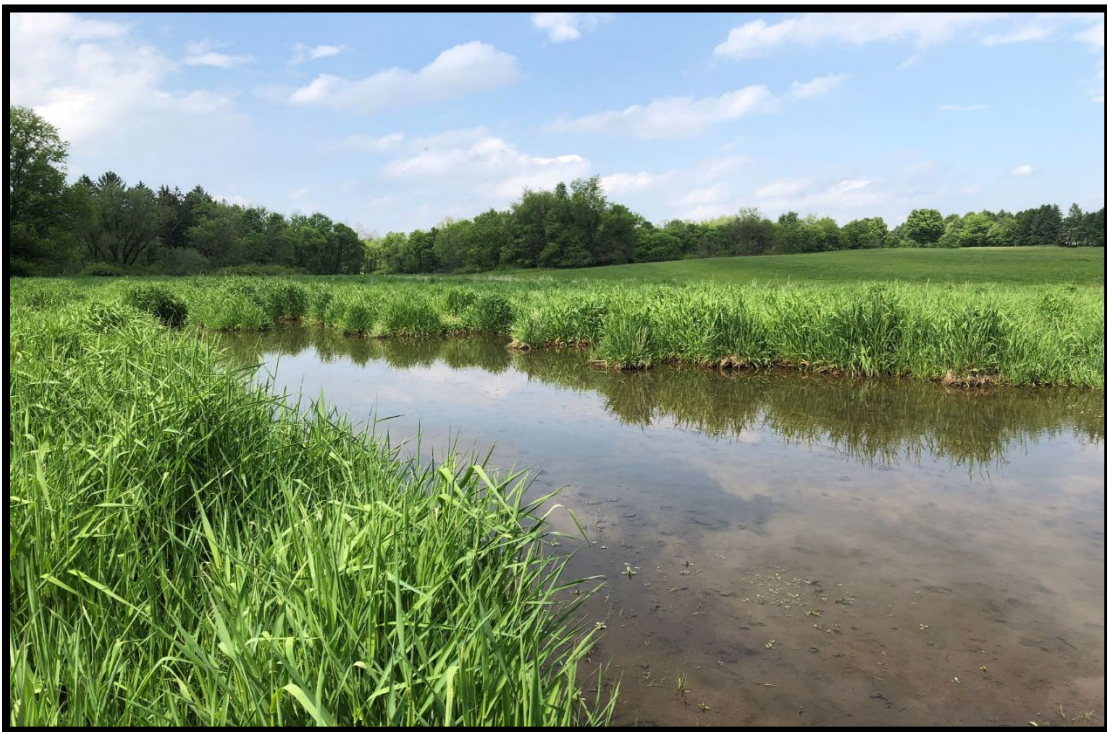
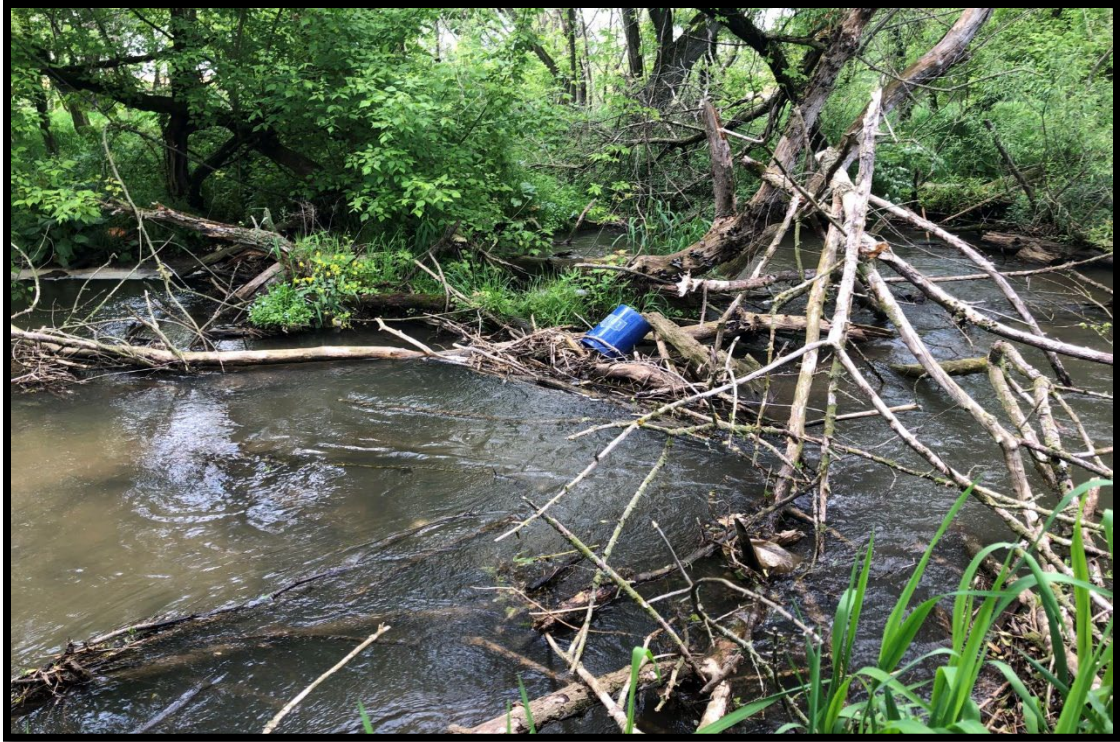
**Fallen trees and large debris jams along upstream end of Reach 18**

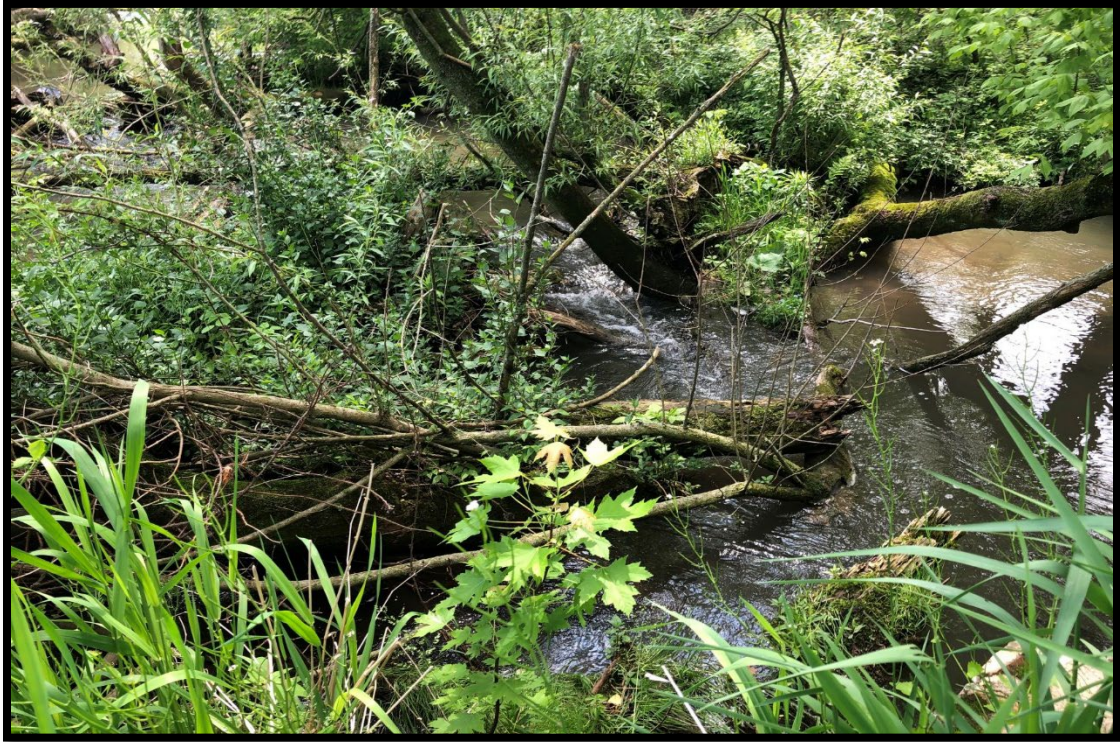
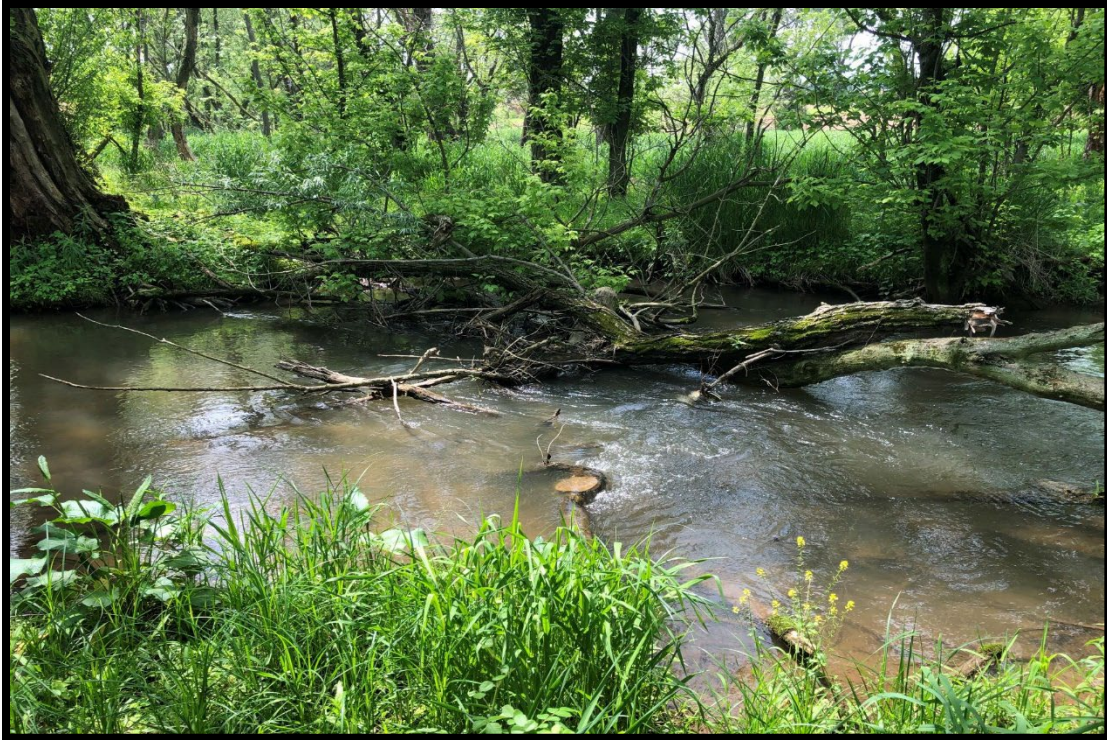
**Fallen trees and debris jams along upper section of Reach 18**

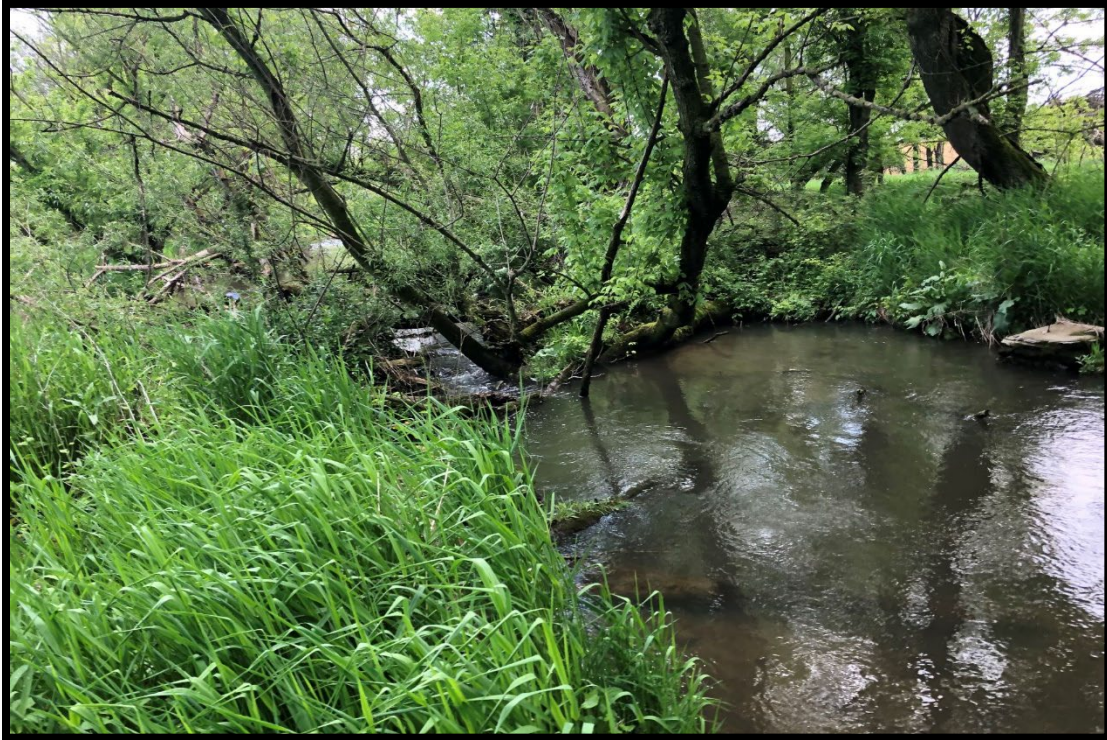
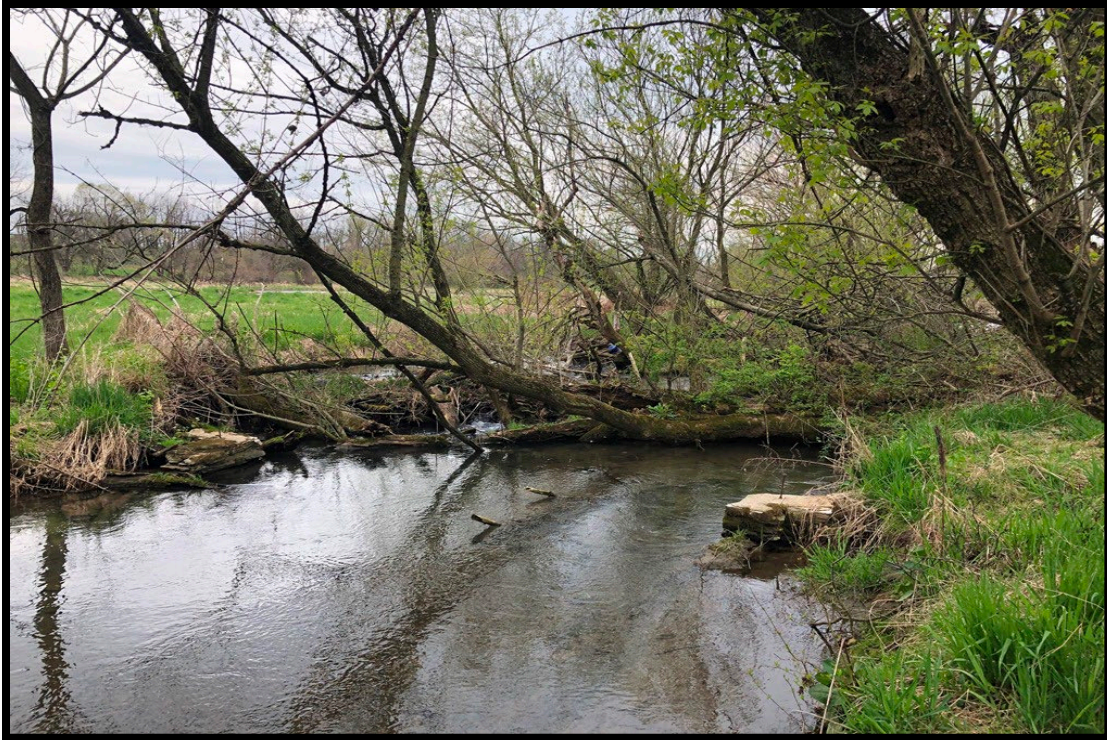
**Fallen trees and debris jams along upper section of Reach 18**

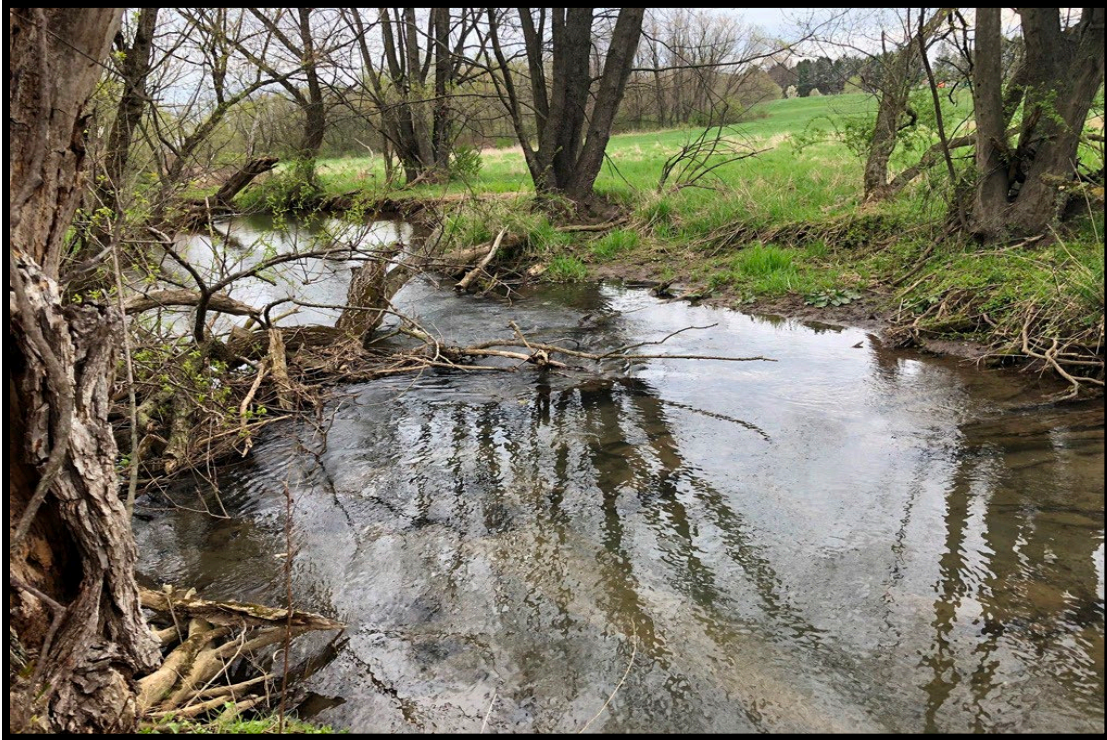
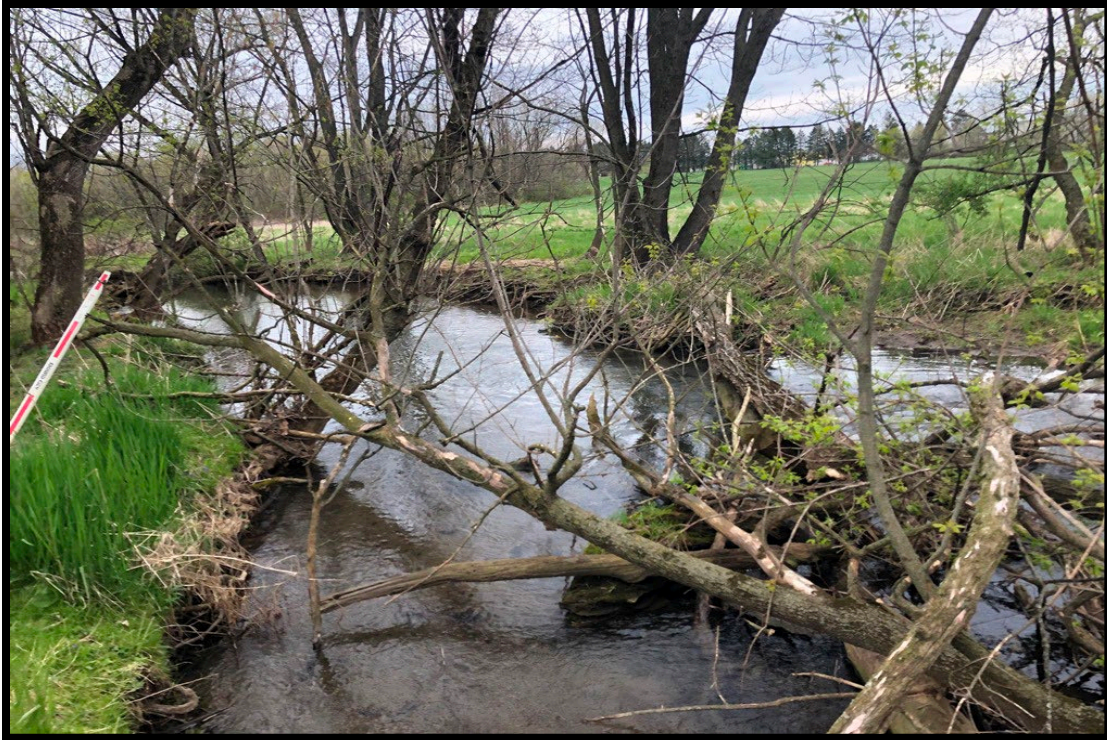
**Fallen trees and debris jams along upper section of Reach 18**

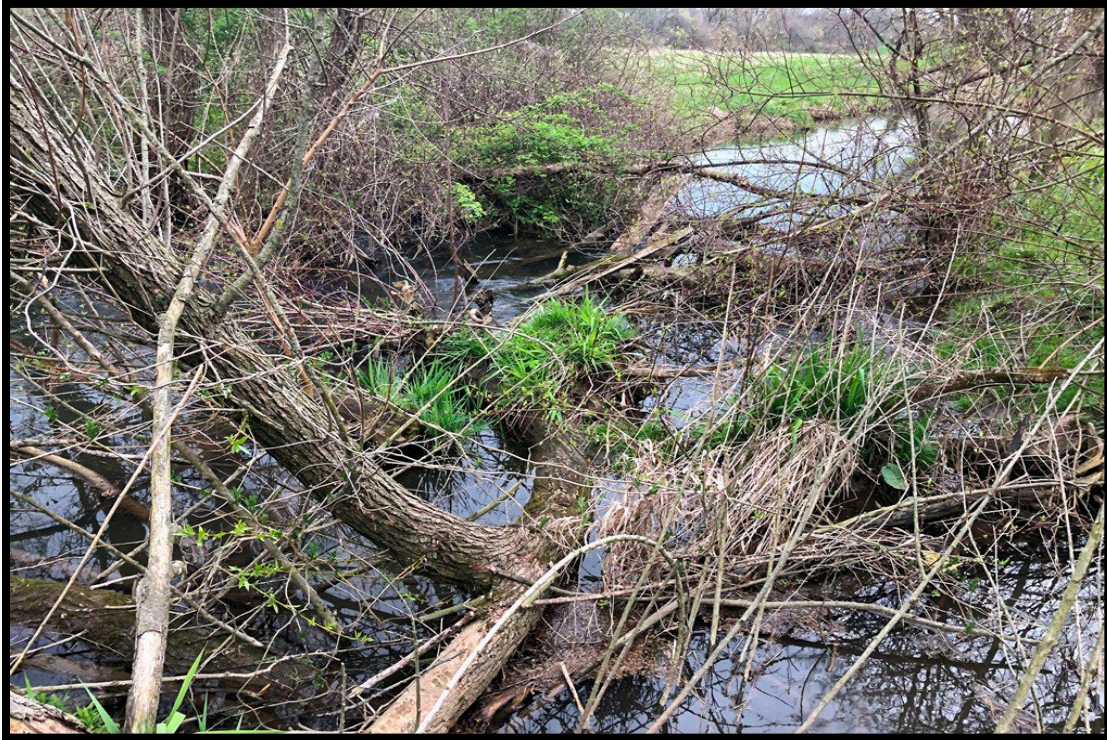
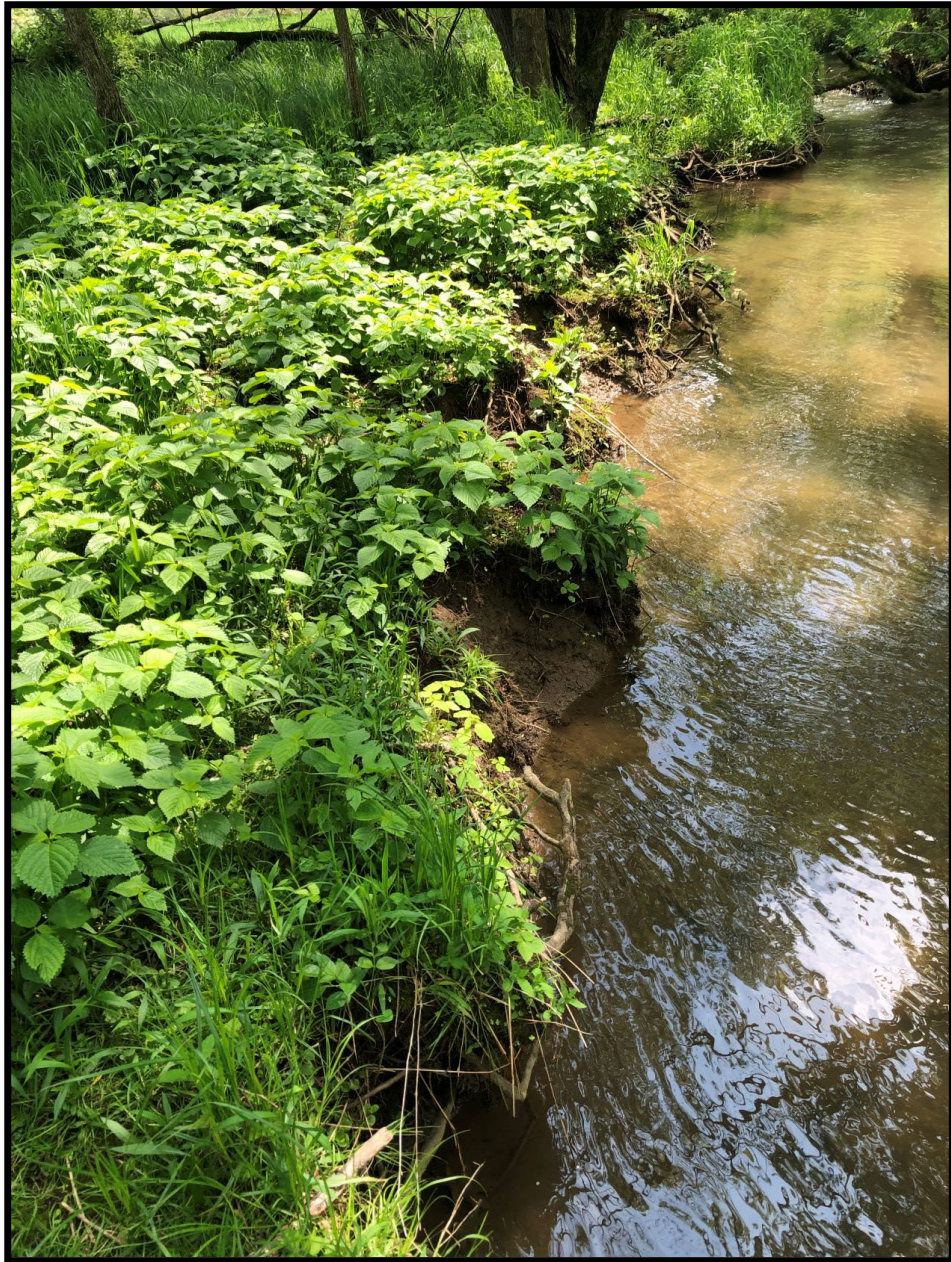
**Eroding right bank along upstream section of Reach 18**

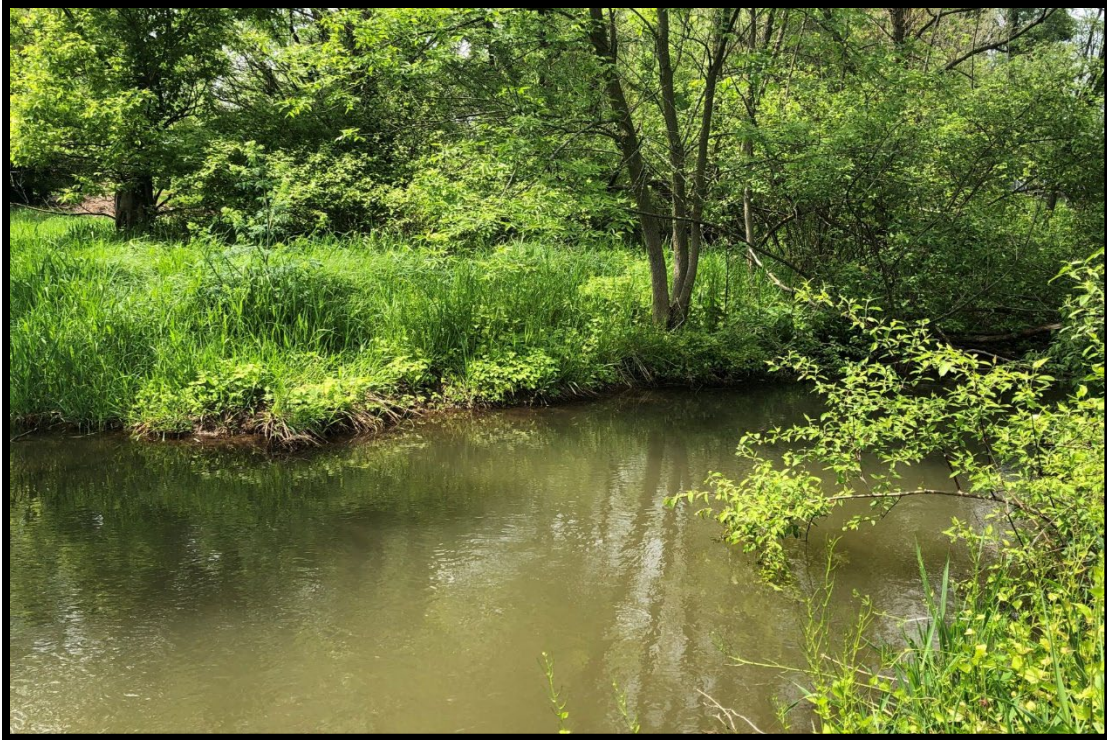
**Stable left banks along upper section of Reach 18**

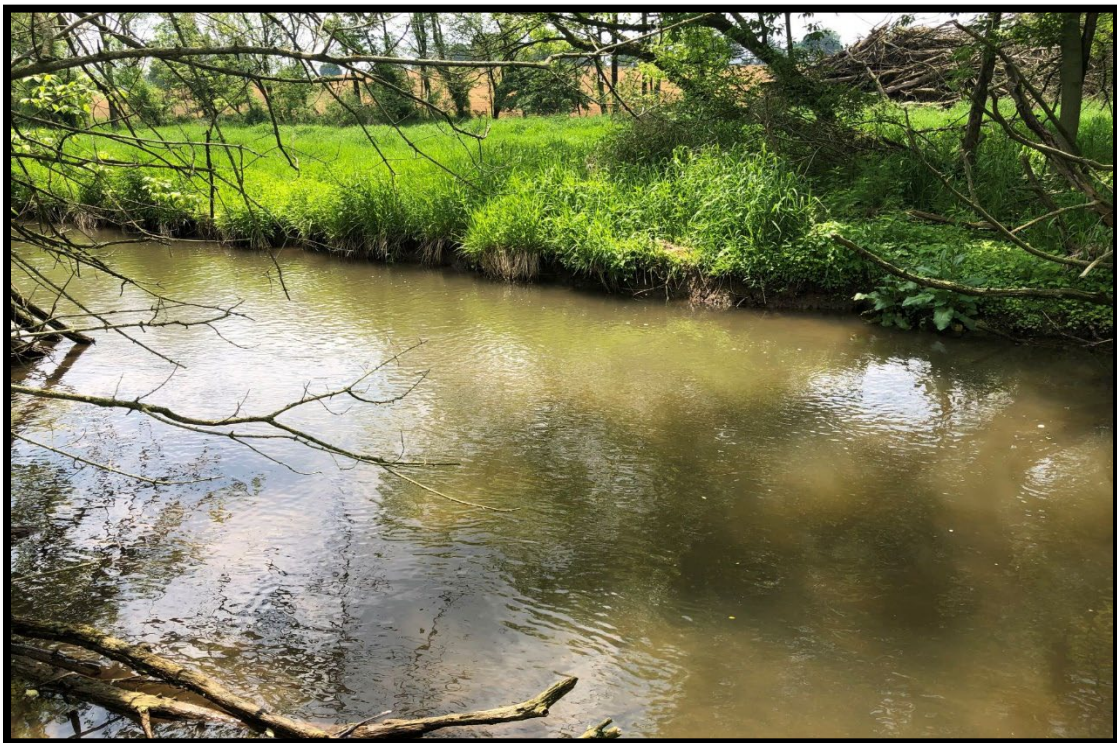
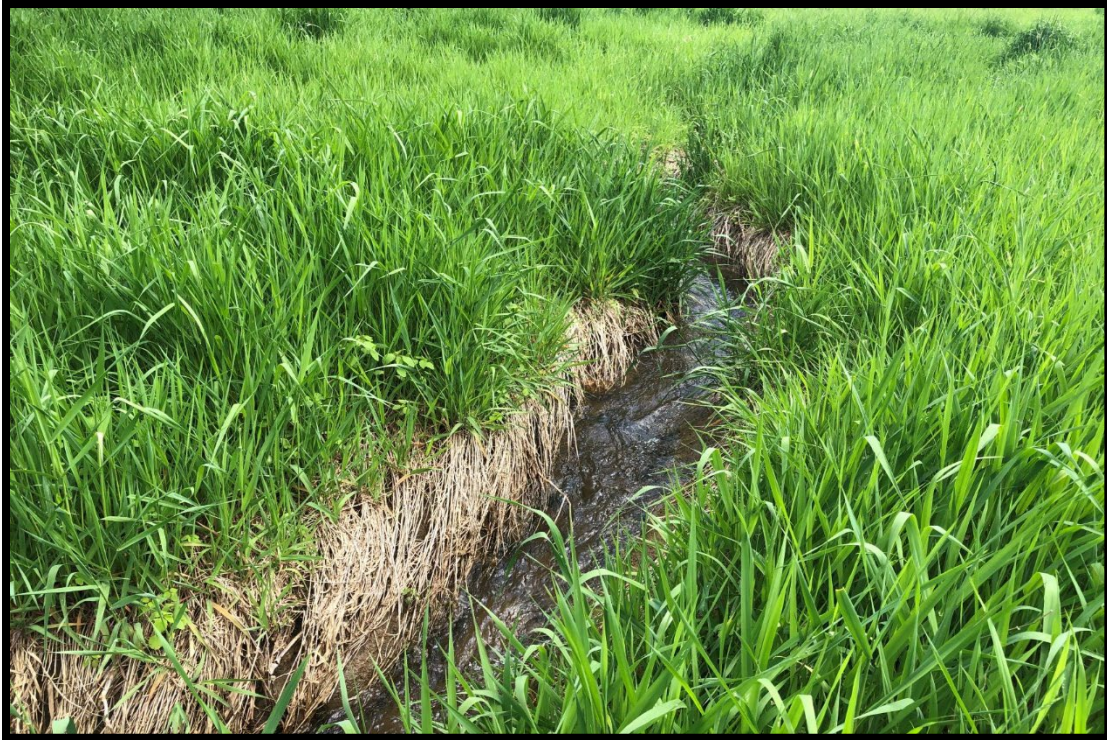
**Ditch cut to drain emergent wetland along right floodplain**

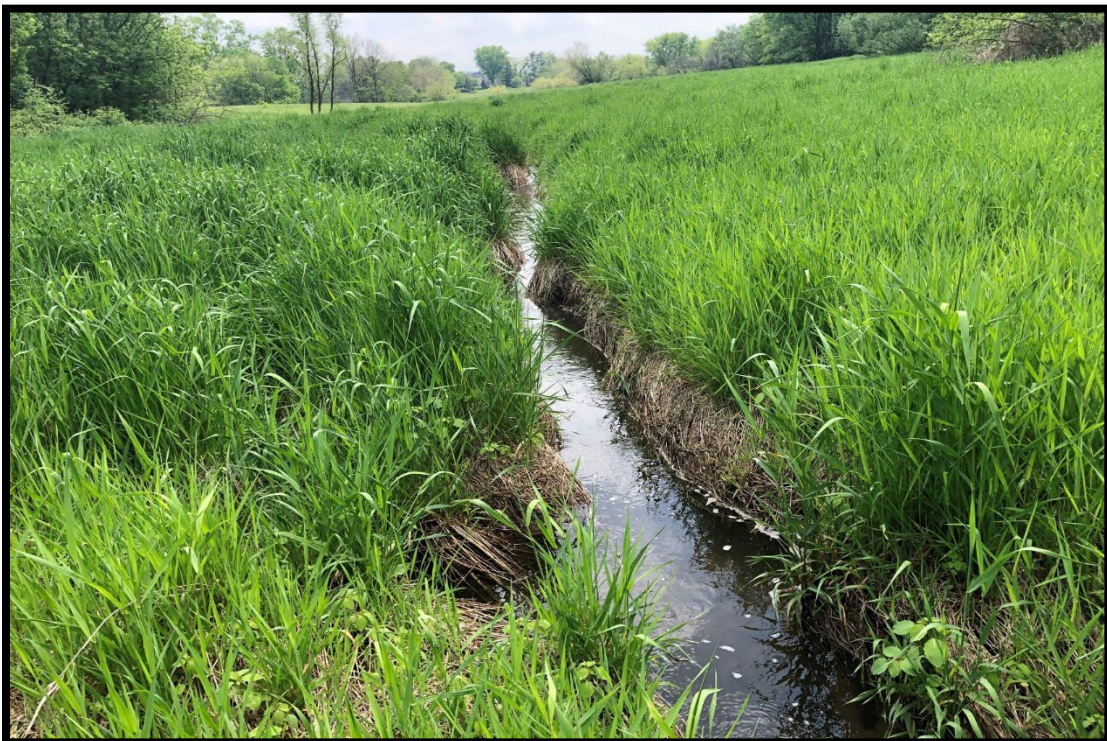
**Drainage ditch evolving into eroding gully**

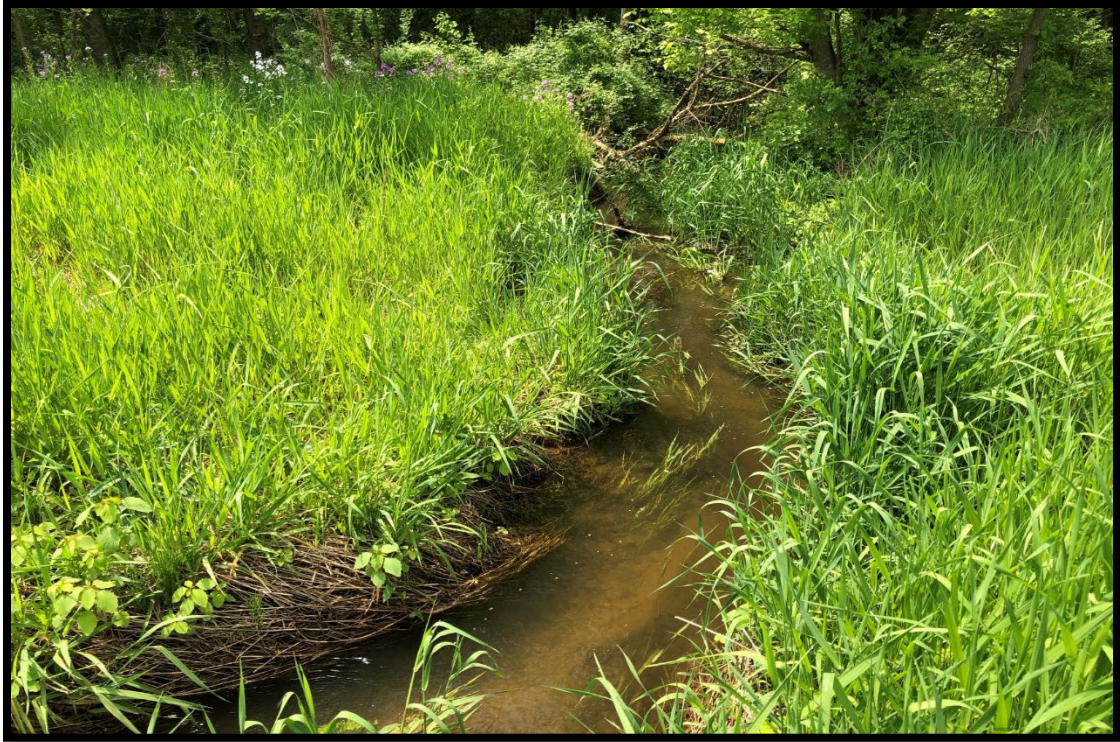
**Drainage ditch along right floodplain turning toward confluence with Snitz Creek**

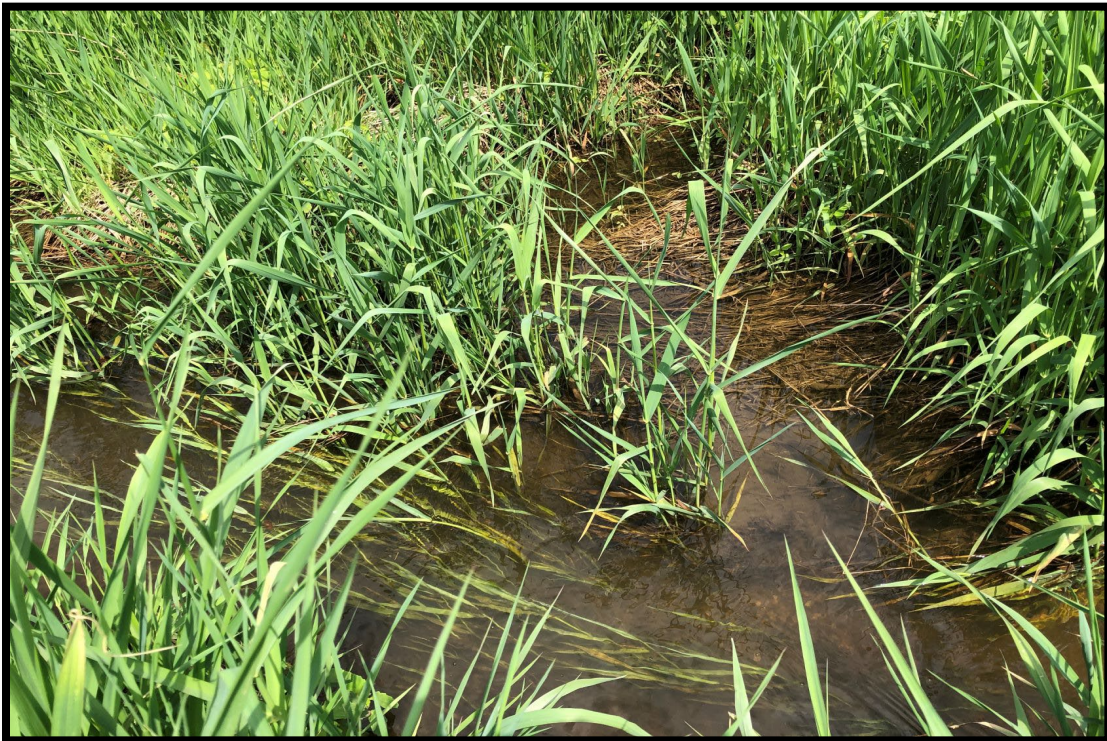
**Hydrologic conditions along right floodplain in spite of drainage ditches**

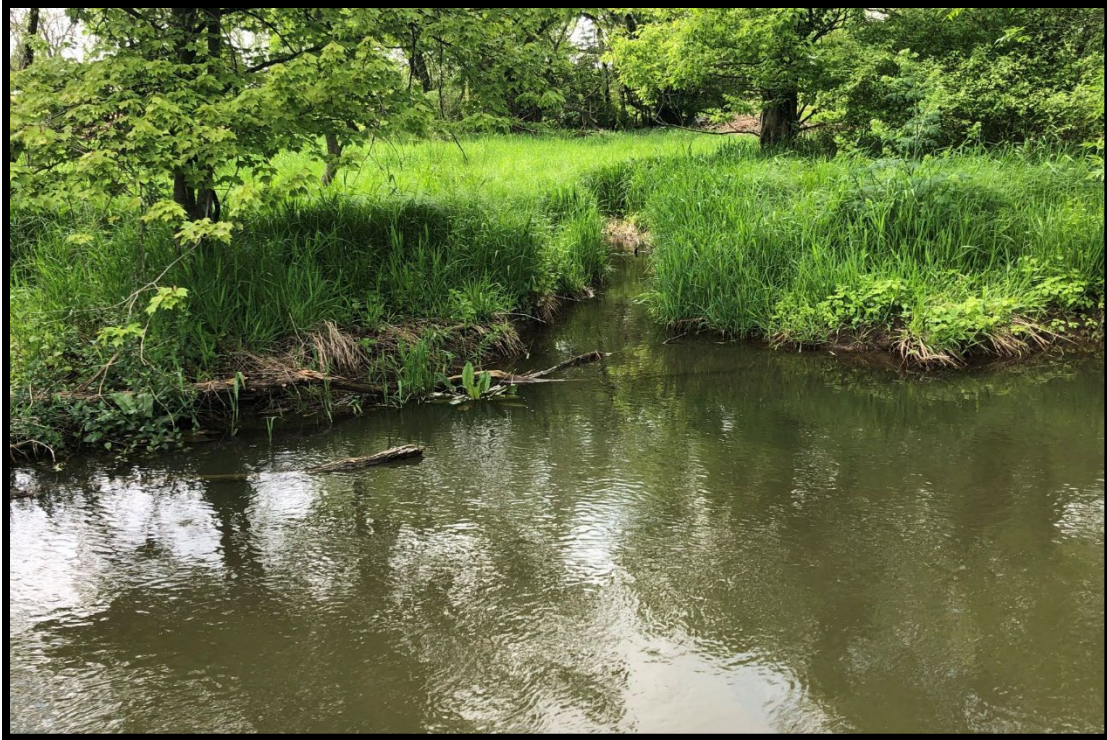
**Typical permanently flooded emergent wetland area along left floodplain.  
Perennial baseflow in side channels.**

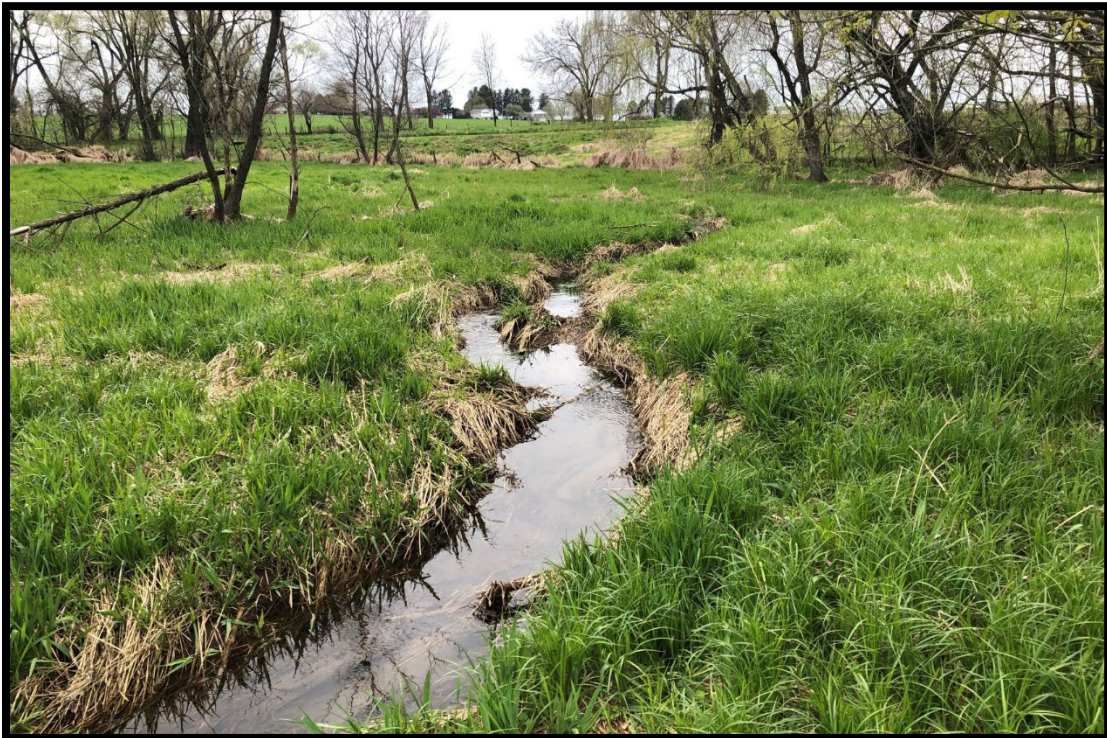
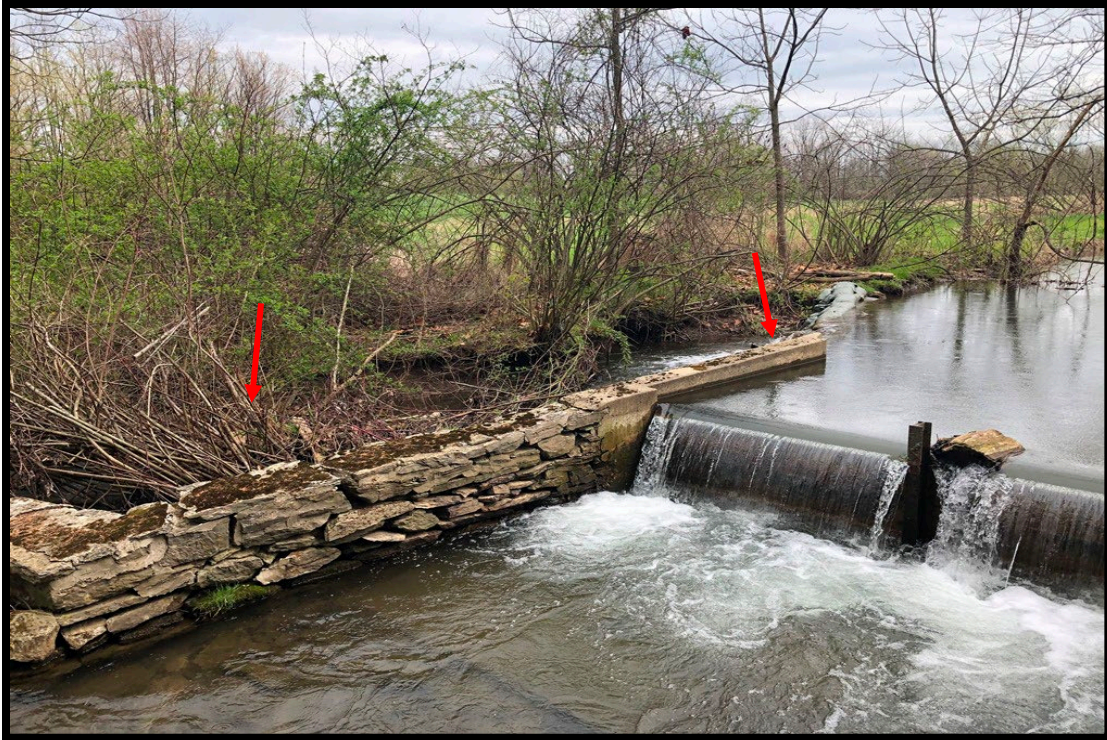
**Low-head dam along middle section of Reach 18. Note eroded cutoff channel.**

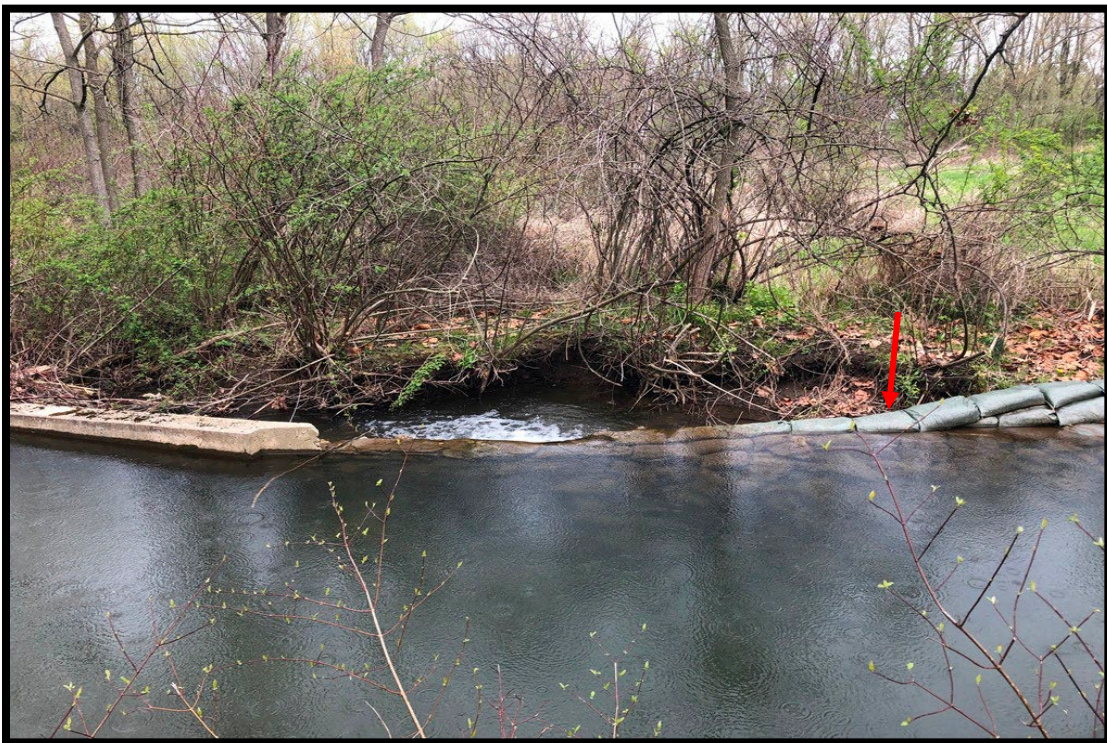
**Sandbags blocking cutoff channel are temporarily maintaining the water level necessary to feed pond inlet**

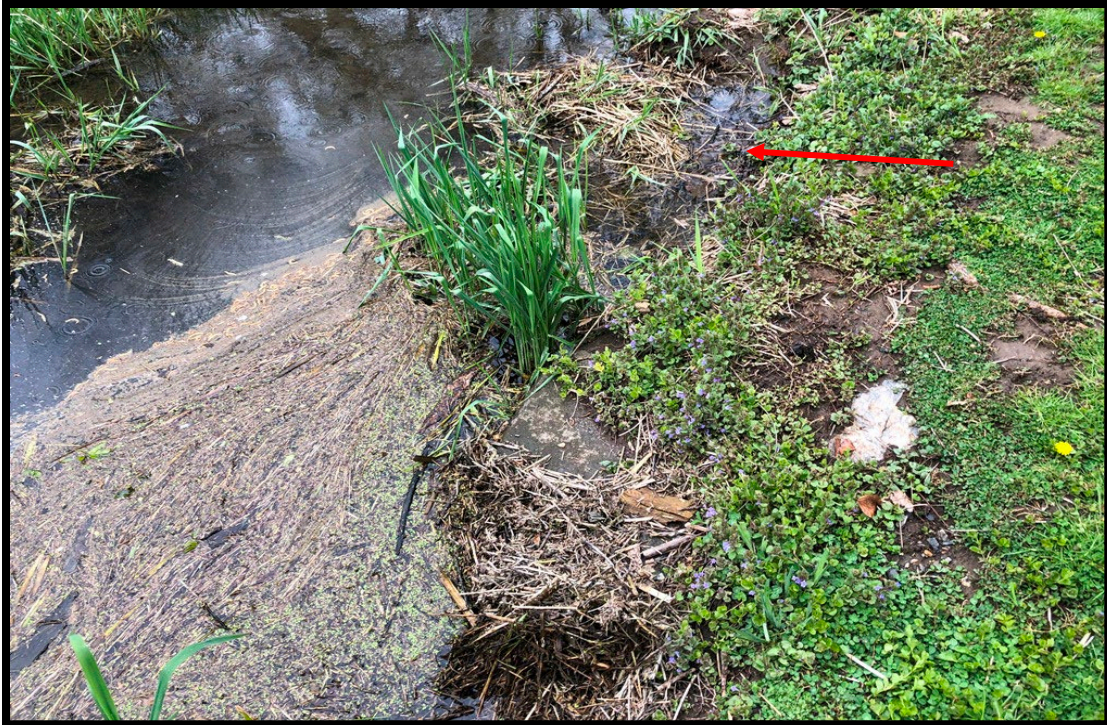
**Pond inlet pipe clogged with vegetation and debris. Inlet pipe outfall into pond.**

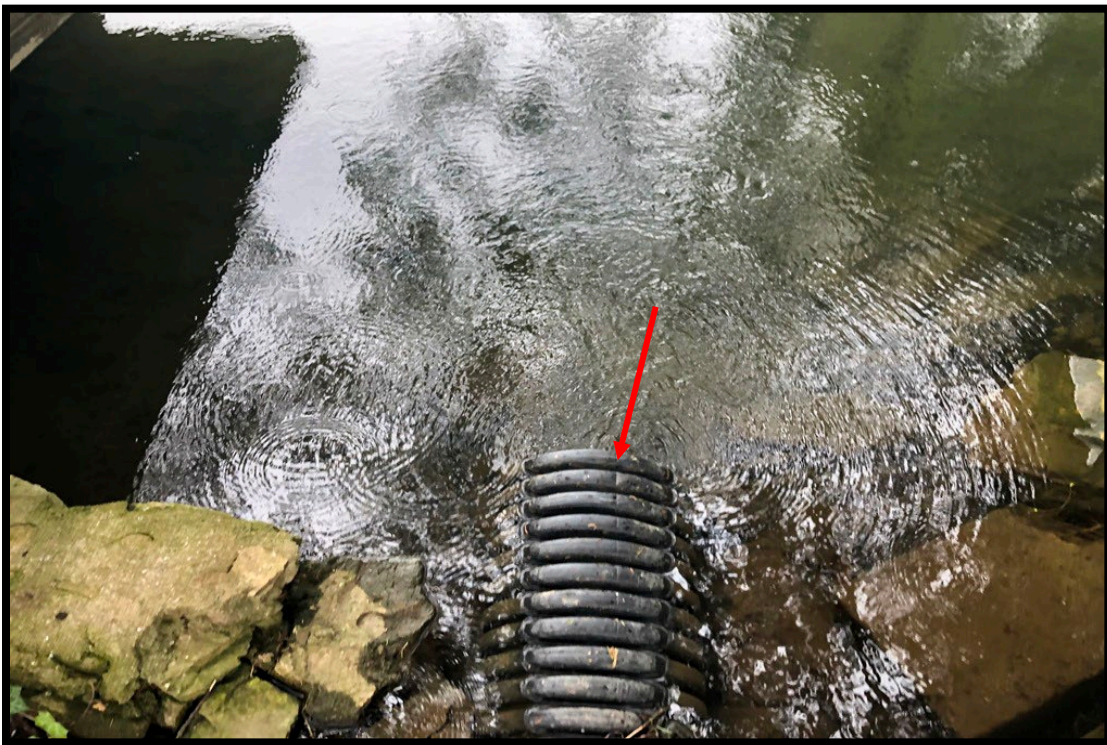
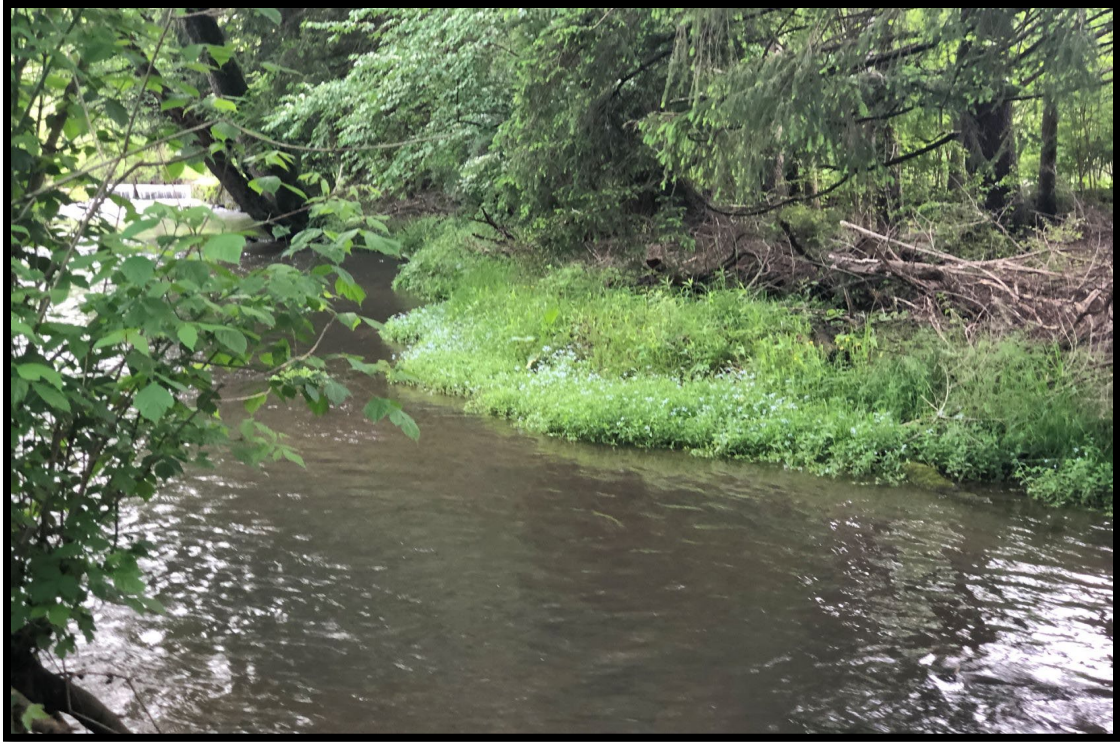
**Stable left banks downstream of dam**

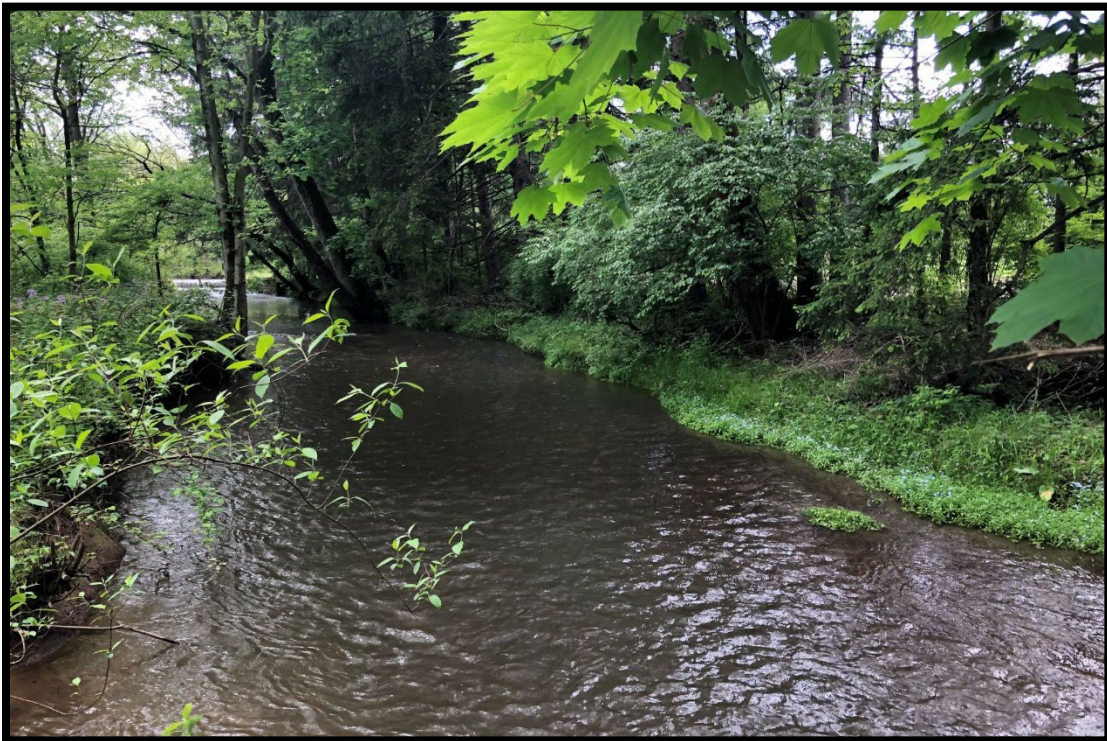
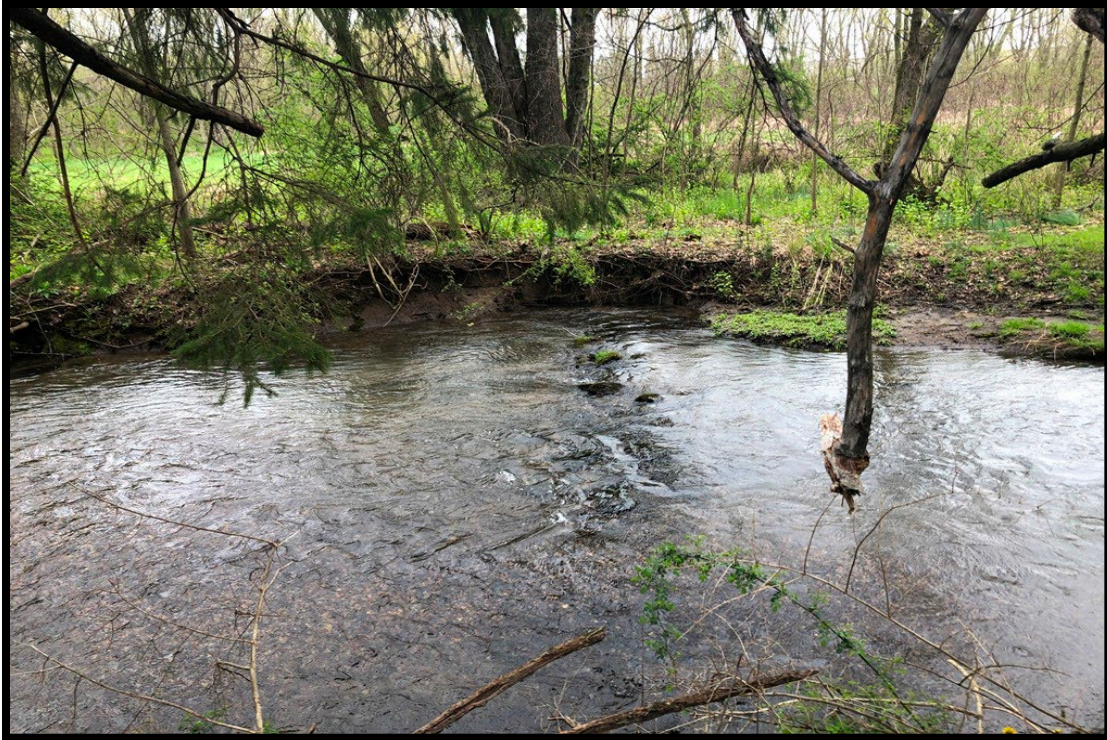
**Erosion along entire length of right bank downstream of dam**

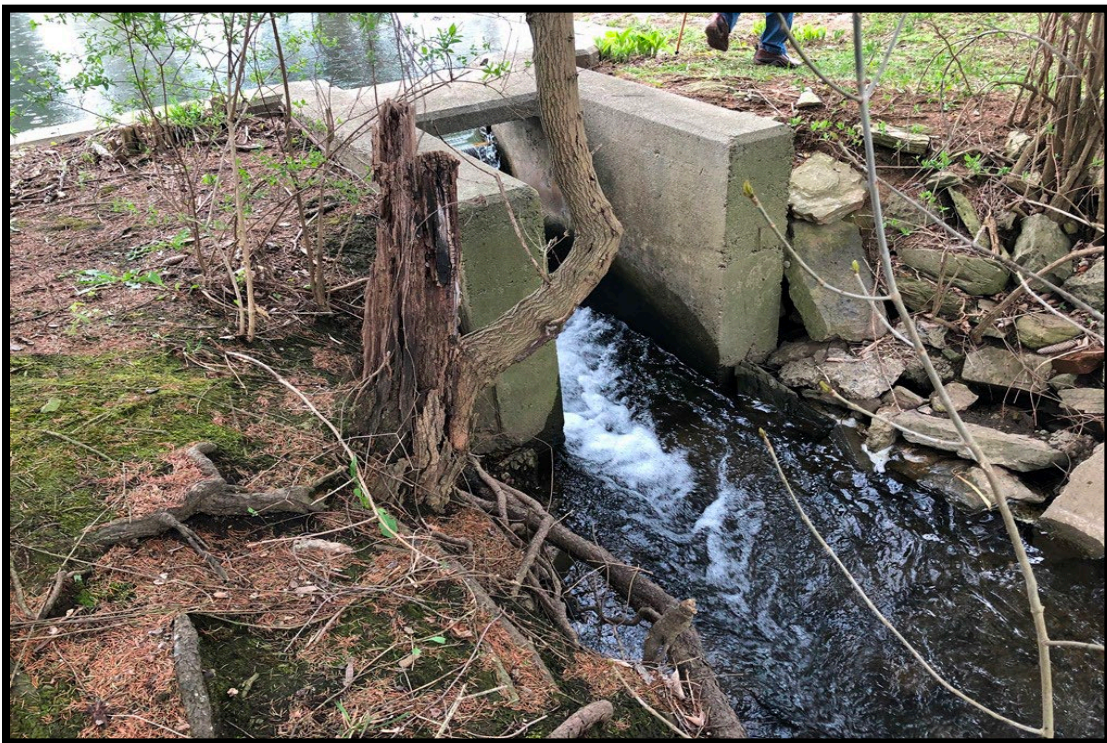
**Concrete and rubble stabilizing bank eroding adjacent to pond outfall.**
