**Snitz Creek 18 and Upper 19 Stream and Floodplain Restoration  
Existing Conditions Photographs**

## Reach 18 - Existing Conditions

## Reach Upper 19 Existing Conditions

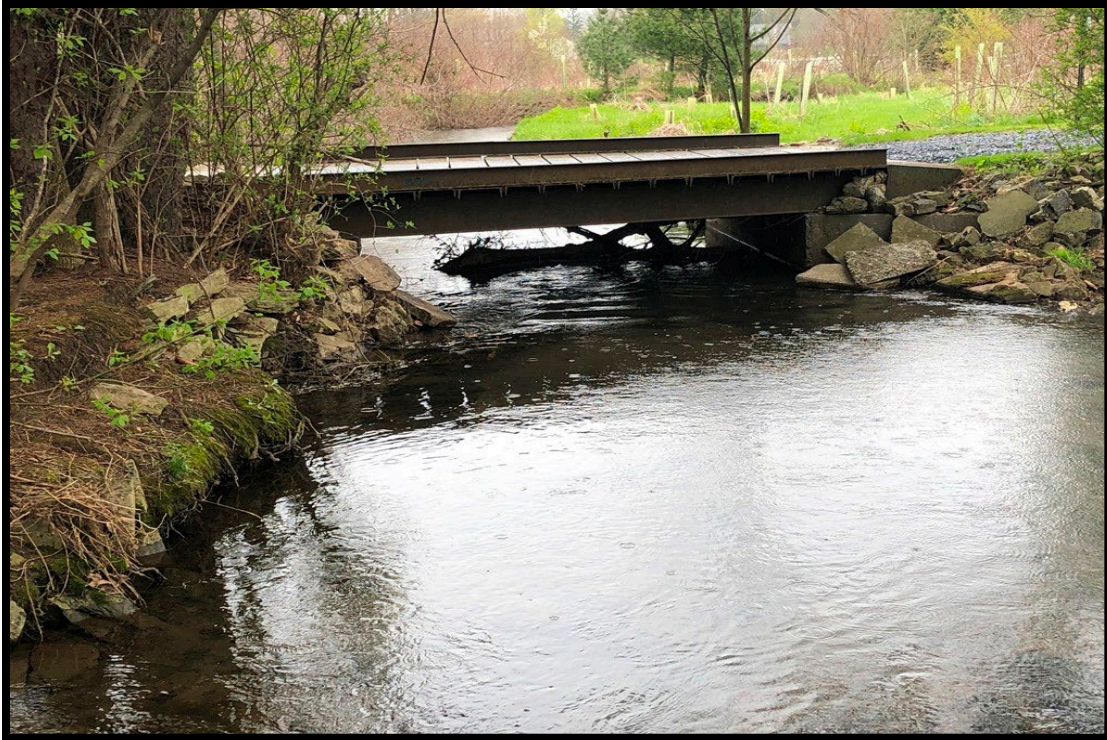
**Bridge with concrete and rubble stabilizing both banks at downstream end of Reach 18**

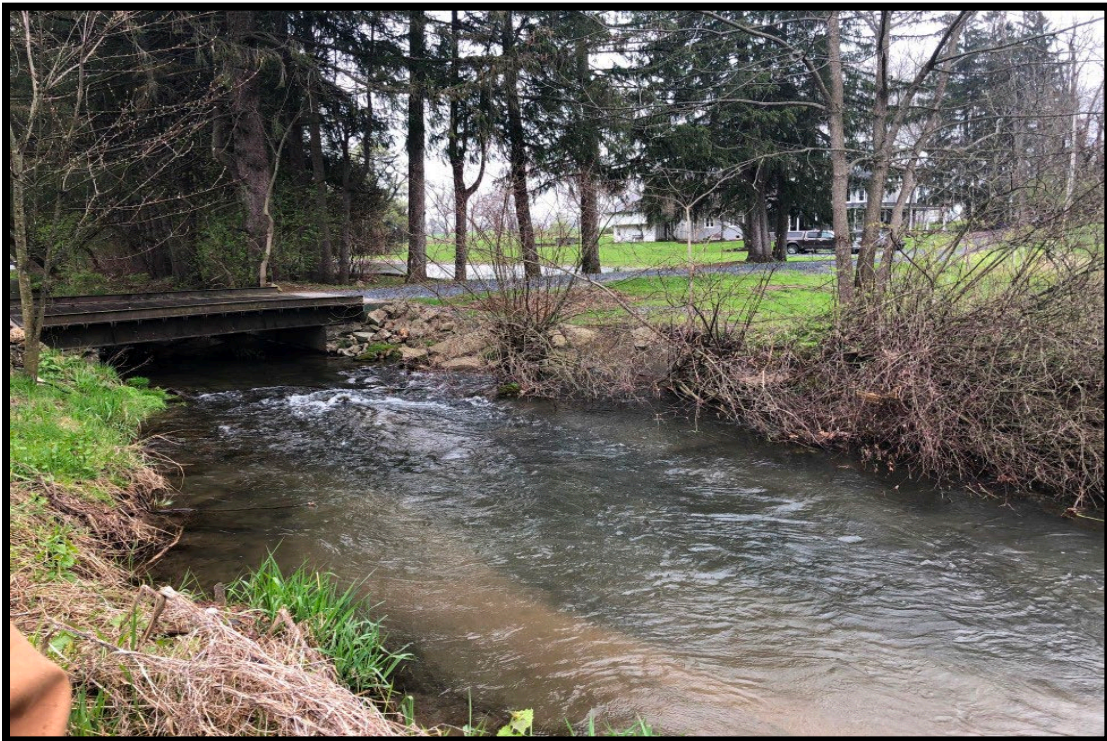
**Bridge at upstream end of Reach Upper 19 with concrete and rubble stabilizing left bank.**

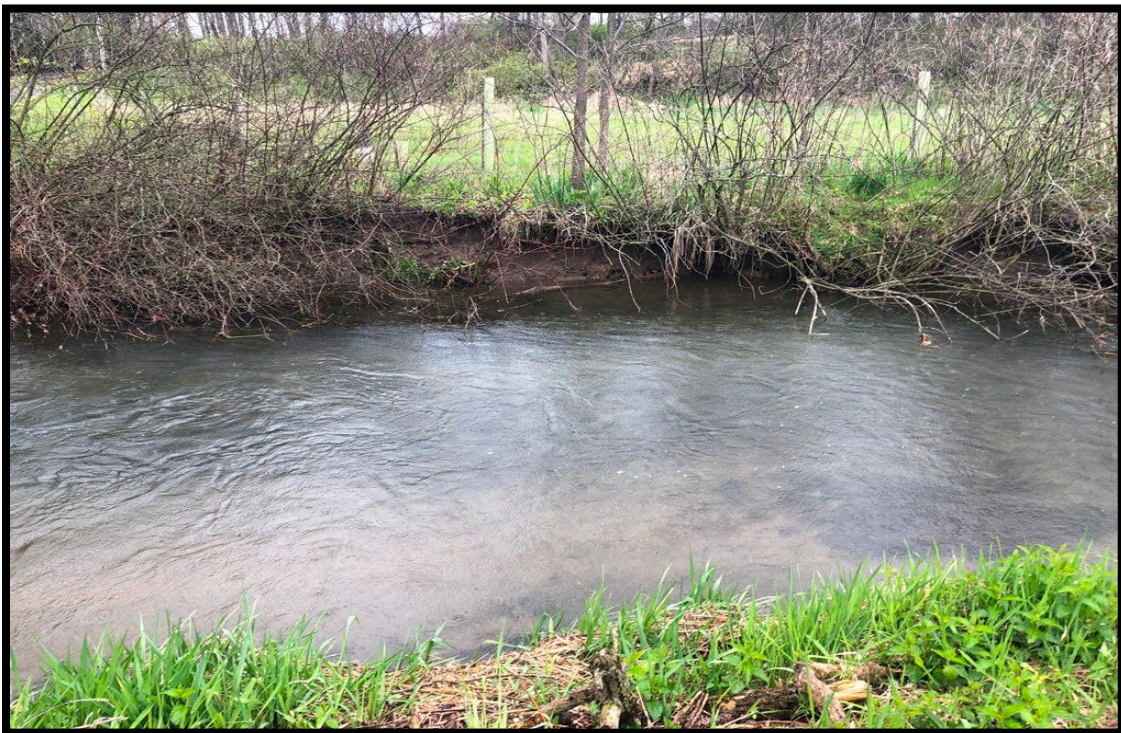
Erosion along entire length of left bank upper section of Reach Upper 19

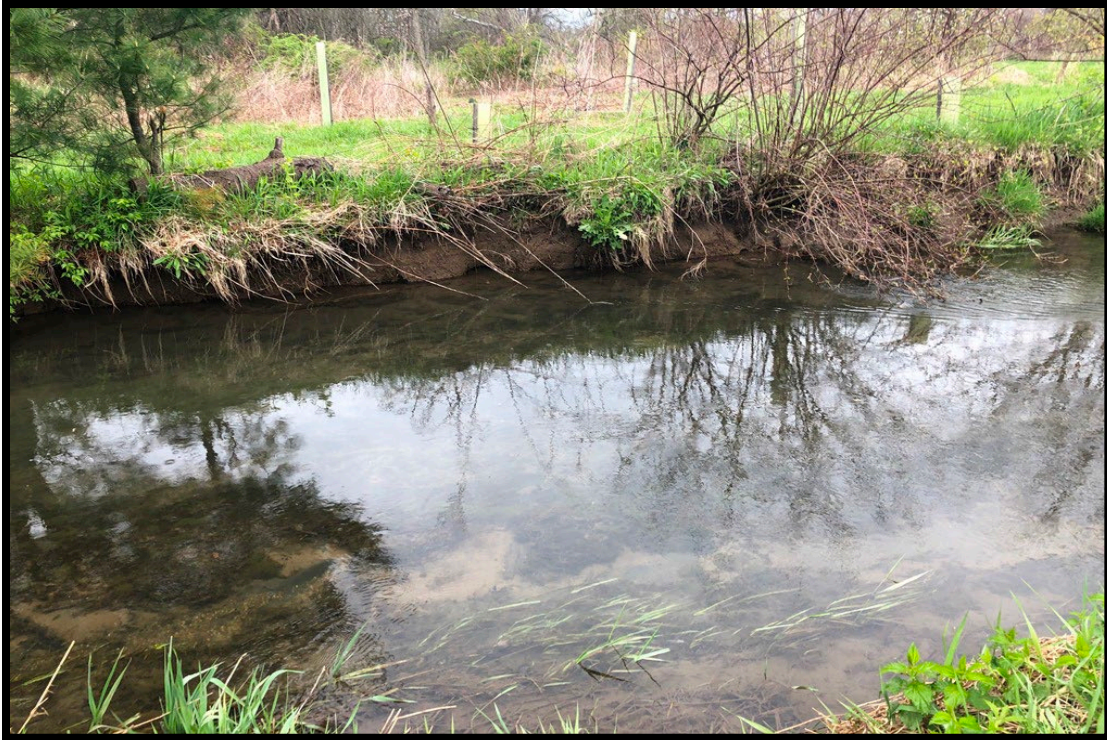
**Erosion along entire length of left bank upper section of Reach Upper 19**

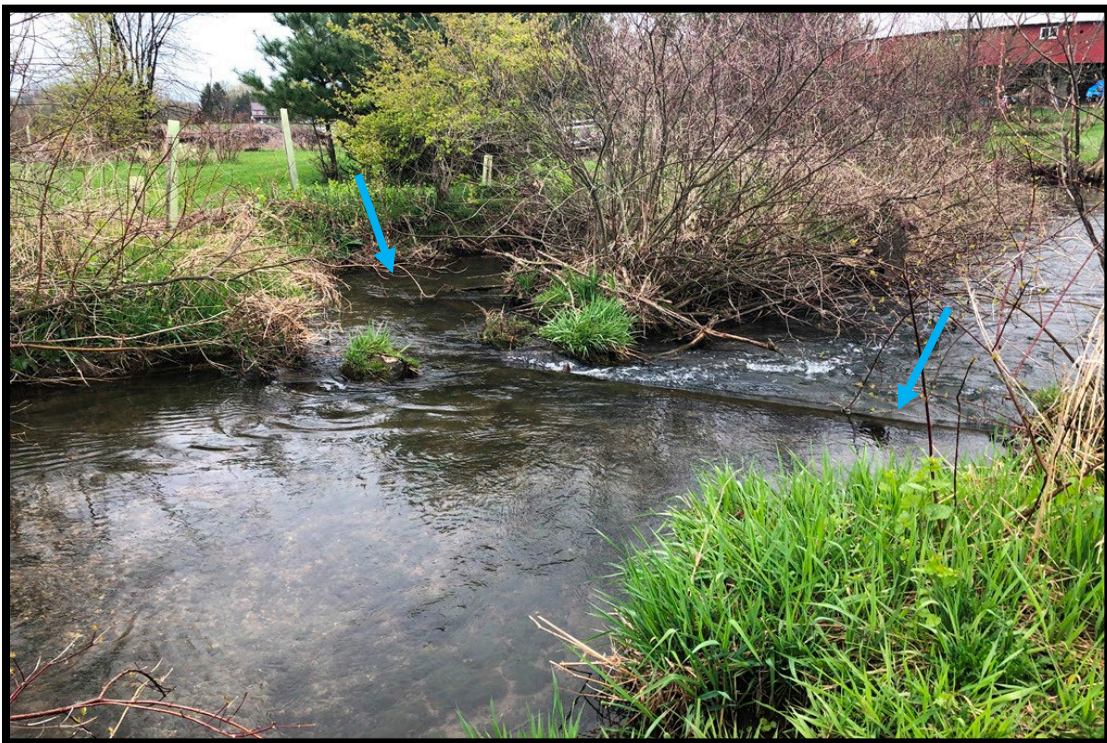
**Split flow around island forcing stormflows into adjacent banks.**

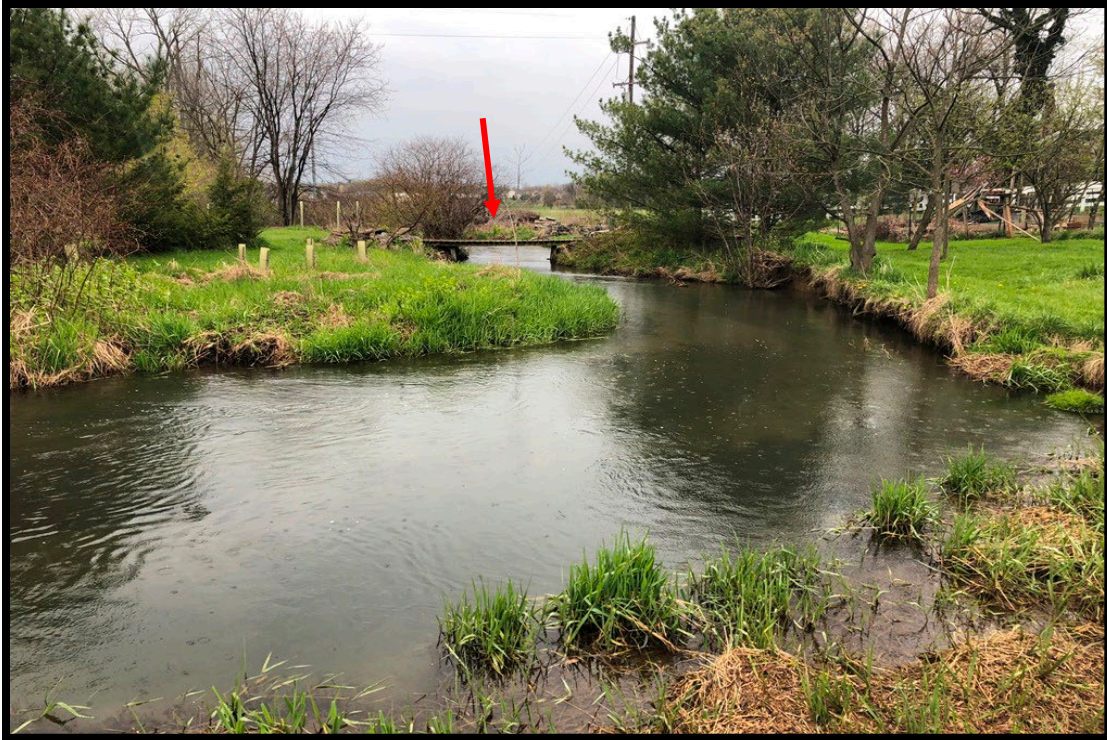
**Right bank has totally collapsed along tight bend downstream of island. Note footbridge in photo center.**

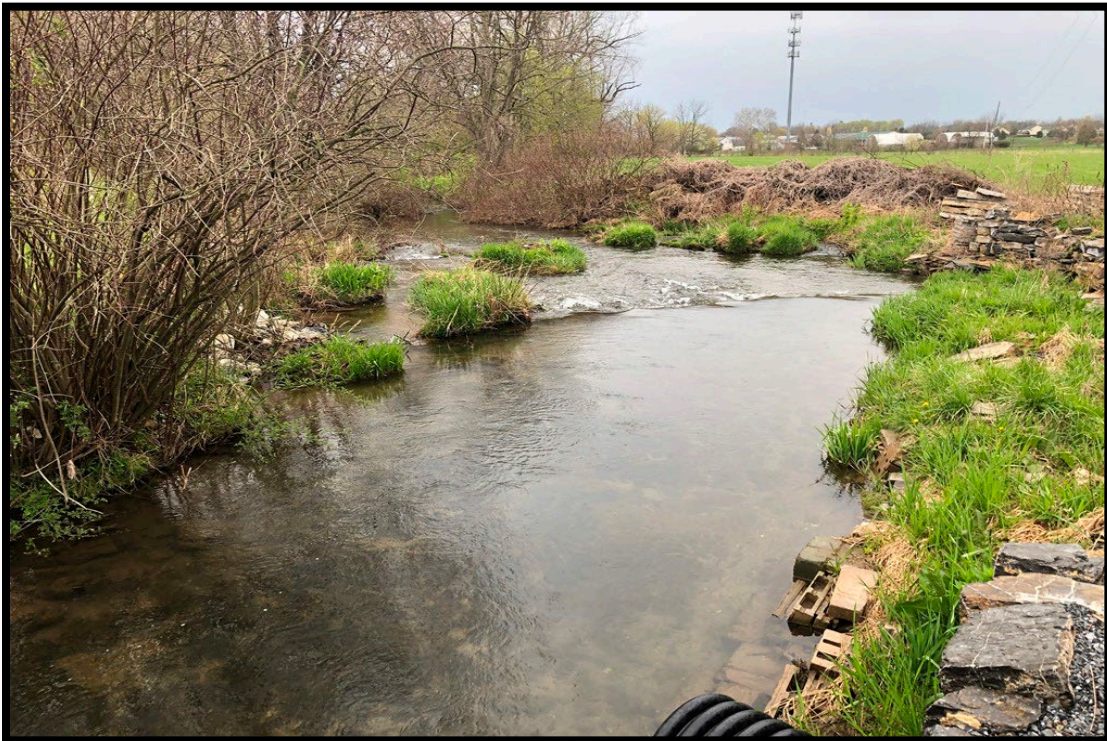
**Overwide section downstream of footbridge armored with concrete, cinder blocks and rubble.**

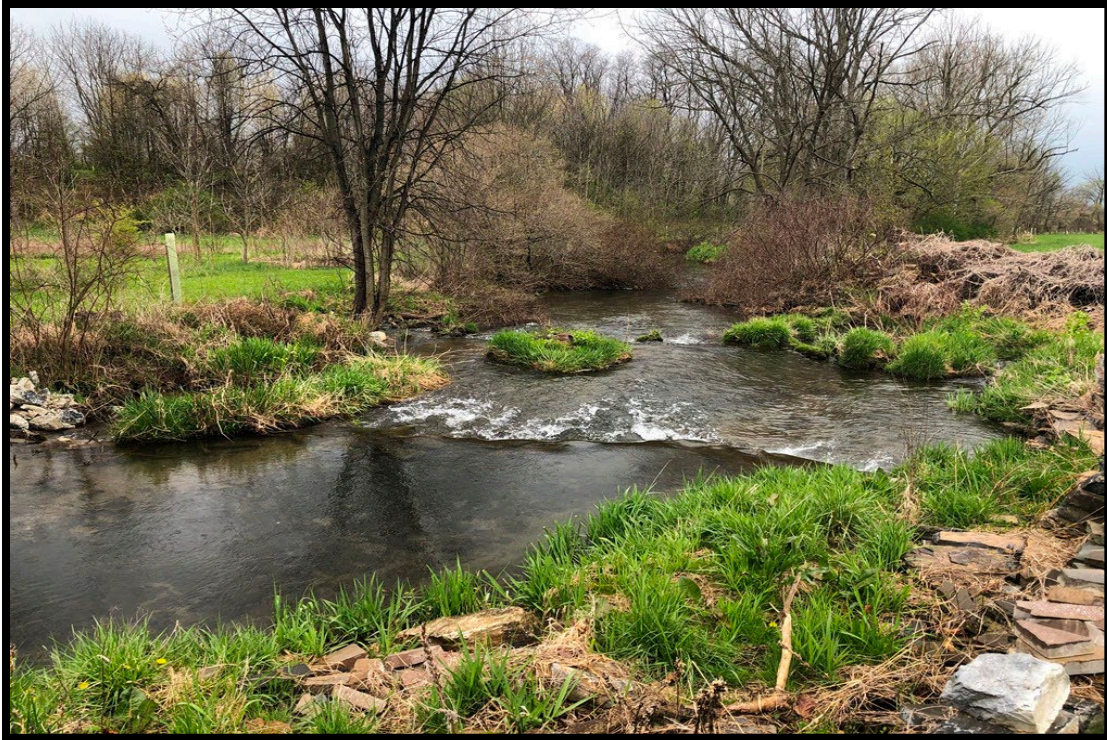
**Overwide section downstream of footbridge armored with concrete, cinder blocks and rubble.**

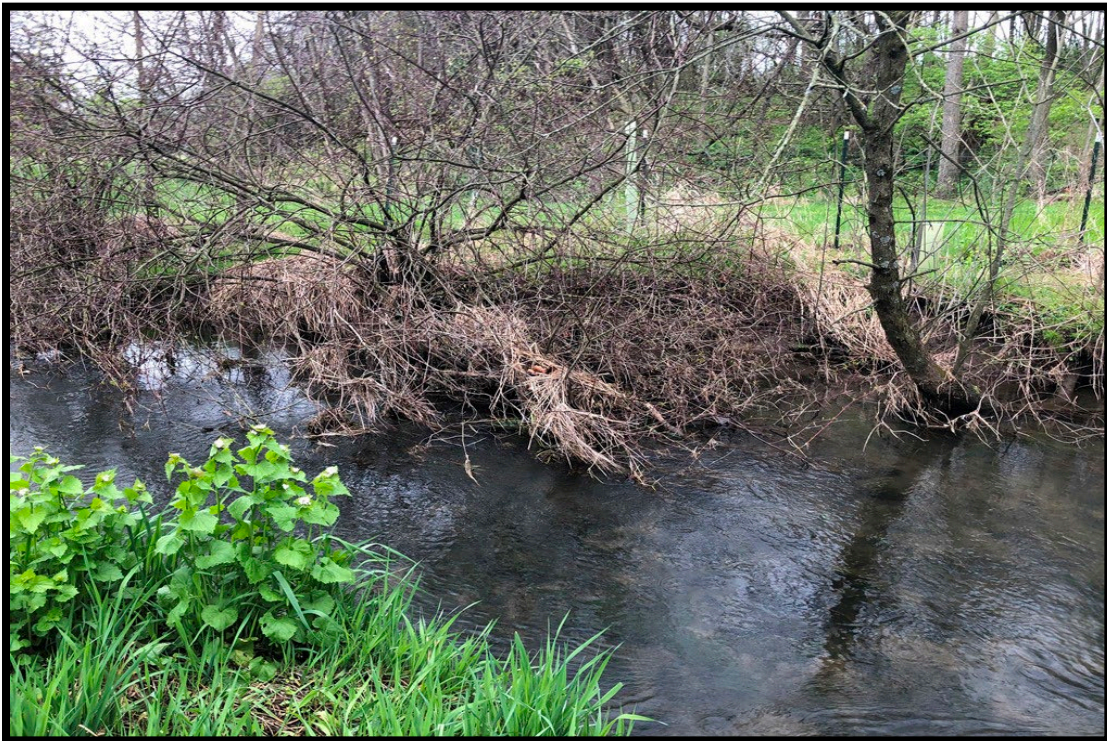
**Bank erosion, undercut and falling trees along both banks majority of lower section of Reach Upper 19**

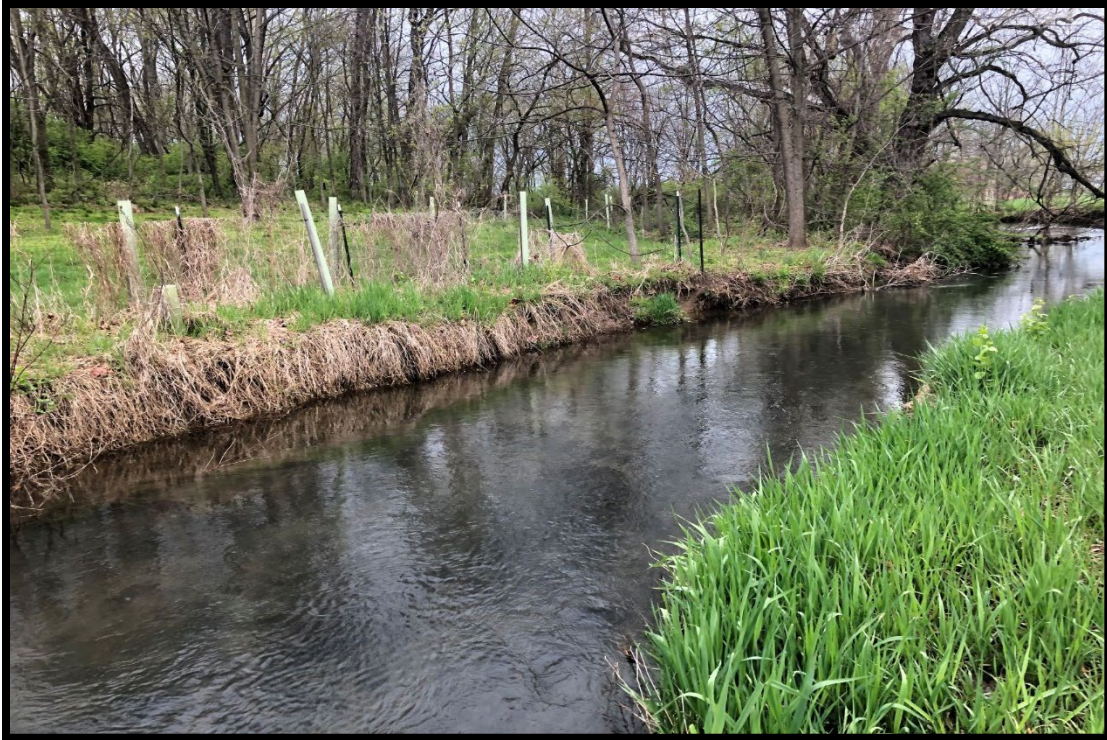
**Bank erosion, undercut and falling trees along both banks for the majority of lower section of Reach Upper 19**
