# **Four Firefighters Injured In Lithium-Ion Battery Energy Storage System Explosion - Arizona**

Mark B. McKinnon  
Sean DeCrane  
Steve Kerber

UL Firefighter Safety Research Institute  
Columbia, MD 20145

July 28, 2020

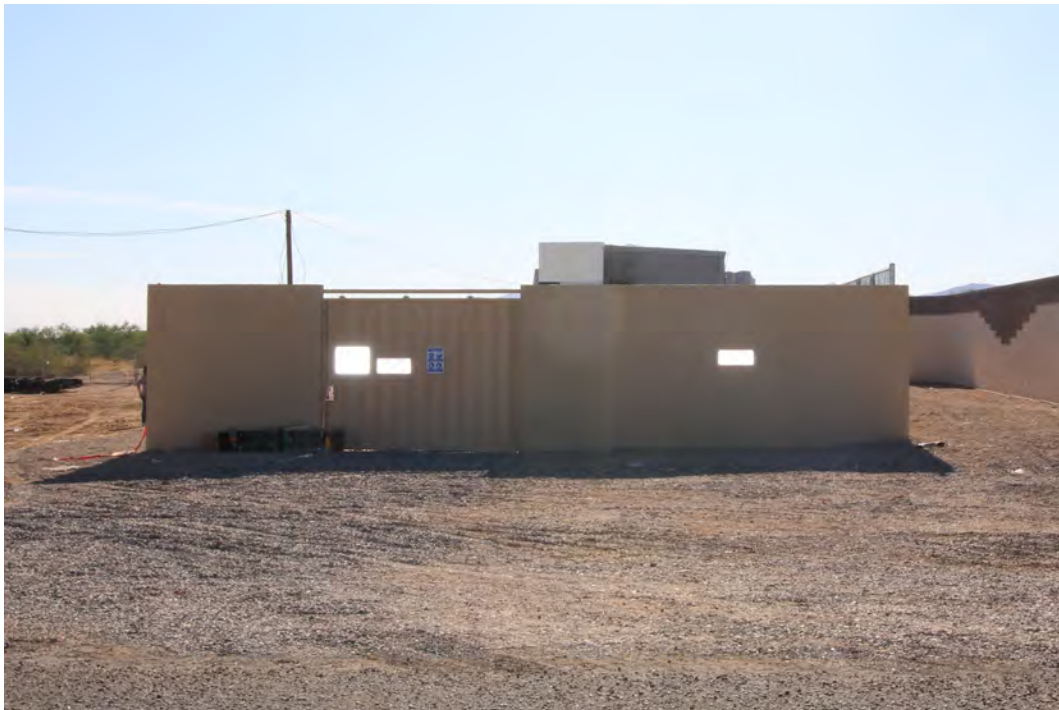
Photographs of the ESS and fence collected after overhaul of the scene are provided in the following figures. Figure 4.2 displays the solid wall and gate that isolated the structure from the frontage road. Figure 4.3 displays the southeast side of the ESS, Figure 4.4 displays the northeast side of the ESS, Figure 4.5 displays the northwest side of the ESS, and Figure 4.6 displays the southwest side of the ESS. Each of these photographs have been modified to remove brand names and logos to protect the anonymity of the owner and designer of the ESS. Note that both doors were removed and destroyed in the deflagration, and those that appear in the following images were installed to retain control of entry and protect the structure from weather.

Figure 4.2: Photograph of the solid wall and gate to the northeast of the ESS [13].

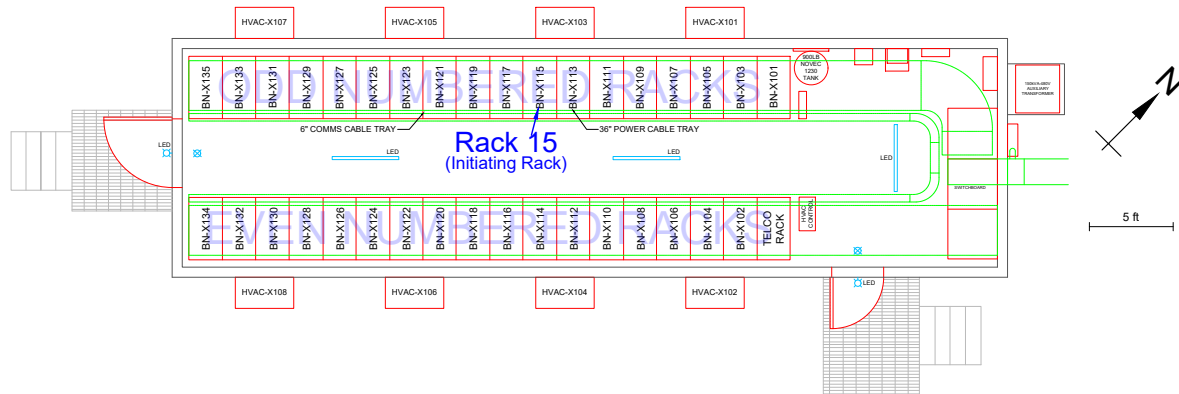
A schematic of the ESS is provided in Figure 4.7. A photo of a typical battery rack installed in the system is displayed in Figure 4.8. The racks also housed a battery protection unit, a node controller, and an inverter. At the time the ESS communication system first indicated an anomaly, all of

Figure 4.7: Schematic of the ESS (adapted from [15]).

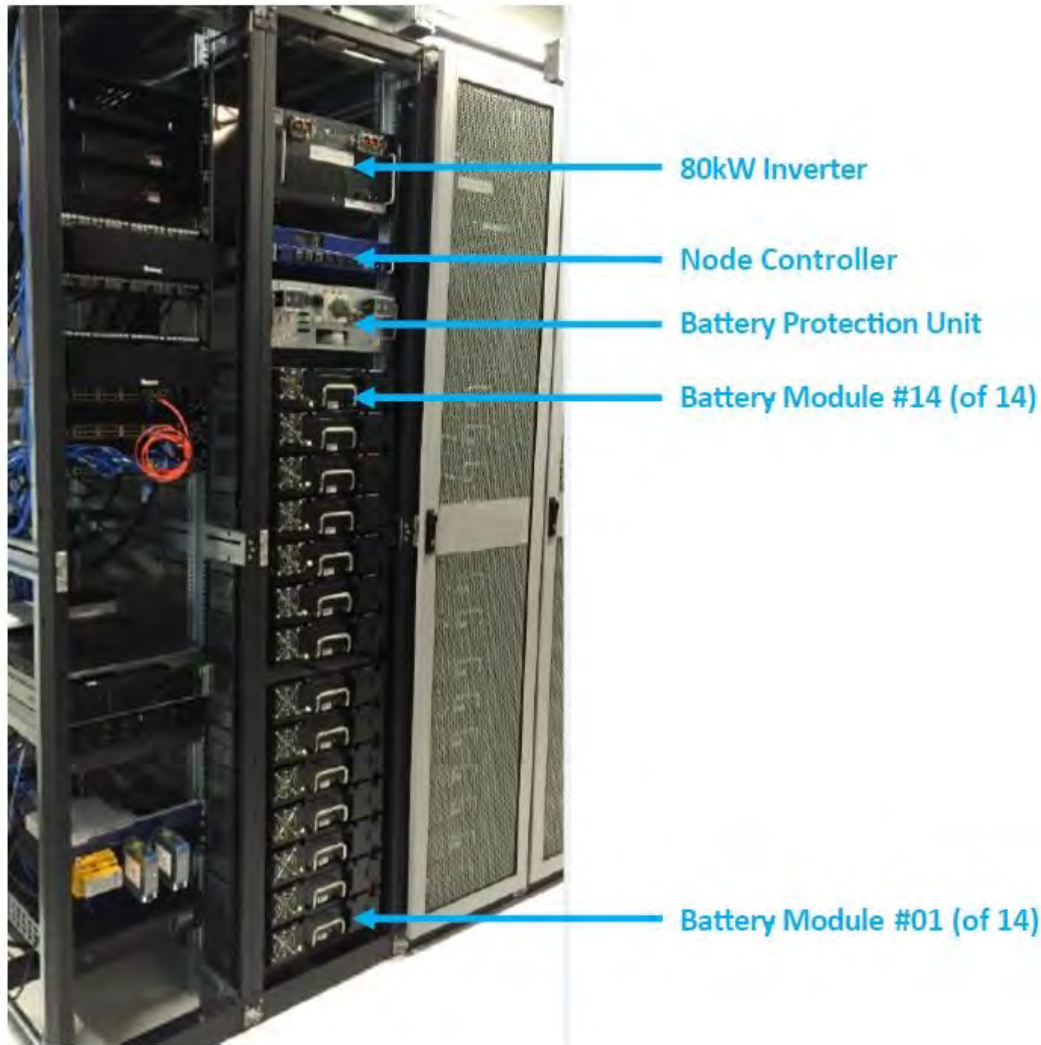
Figure 4.8: Photo of an example battery rack in an ESS [15].

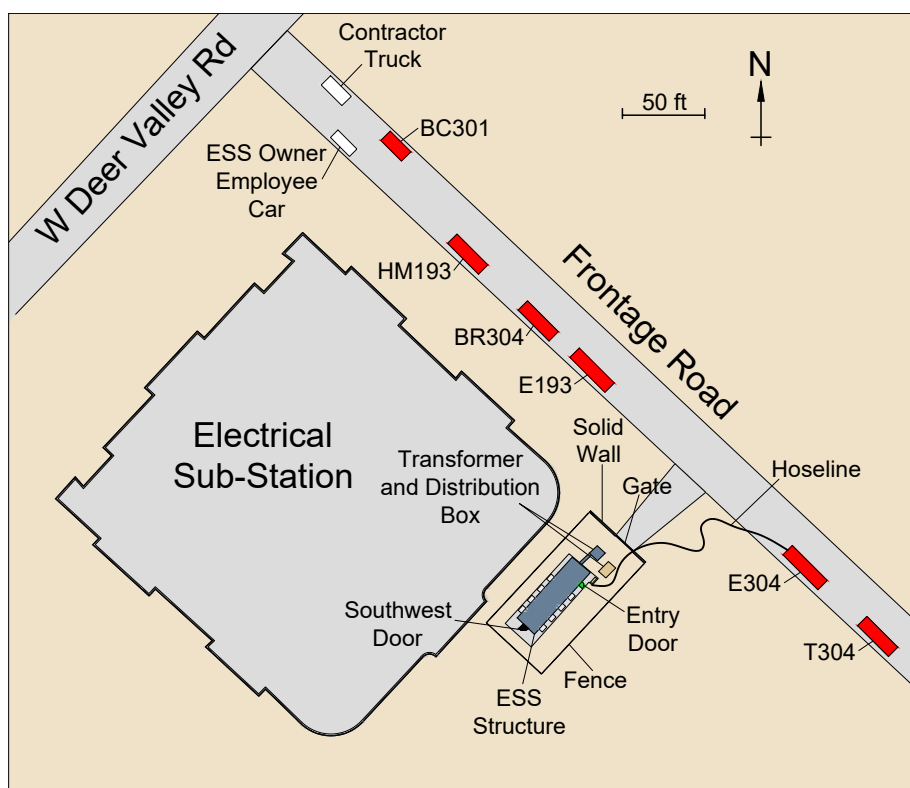
Figure 4.10: Diagram representing approximate locations of vehicles relative to the ESS [6,7]

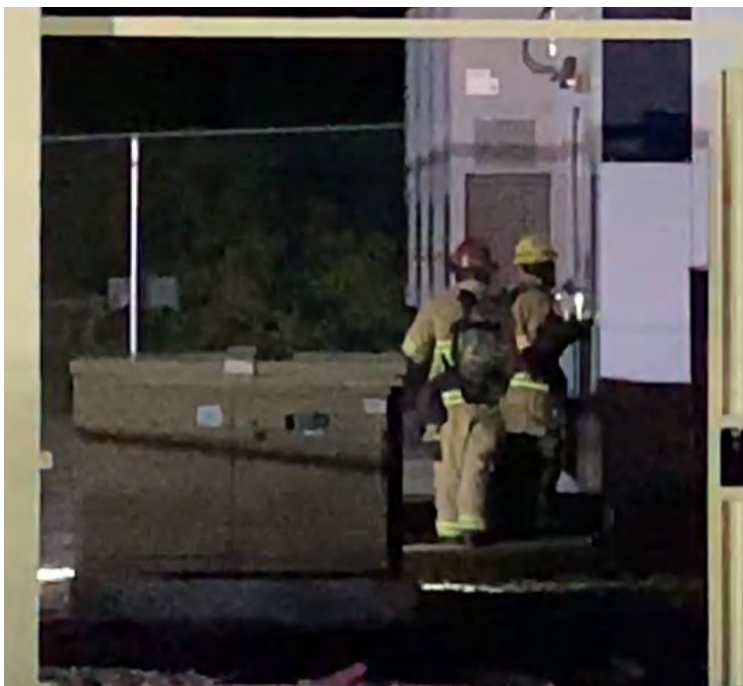
the container with the TIC. A visible white gas/vapor mixture immediately poured out of the open door while the HAZMAT team measured gas concentrations and continued to monitor the ESS. Images extracted from a video recorded on the scene as the door was opened are displayed here. Figure 4.11 displays E193 Capt (red helmet) and E193 FE (yellow helmet) just prior to E193 FE opening the door to the ESS. The hoseline that the HAZMAT team had brought into the hot zone in preparation of opening the door can be seen at the bottom of the image at the entrance gate. Figure 4.12 displays E193 Capt, E193 FE, and HM193 FF1 (far left of image) approximately 5 s after the door was opened. Dense gases and vapors can be seen in the image in Figure 4.12 flowing out of the ESS through the door.

Figure 4.11: Image of the HAZMAT team just prior to door opening [14].

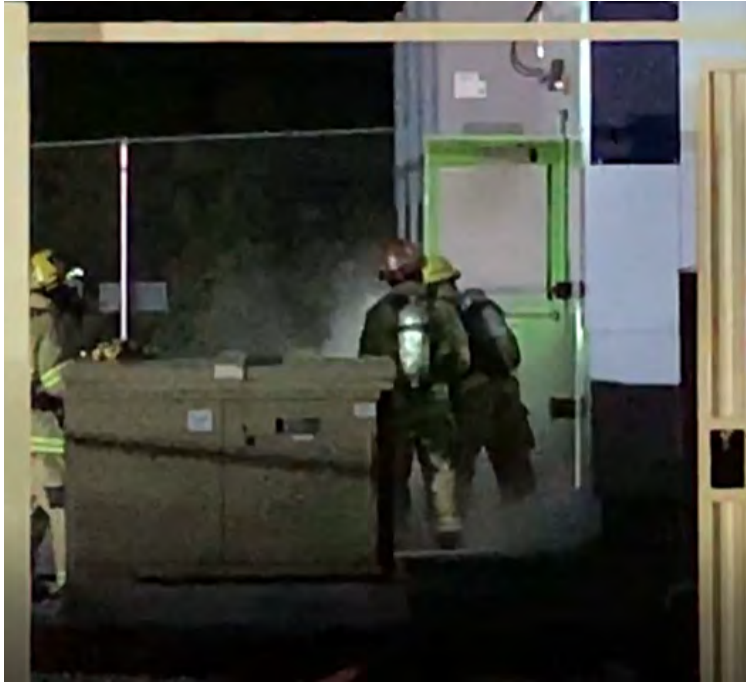
Figure 4.12: Image of the HAZMAT team 5 s after opening the door [14].

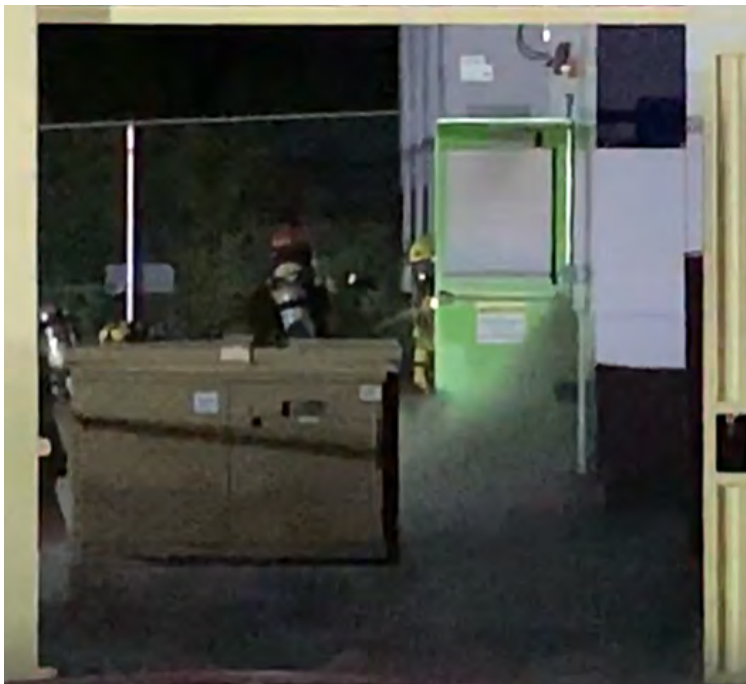
Figure 4.13 displays E193 Capt, E193 FE, and HM193 FF1 approximately 22 s after the door was opened. E193 Capt is shown using a TIC to monitor temperatures inside the ESS. Apparent in the image is an increased flow of high-density gases and vapors out the door as well as increased coverage of the ground in the vicinity of the ESS by the gas/vapor mixture. Figure 4.14 shows E193 FE holding the door open and E193 stepping away from the ESS to retrieve a gas meter approximately 33 s after the door was opened. The high-density gas/vapor mixture can be seen flowing from the door from high elevation to low elevation.

Figure 4.13: Image of HAZMAT team 22 s after opening the door [14].

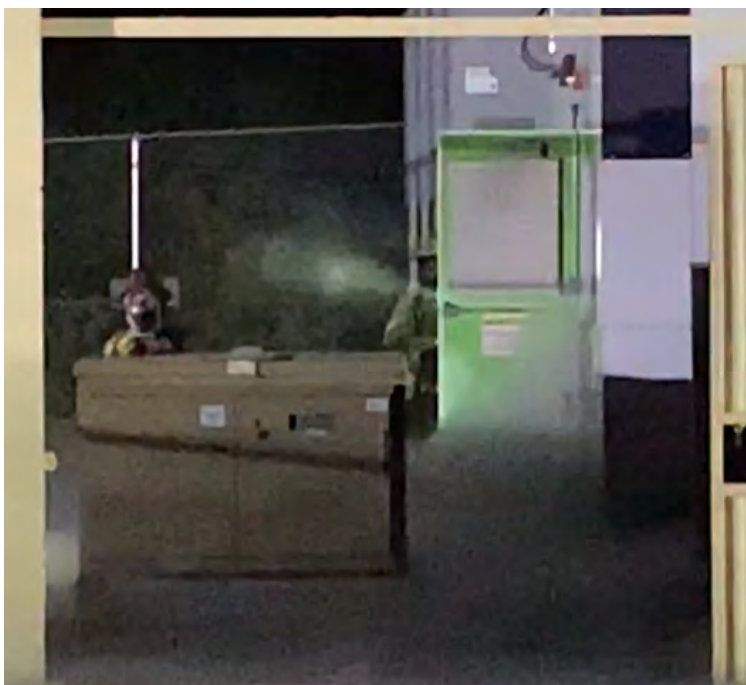
Figure 4.14: Image of the HAZMAT team 33 s after opening the door [14].

it was. HM193 FF1 advised that he could see the top of the round object without the TIC as the gas/vapor mixture flowed out of the doorway but he did not know what it was [6]. This indicates that prior to the deflagration event, visibility was such that the back wall of the ESS was visible, the gas/vapor mixture was flowing out of the doorway from high elevation, and the level of the gas/vapor mixture in the ESS had descended to approximately 5 ft above the floor. A photograph facing into the ESS taken from the entry door after decommissioning is presented in Figure 4.15. This image shows the red suppression agent storage tank, which is the object the HAZMAT team was able to see just prior to the deflagration event.

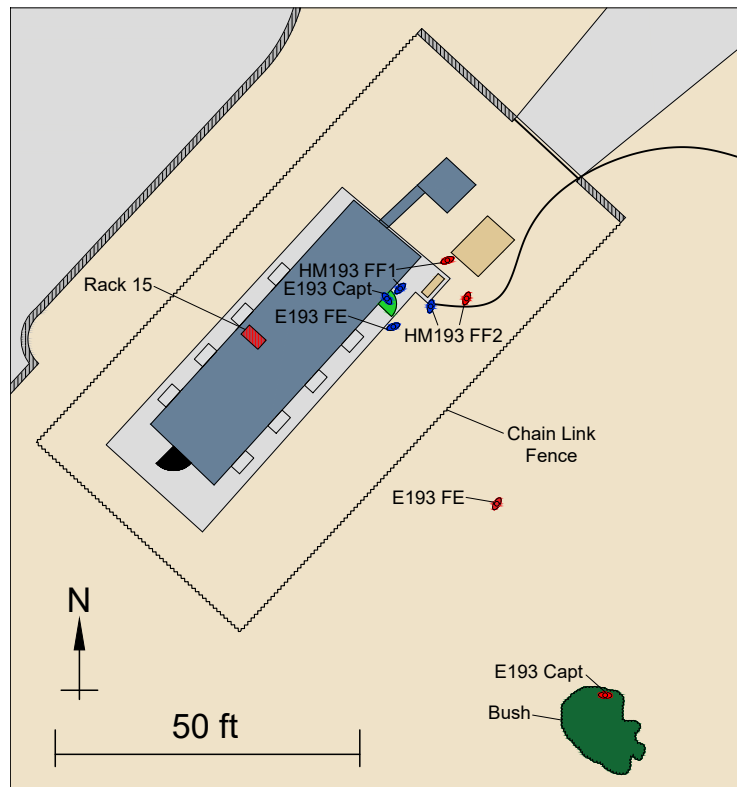
The approximate locations of the members of the HAZMAT team are displayed in Figure 4.16, in which positions just prior to the deflagration are displayed in blue and approximate positions after the deflagration are displayed in red. E193 Capt was at the door, E193 FE was back and to the left at a 45-degree angle from the door, HM193 FF1 was to the right of the door with a multi-gas meter, and HM193 FF2 manned the hoseline at a 45-degree angle back and to the right of the door [6].

Figure 4.16: Diagram representing the locations of firefighters just before the deflagration event. Approximate positions prior to the deflagration event are displayed in blue, and approximate positions after the deflagration event are displayed in red [6].
