# FUKUSHIMA EARTHQUAKE AND TSUNAMI STATION BLACKOUT ACCIDENT

© M. Ragheb  
12/4/2021

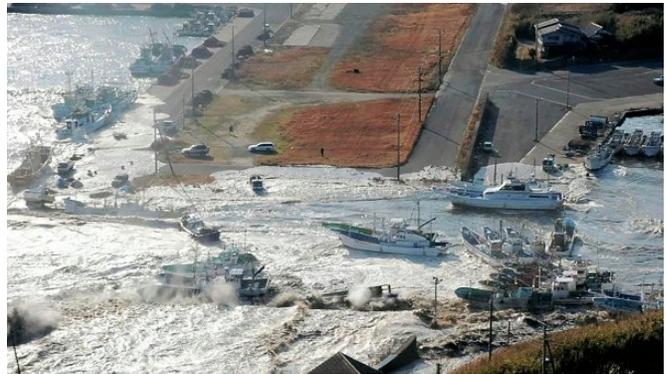
Figure 2. Earthquake and Tsunami maximum wave amplitude, March 11, 2011, Japan. Source: Reuters, NOAA.

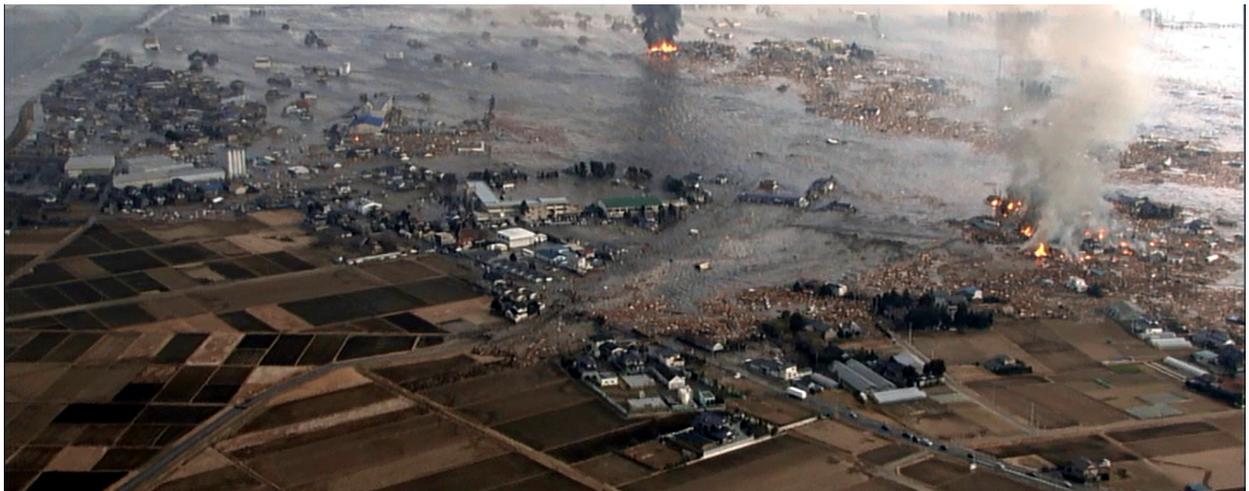
Figure 3. Tsunami effects as flooding and fires at the Fukushima area.

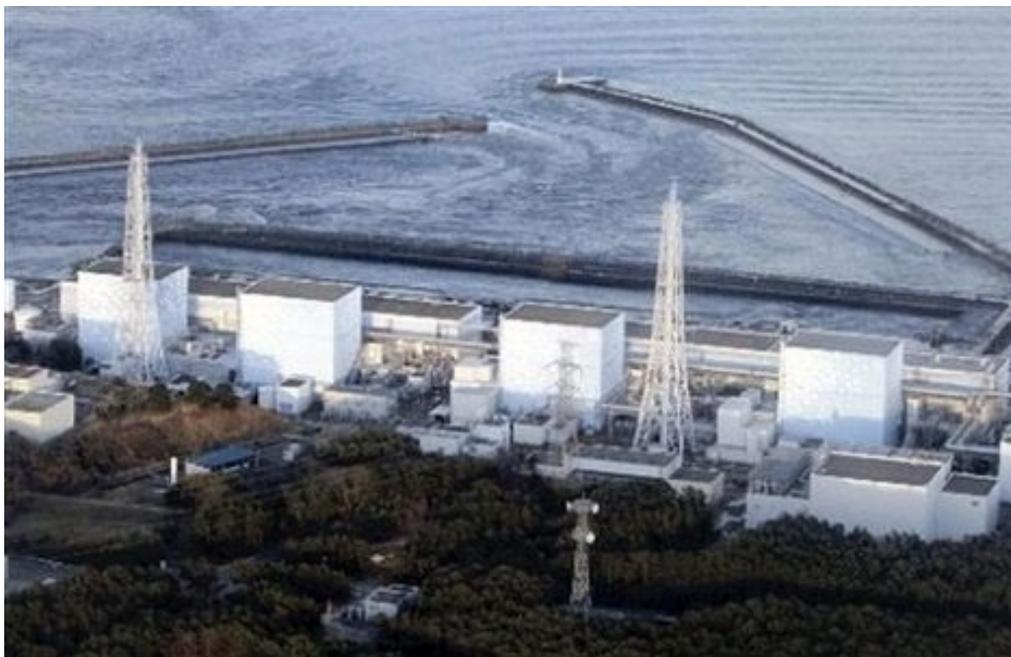
Figure 5. Siting of Fukushima plant down a hill sloping towards the sea. Source: Tepco.

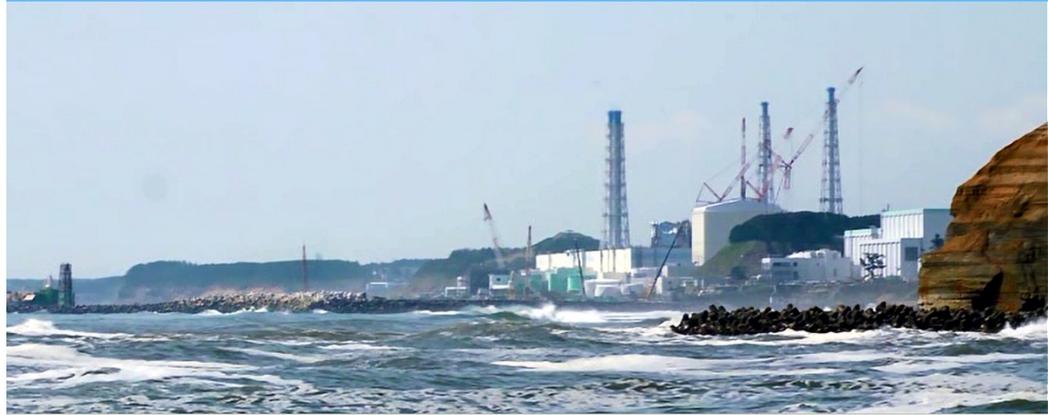
Figure 6. Siting of Fukushima plant on an artificially flattened area close to sea level. Source: Tepco.

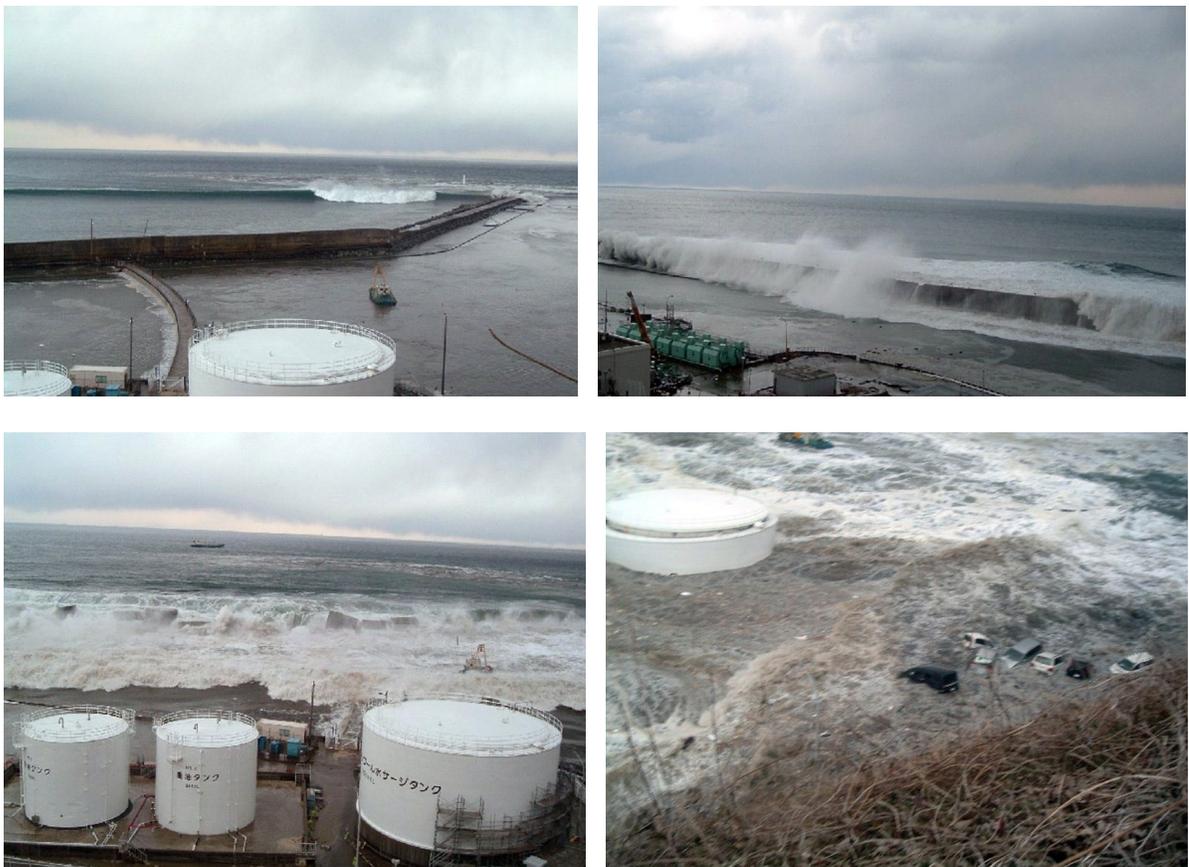
Figure 7 The tsunami wave more than 14 m (46 ft) high that originated 125 miles (200 kms) to the East, impinging on the 6 m protective wall and drowning the Fukushima Daiichi nuclear power plant site, March 11, 2011, Japan. According to the plant design, the maximum probable height of a tsunami at Fukushima was at just 5.7 meters compared with the actual 14 m. The breakwater wall offered protection against typhoons, but was breached by the tsunami. Source: Tepco.

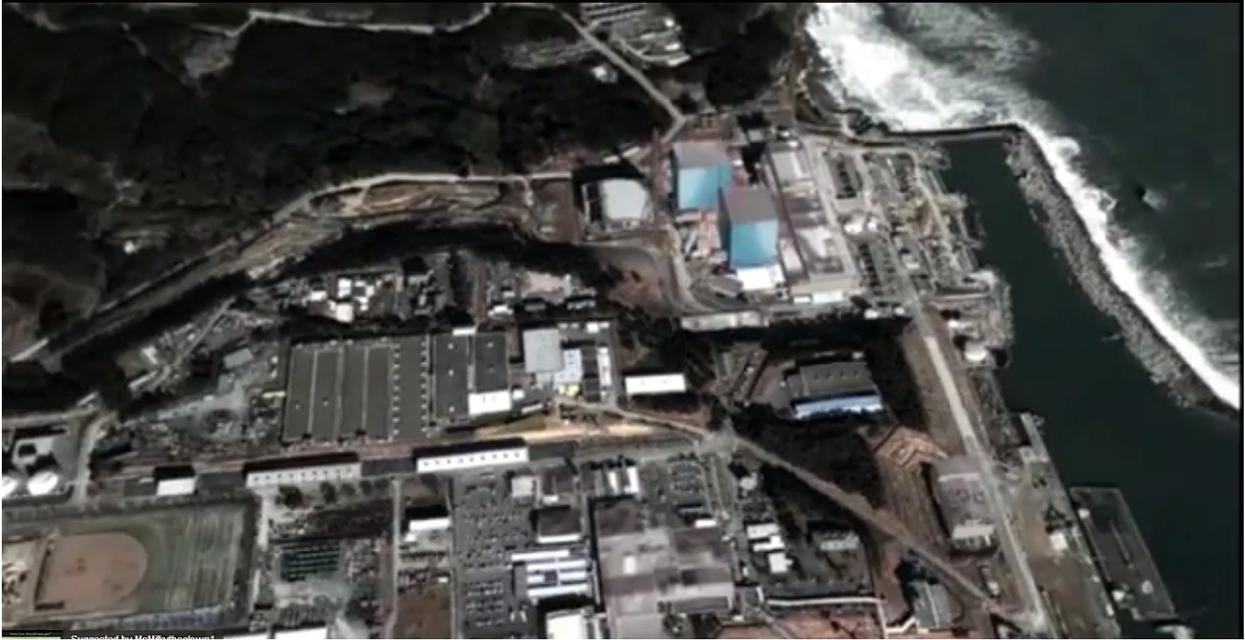
Figure 8. Units 5 and 6 were constructed on high ground by the General Electric and Ebasco Companies and were not affected by flooding and remained intact.

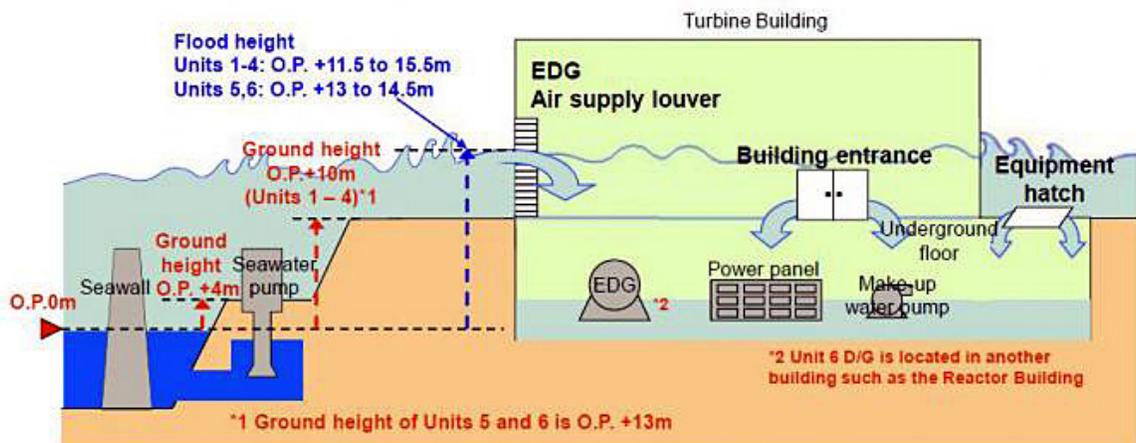
Figure 9. Inundation paths of major buildings at Fukushima plants. EDG: Emergency Diesel Generator. Source: Tepco.

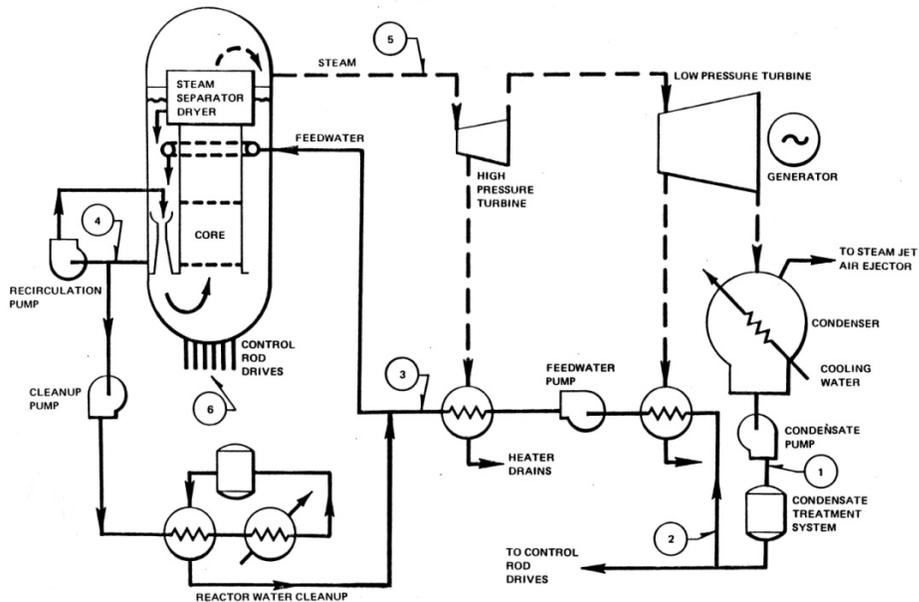
Figure 10. Typical BWR flow diagram. The role of the core spray system in the progression of the accident is undetermined. Source: GE.

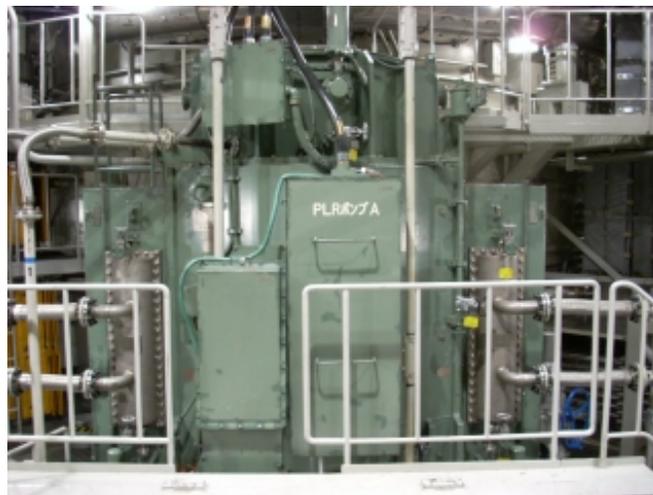
Figure 11. BWR primary coolant recirculation pump. Source: Tepco.

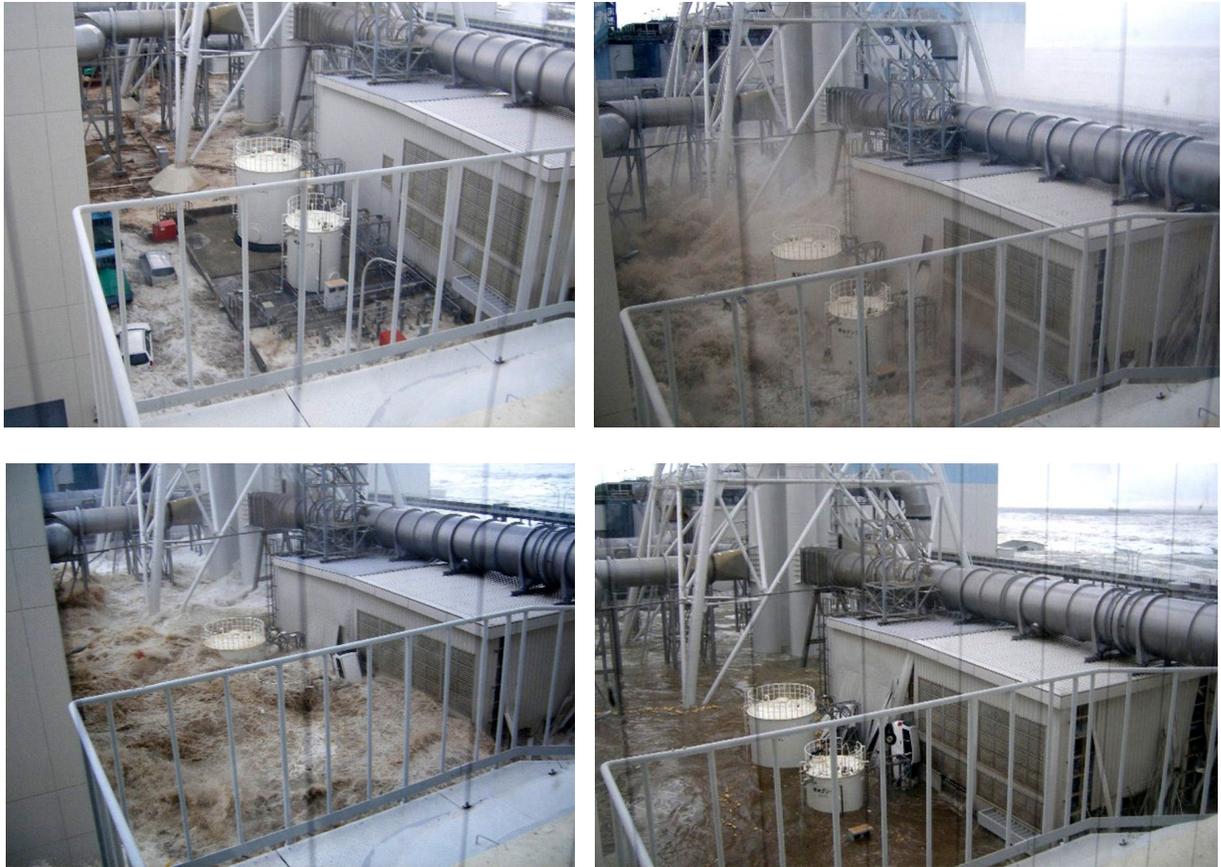
Figure 12. Fukushima Daiichi Tsunami water ingress and egress, drowning plant components at the base of the ventilation stack system, March 11, 2011. Source: Tepco.

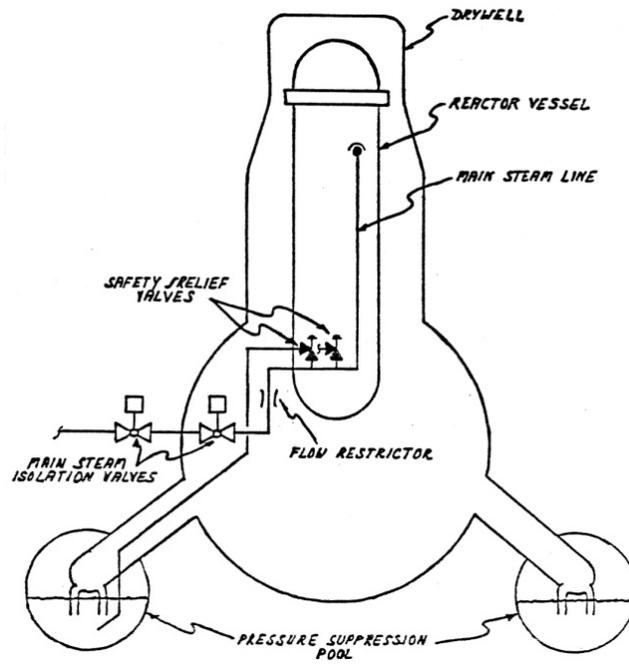
Figure 13. Main isolation valves and safety relief valves used in depressurization of the BWR.  
Source: GE.

The nuclear pressure relief system protects the Coolant Pressure Boundary, RPCB against damage due to overpressure. Pressure operated main Safety Relief Valves, SRVs are available to discharge steam from the Nuclear Steam Supply System, NSSS to the pressure suppression pool.

Part of it is the Automatic Depressurization System, ADS which depressurizes the NSSS in the case of a LOCA in which the High Pressure Injection System, HPCI fails to maintain Reactor Pressure Vessel, RPV water level. The HPCI pumps generate a high head and consequently a low flow rate.

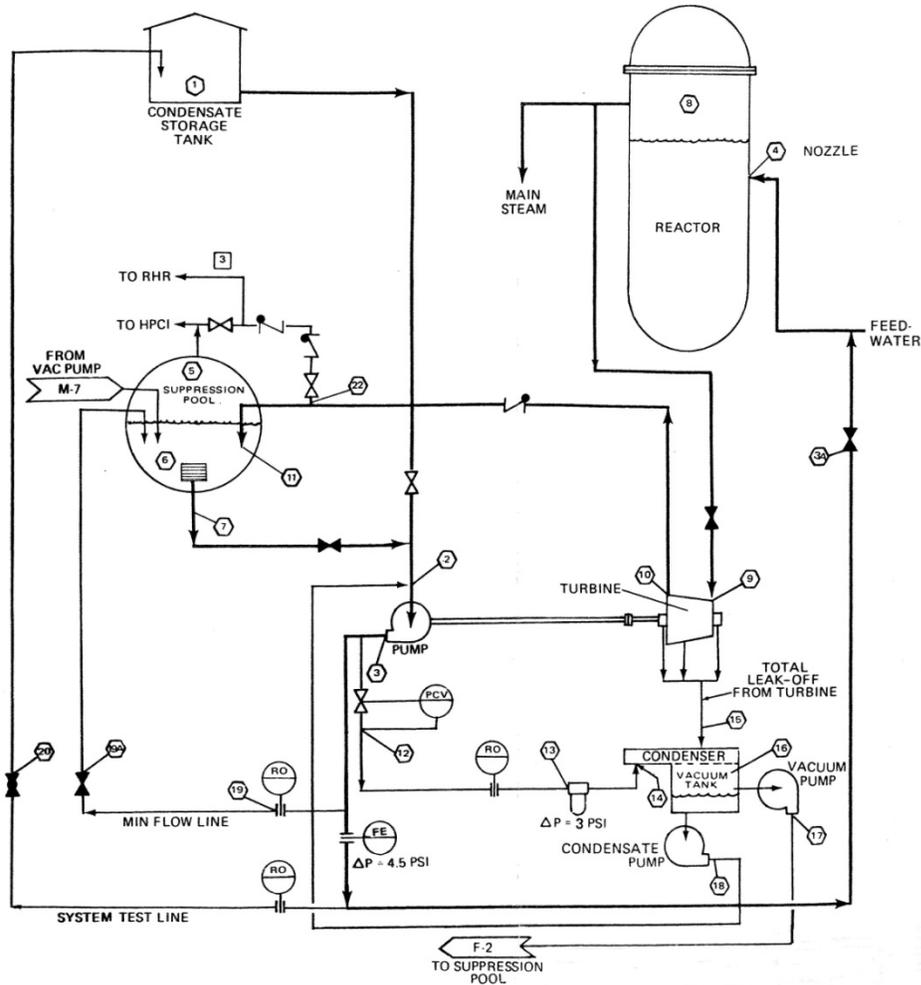
Figure 14. BWR Reactor Core Isolation Cooling system, RCIC. A steam turbine uses steam to drive a pump injecting water drawn from the condensate storage tank into the core. Exhaust from the steam turbine is directed to the pressure suppression pool. HPCI: High Pressure Coolant Injection system, RHR: Residual Heat Removal system.

Failure of the reactor cooling function carried out by the Reactor Core Isolation Cooling, RCIC system occurred in units 1, 2 and 3 at the Fukushima Daiichi site and at unit 4 at the Fukushima Daini site; a situation stipulated in article 15, clause 1 of the “Act on Special Measures Concerning Nuclear Emergency Preparedness” in Japan.

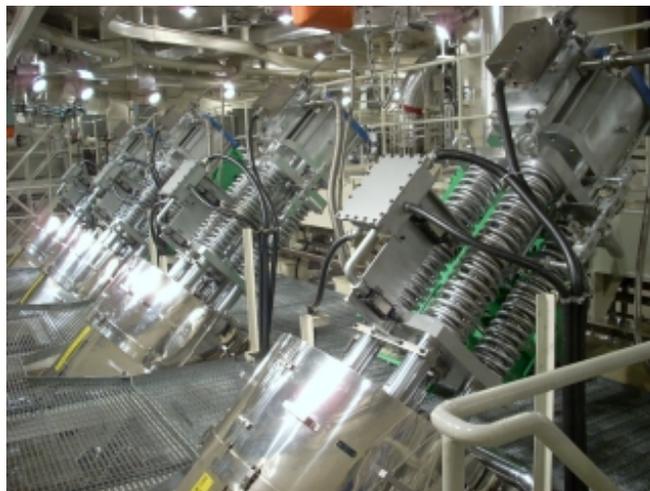
Figure 15. BWR Main Steam Isolation Valves, MSIVs. Source: Tepco.

Usually 3 MSIVs are installed on each main steam line. These consist of two MSIVs, one located inside, and the other outside of the primary containment, and a Main Steam Stop Valve, MSSV that is located downstream from of the outboard MSIV as a long term isolation valve.

The part of the main steam line supply system between the outboard MSIV and the MSSV are designed to assist in eliminating air leakage from the MSIVs after a postulated accident.

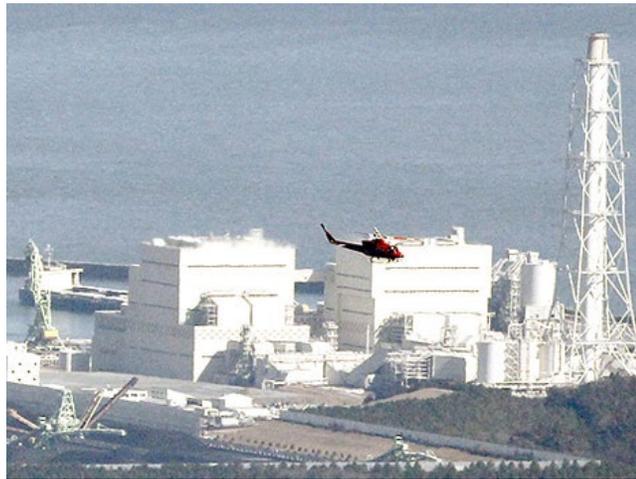
Figure 16. Steam appears to be leaking from top of left containment structure prior to hydrogen explosion. Source: Reuters.

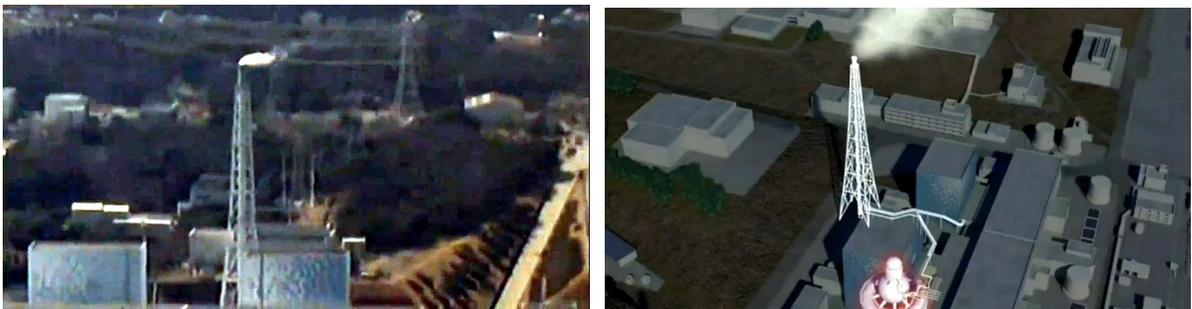
Figure 17. Venting primary containment of unit 2.

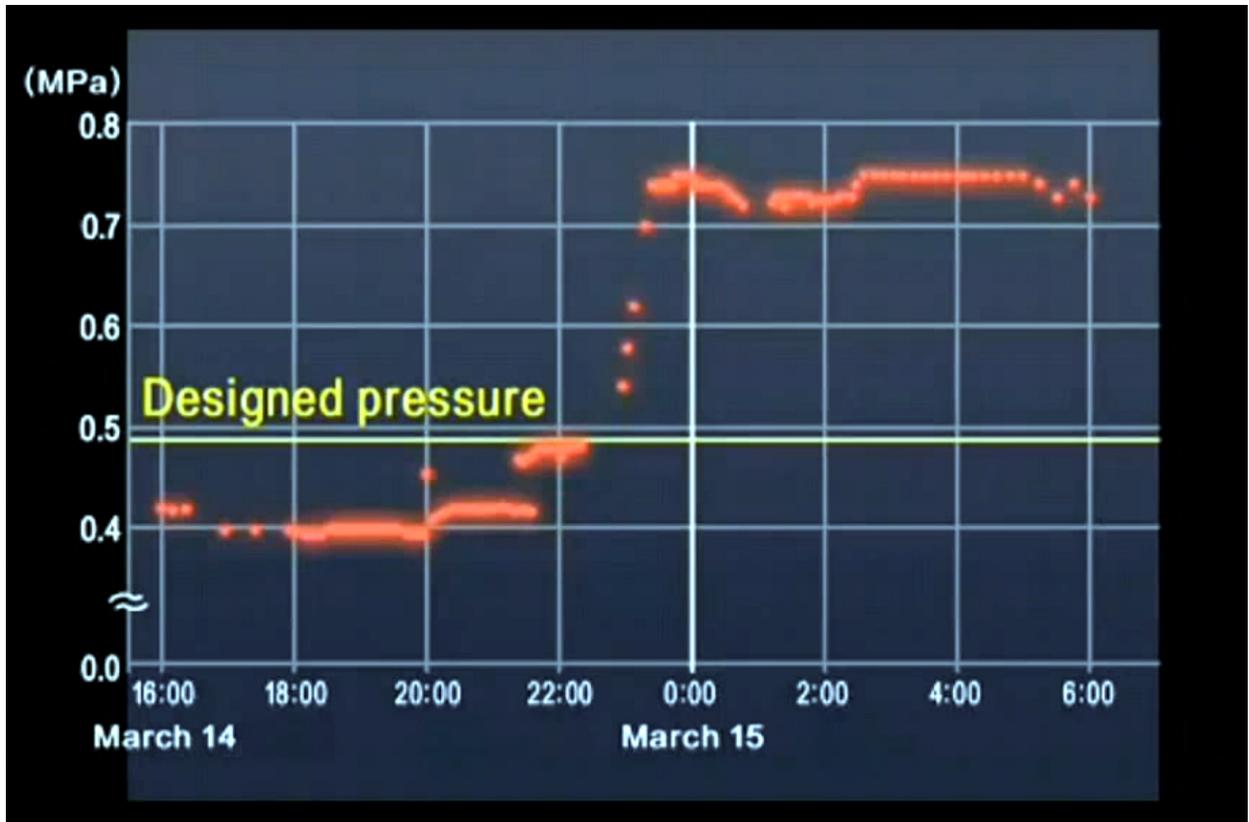
Figure 18. Increase in drywell pressure.

As no circulation of the core was provided the water turned into steam uncovering the core. In some BWRs a core spray system would spray the fuel assemblies to cool them. Steam was generated at an increasing rate raising the system's pressure. The safety relief valves vented the steam into the pressure suppression pool, quenching and condensing it.

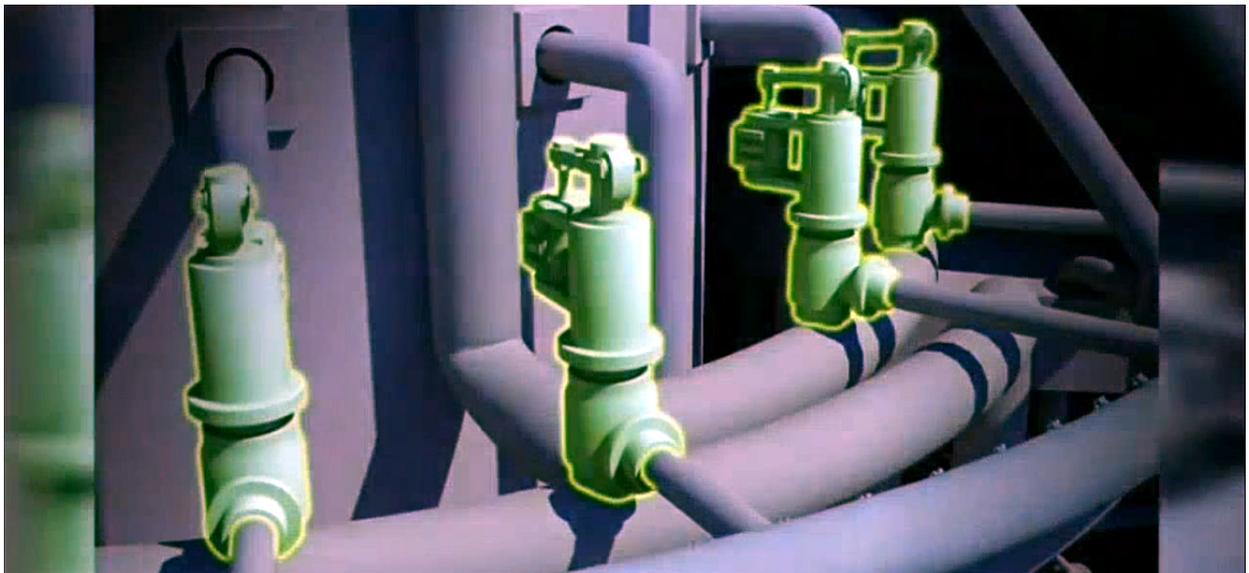
Figure 19. Bank of 8 safety relief valves of the primary containment failed to operate to vent the hydrogen and steam pressure from the containment.

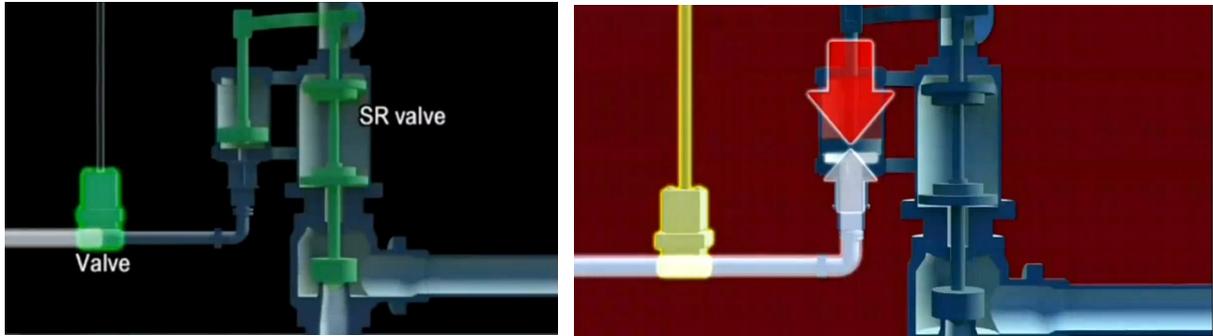
Figure 20. Battery-operated auxiliary valve releases nitrogen pressure to open safety relief valve to vent the containment of hydrogen and steam failed to operate because of unexpected high pressure in the containment that countered the nitrogen pressure. Operators tried to use connected car batteries to operate it unsuccessfully.

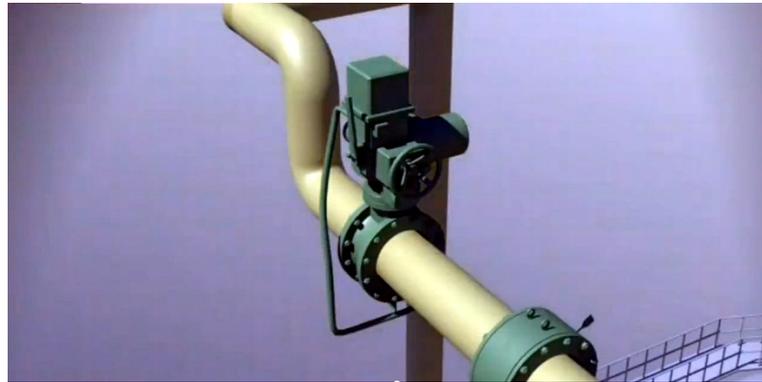
Figure 21. Manually-operated safety relief valve.

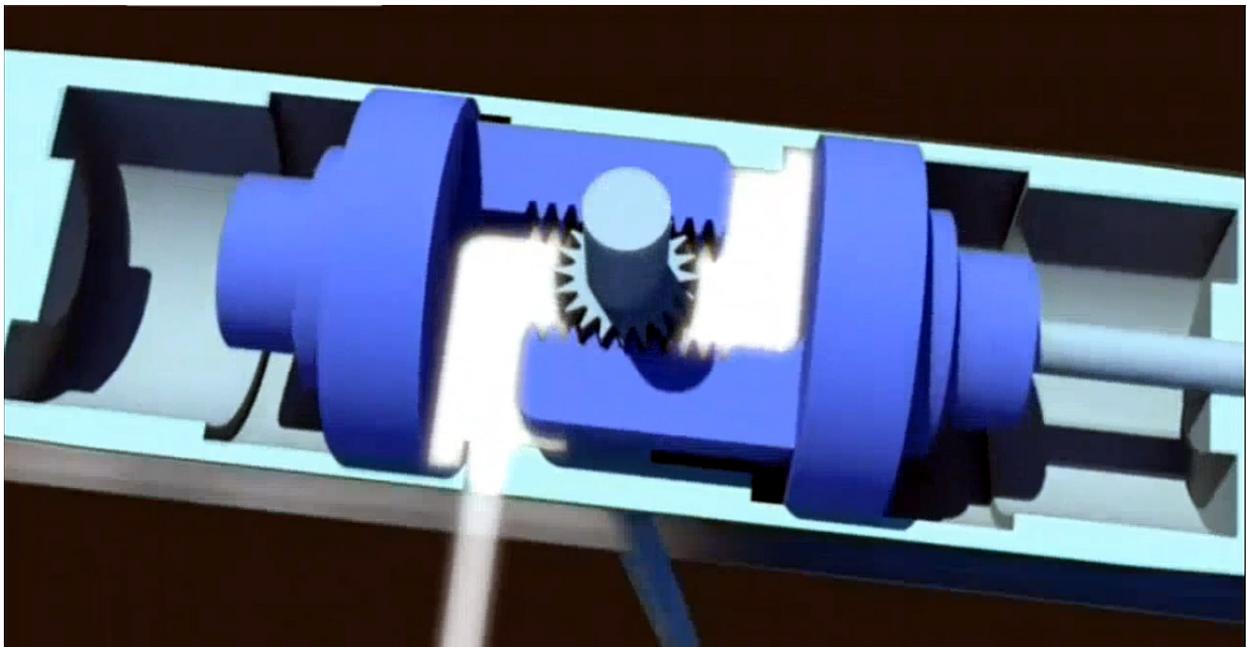
Figure 22. Remote controlled compressed air safety relief valve. Failed to operate due to pressure loss in the compressed air lines.

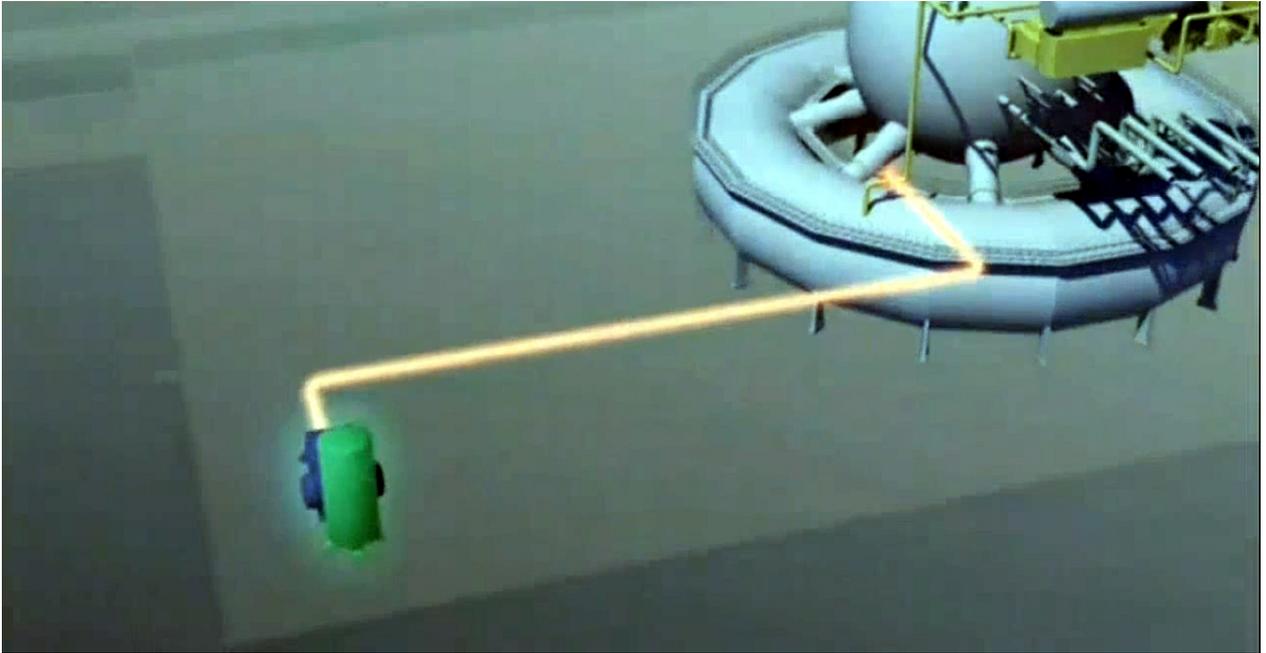
Figure 23. Compressed air containment venting valve failed to operate because of suspected loss of pressure in compressed air lines due to earthquake damage.

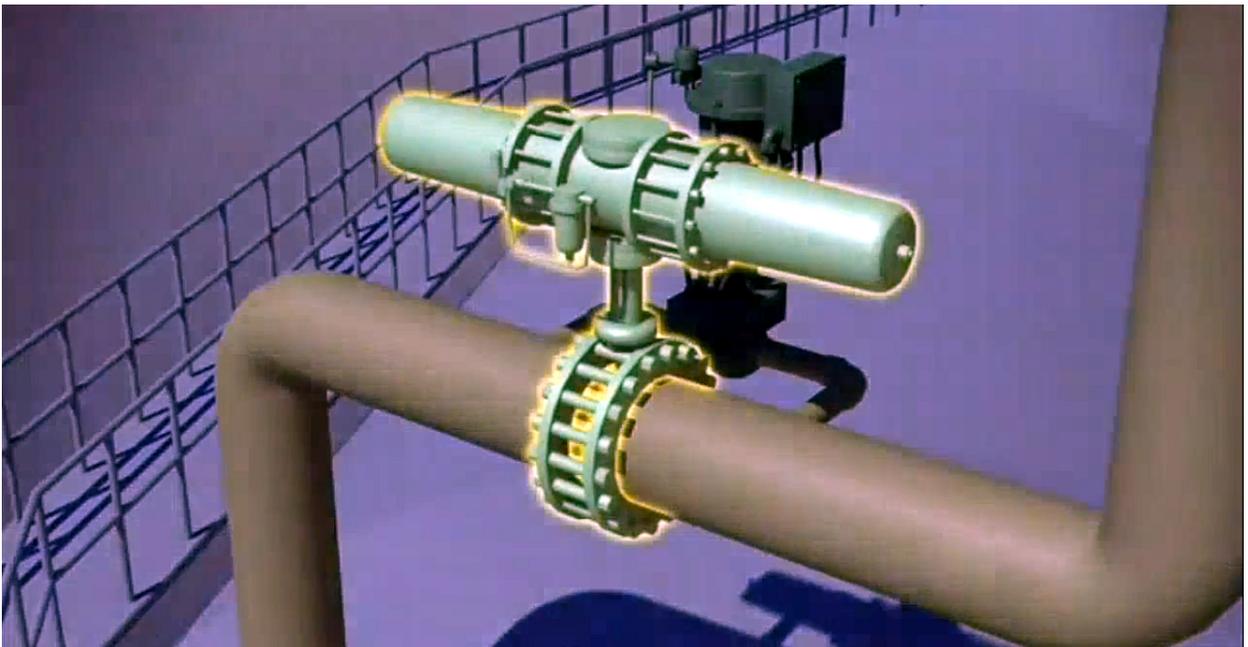
Figure 24. Second non-manually operated relief valve.

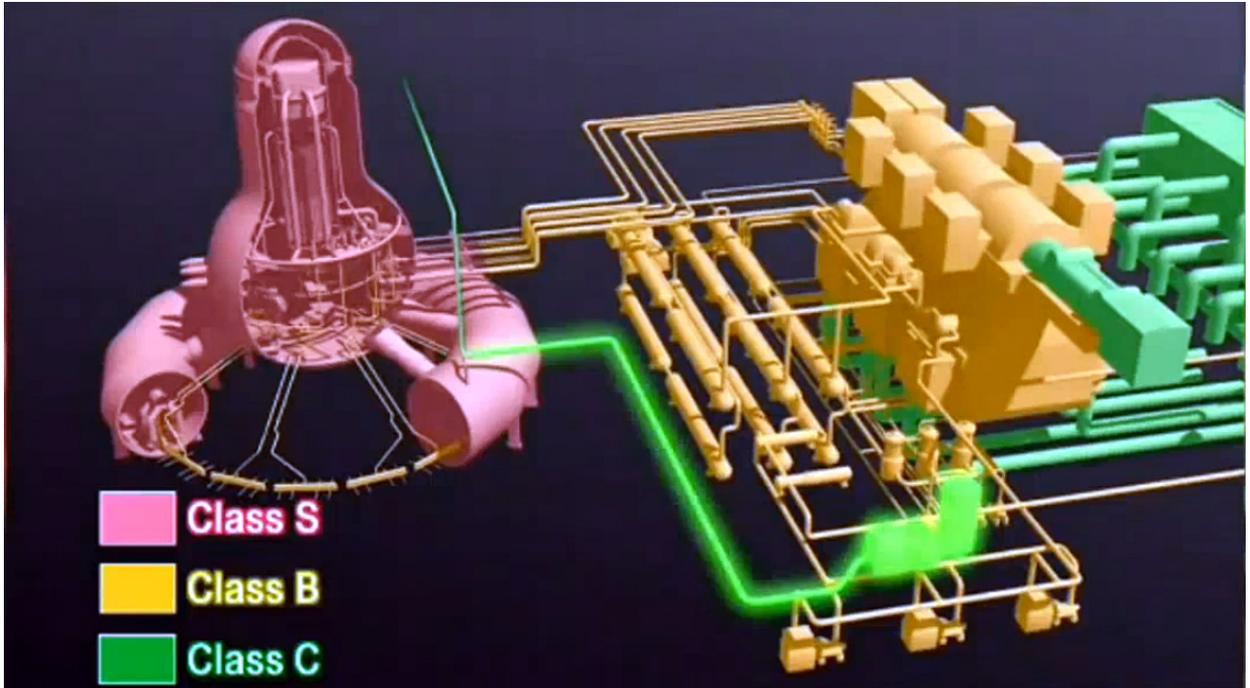
Figure 25. Seismic class C air duct to venting valve may have sustained cracks as a result of the earthquake.

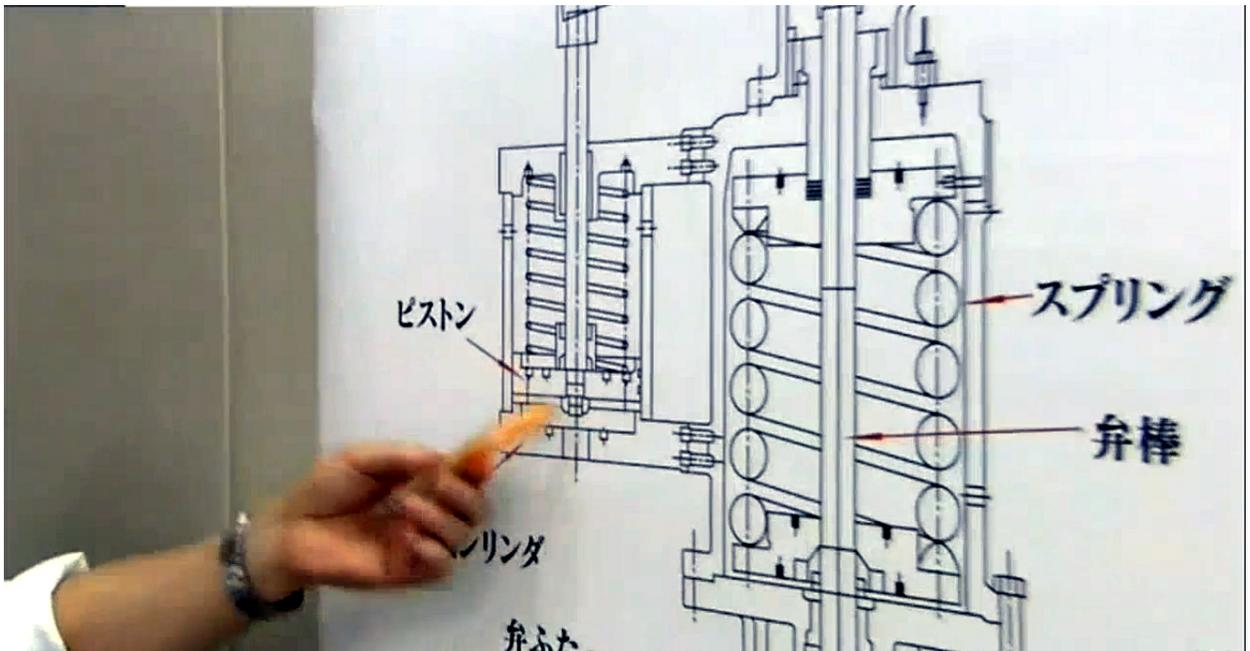
Figure 26. Safety relief valve design.

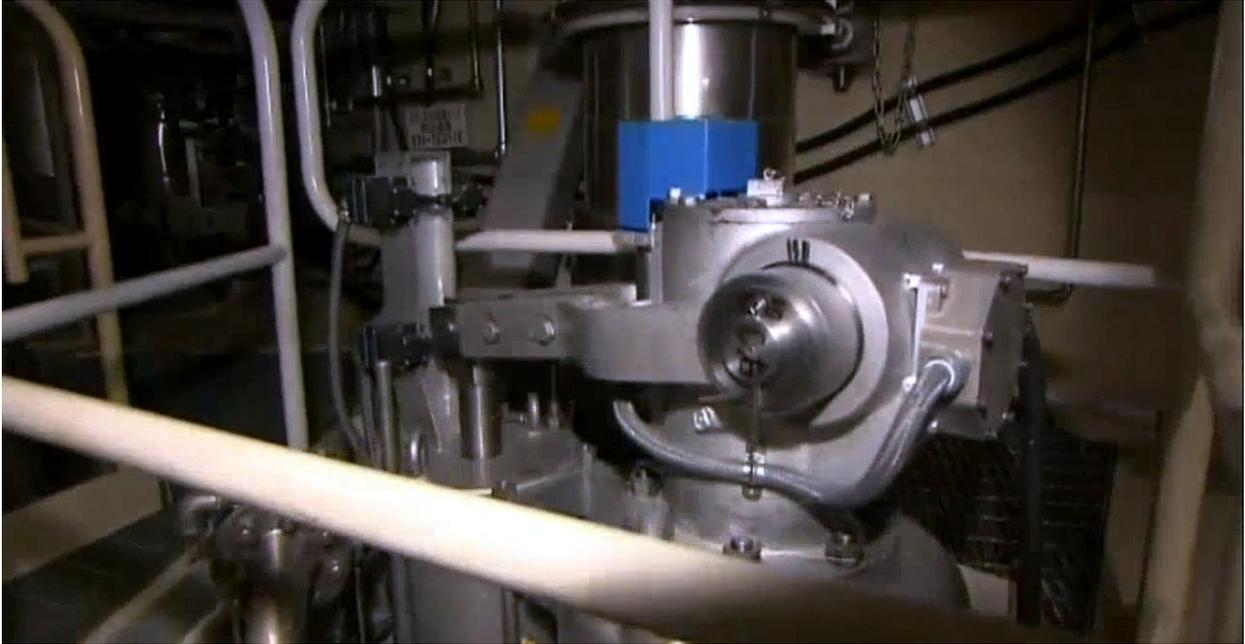
Figure 27. Safety relief valve picture.

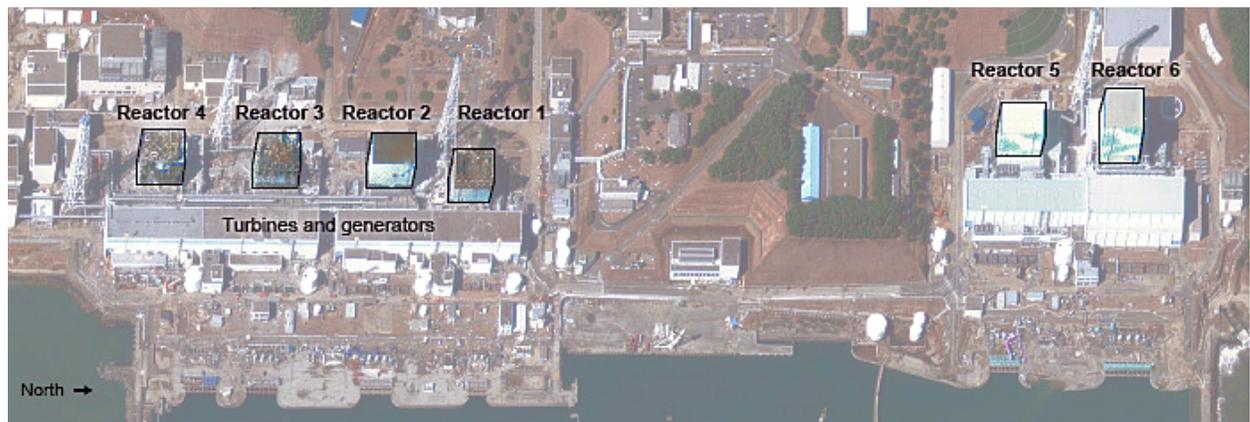
Figure 28. Fukushima Daiichi units 1-6. Source: GeoEye, Digital Globe.

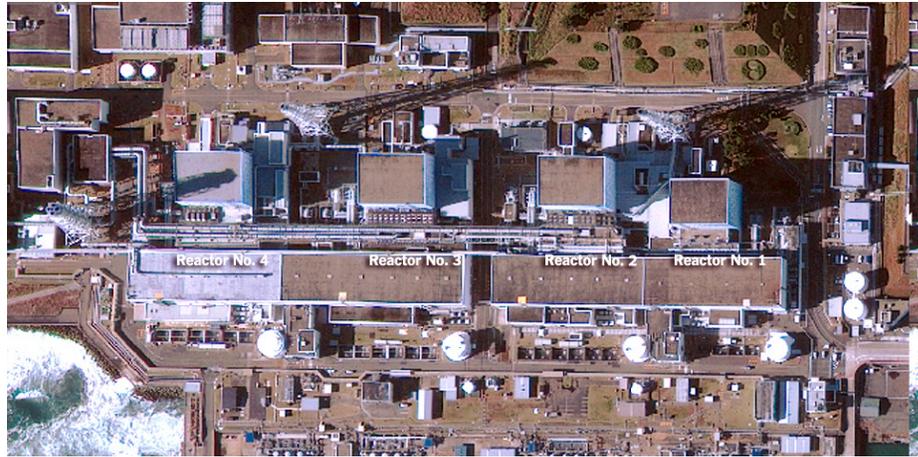
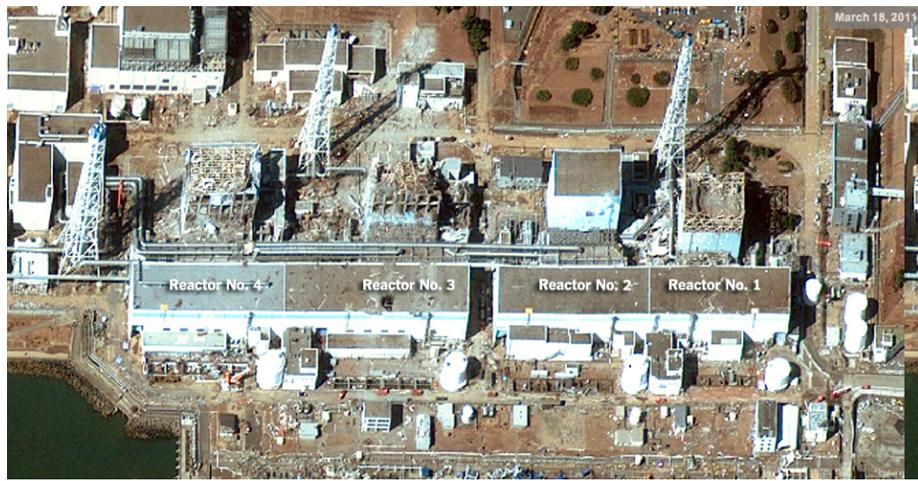
Figure 29. Fukushima Daiichi units 1-4 before and after the earthquake and tsunami event. Steam can be seen venting from the reactor unit 2 on March 27, 2011. Source: Digital Globe.

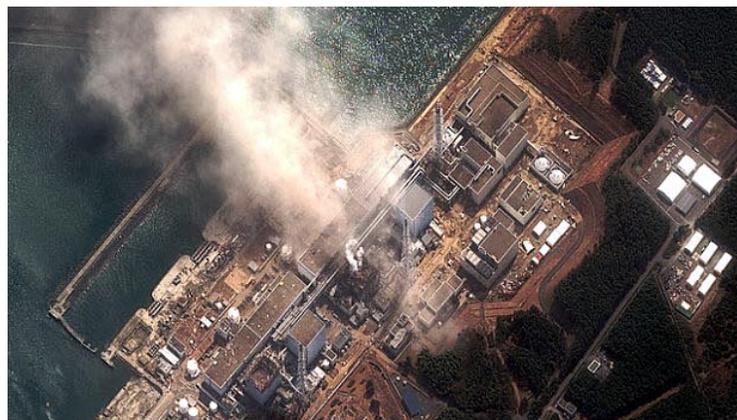
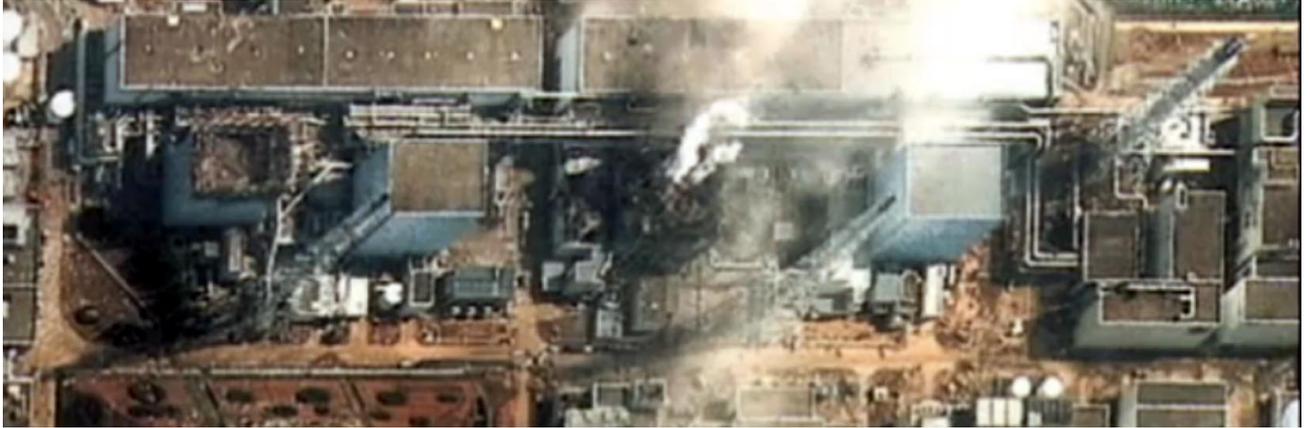
Figure 30. Remnants of a hydrogen explosion in Fukushima unit 1 (far left) exposing reactor loading deck and burying it under concrete rubble. Fire and a hydrogen explosion associated with steam depressurization and fuel damage occurred in unit 3. Fire starting at side of building in unit 4 may have originated from hydrogen generated in unit 3 that was piped into the shut-down unit 4, on March 15, 2011. Photo: DigitalGlobe.

In the process of venting steam to reduce the pressure in the containment system, a stipulated hydrogen explosion was reported at the Fukushima unit 1 on March 13, 2011 at the Daiichi site with associated fuel damage, containment structure damage, partial core meltdown and fission products release. Small amounts of radioactivity were vented, the reactor had 400 fuel assemblies loaded in its core, and the storage fuel pool had 292. The rubble from the roof covered the reactor's loading deck and fell into the fuel storage pool.

At 6 pm, March 15, 2011 a possible hydrogen explosion occurred within the previously shut-down unit 4, which under an outage condition, had the fuel from its core transferred to its storage fuel pool. The pool is reported to contain 1,331 fuel assemblies of which 548 were removed from the core for maintenance considerations.

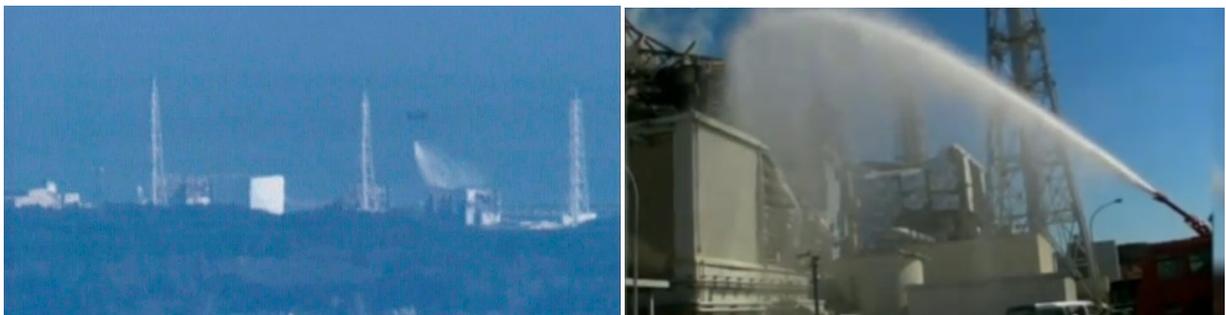
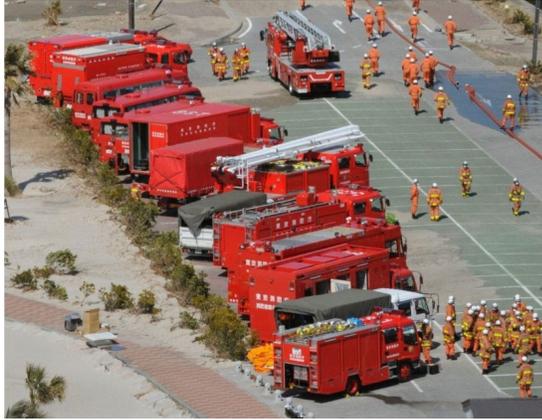
Figure 31. Military helicopters dumping water into fuel storage pools on March 17, 2011, were ineffective because of high winds. They were replaced by water cannons from fire trucks on March 18, 2011 to extinguish fires and add water to the fuel storage pools. Source: Japan Self Defense Forces.

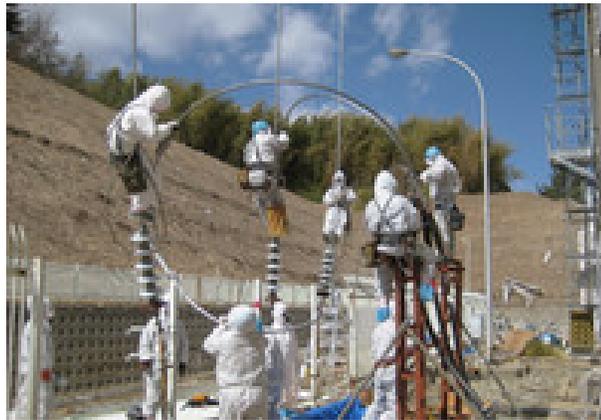
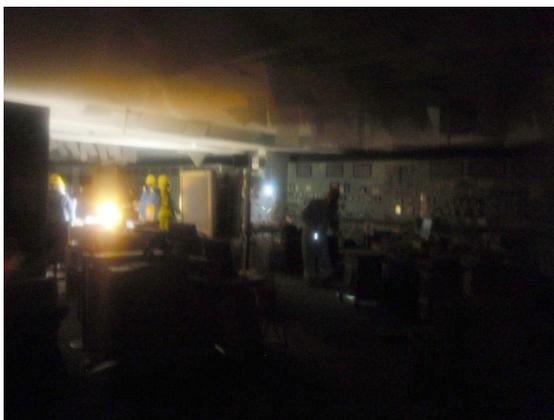
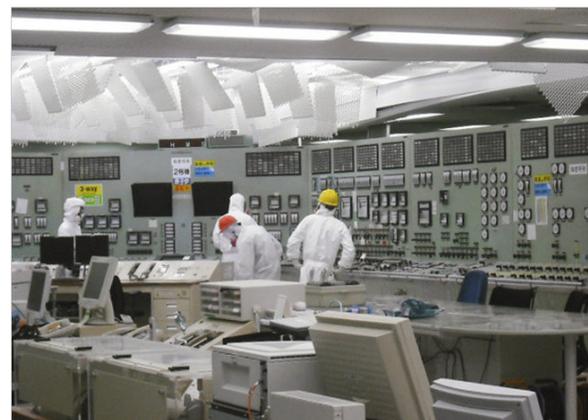
Figure 32. Station Blackout loss of power to the control room of the Fukushima Daiichi unit 1 reactor on March 24, 2011. Restoring offsite power to units 1 and 2 and power to the control room of unit 2 on March 26, 2011. The hanging ceiling tiles resulted from the earthquake. Source: Tepco.

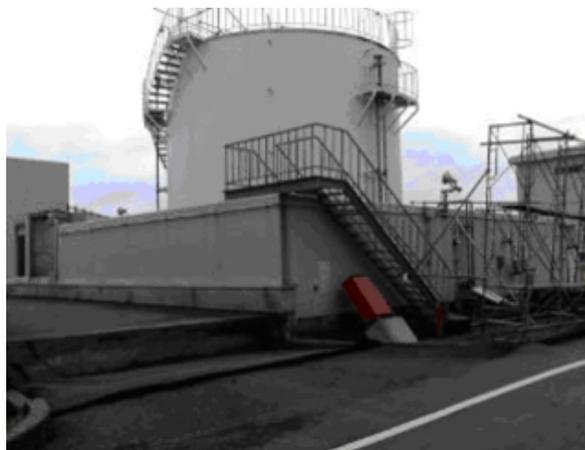
Figure 33. Earthquake-caused ground subsidence around light oil storage tank of 30,000-40,000 gallons capacity, 1979. Source: Tepco.

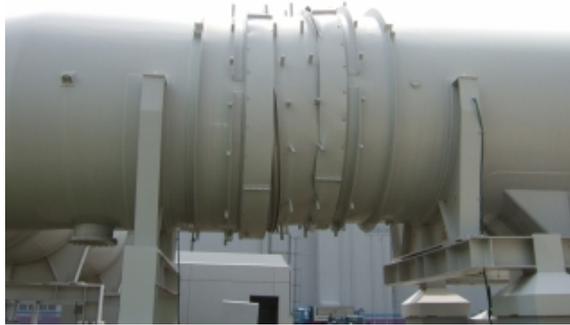
Figure 34. Earthquake-caused displacement of connecting duct to the main ventilation stack, 1979. Source: Tepco.

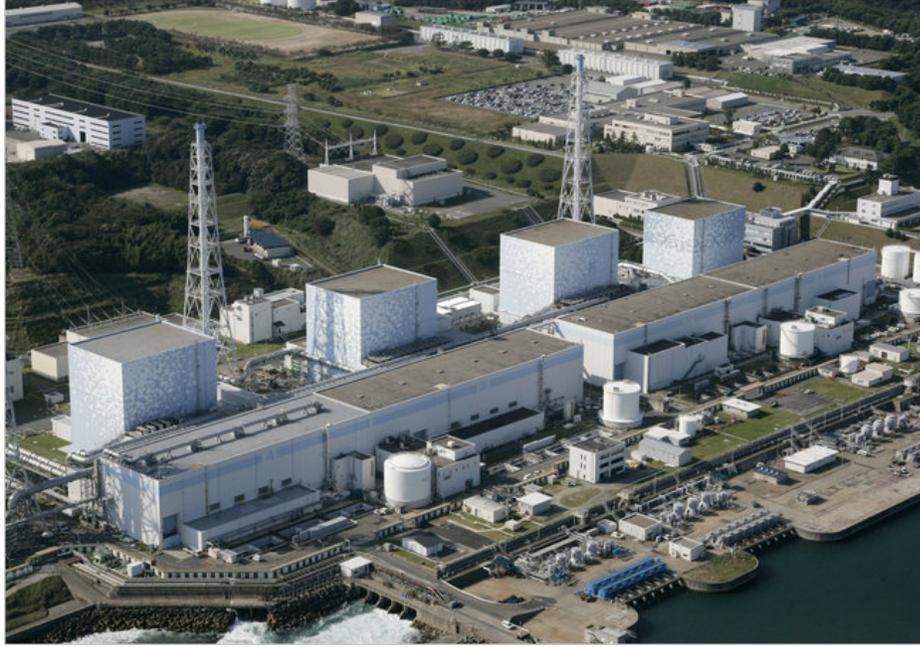
Figure 35. Fukushima Daiichi Boiling Water Reactors, BWRs nuclear Power plant, at Okumamachi, Fukushima Prefecture, Japan. The reactors are cooled with ocean water and are situated 148 miles or 238 km northeast of Tokyo. Connection to the grid shows up at the upper left side. Source: AP.
