# FUKUSHIMA EARTHQUAKE AND TSUNAMI STATION BLACKOUT ACCIDENT

© M. Ragheb  
12/4/2021

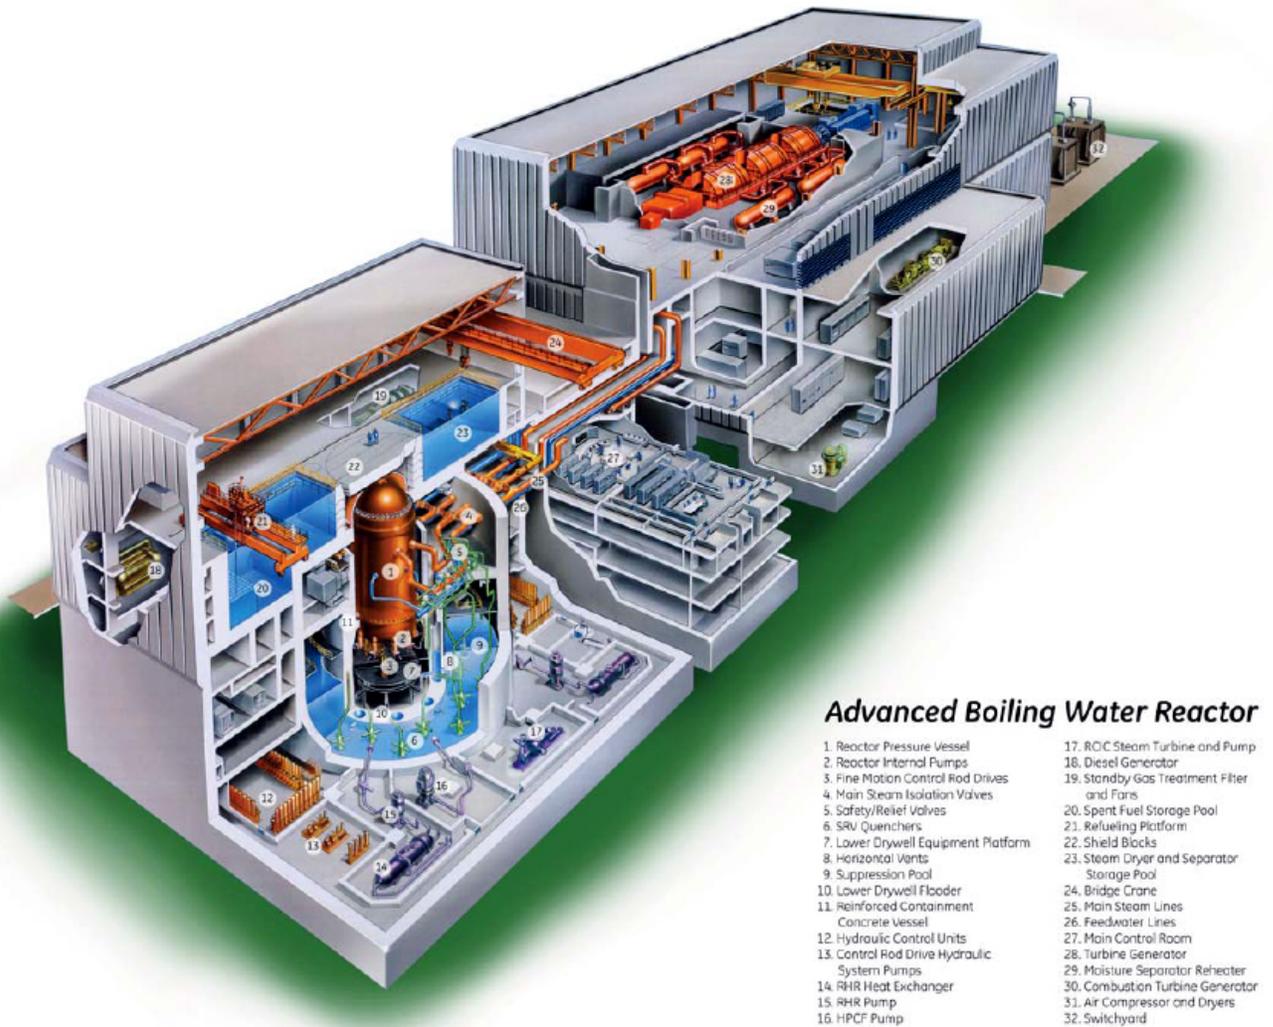
Figure 36. Plant layout of the Advanced Boiling Water Reactor, ABWR design identifies the diesel generator (18) as located high up at the level of loading deck inside the reactor building (upper left). The transformers in the switchyard (33), which were misidentified from satellite photographs as the diesel generators, are outside the building enclosure and could have been affected by the tsunami. The most significant vulnerability to the tsunami is the flooding of the lower level of the plant that would have impacted the functioning of the electrical components as well as the Residual Heat Removal, RHR pump (15), the HPCF pump (16), and the Reactor Core Isolation Cooling RCIC system steam turbine and pump (17). Source: GE.

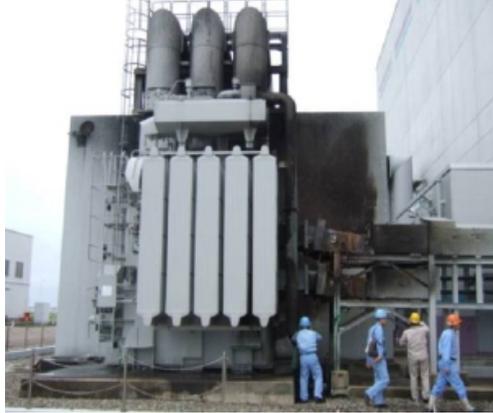
Figure 37. Transformer fire caused by 1979 earthquake. Notice the location of the transformer outside the plant enclosure and its vulnerability to water-flooding from the tsunami event.  
Source: Tepco.

Concurrently, a fire broke out in a transformer and was extinguished at the Tohoku Electricity Company's Onagawa nuclear plant in northeast Japan as a consequence of the earthquake. A reactor at the Onagawa site experienced a coolant leak.

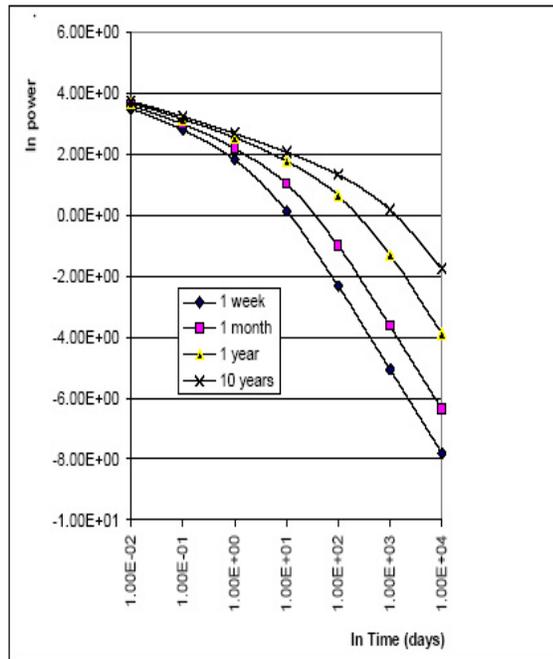
Figure 38. Decay heat power release for a 3,000 MWth Light Water Reactor, LWR for different operational times. The decay heat generation power decreases rapidly within a few days after shutdown.

Upon shutdown of the fission power generation by the control rods, decay heat continued to be generated to an initial level of about 3 percent of the fission power at one minute after shutdown. It decreases exponentially as a function of time but must continue to be cooled over a few days period by the Residual Heat Removal, RHR system.

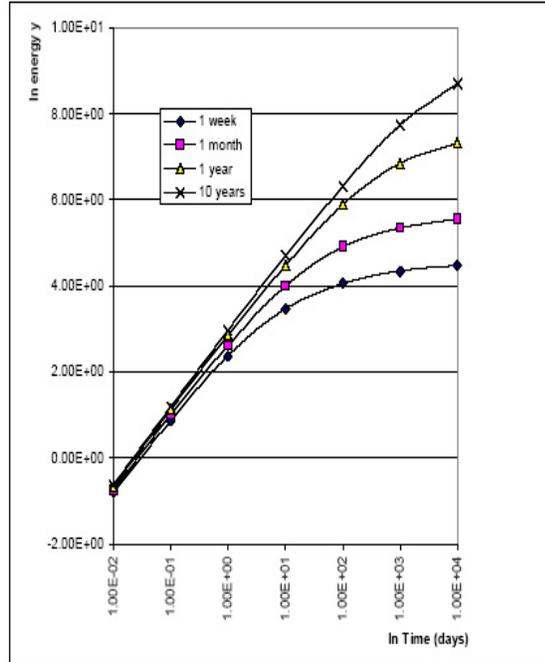
Figure 39. Decay energy or integrated power release after shutdown for a 3,000 MWth LWR for different reactor operational times. If not extracted and rejected, the energy released would result in fuel damage including fission products release and hydrogen generation.

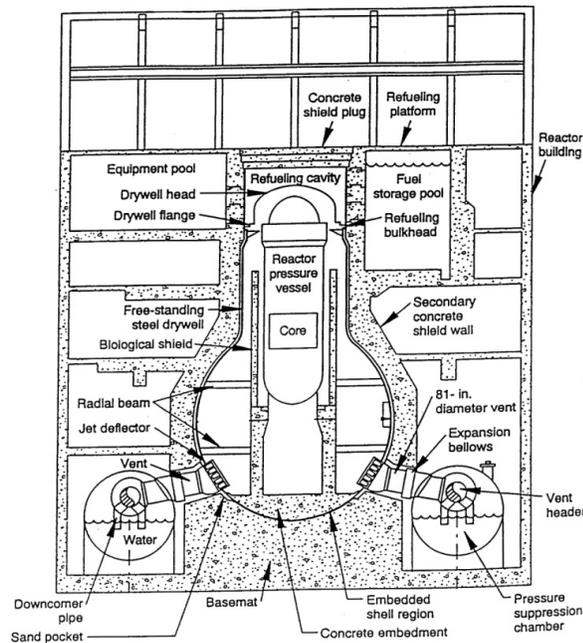
Figure 40. Primary and secondary containments configuration at Fukushima plants.

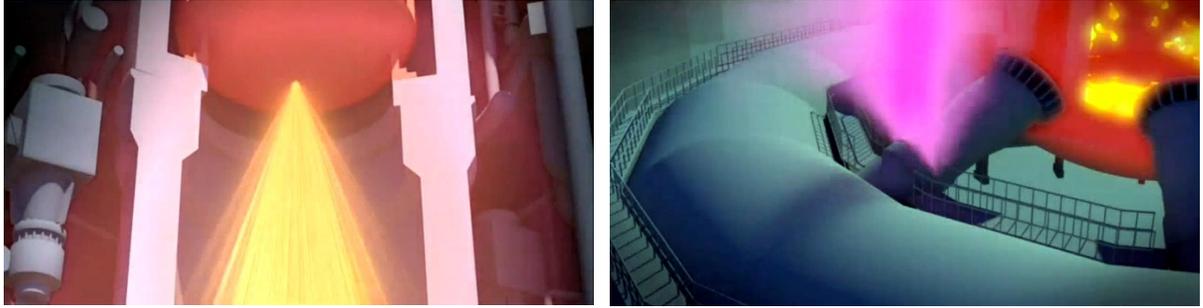
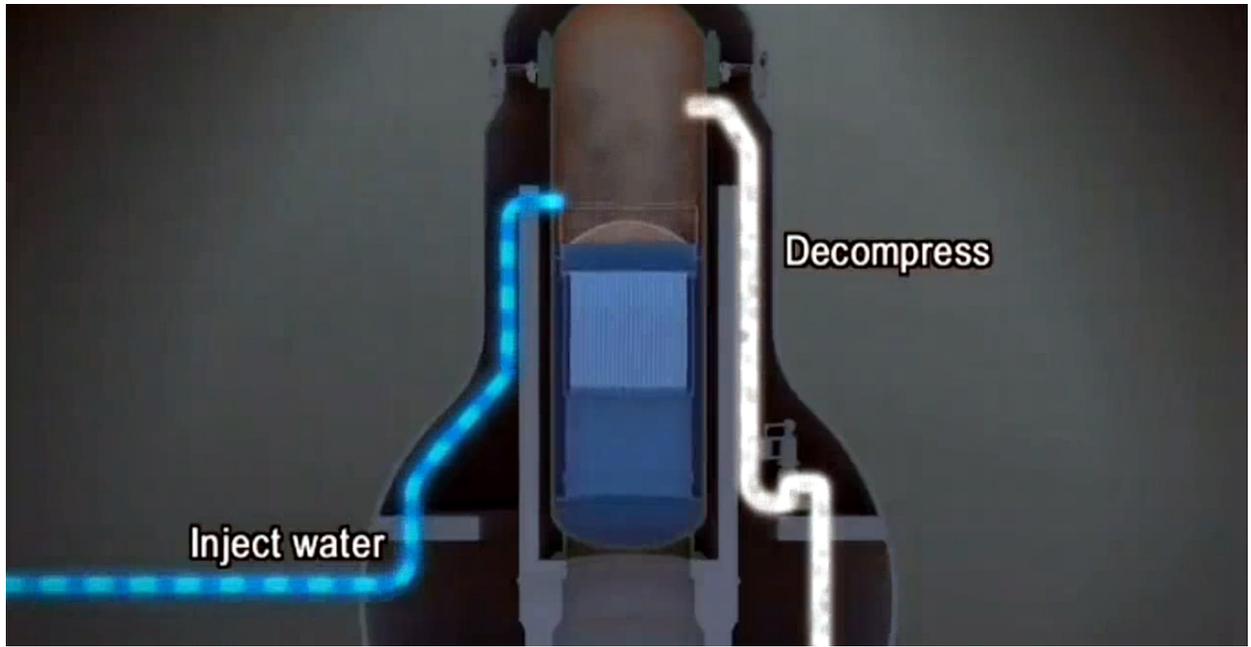
Figure 41. Depressurization of reactor vessel to allow Low Pressure Coolant Injection (LPCI) System to inject water at a high rate into reactor vessel..

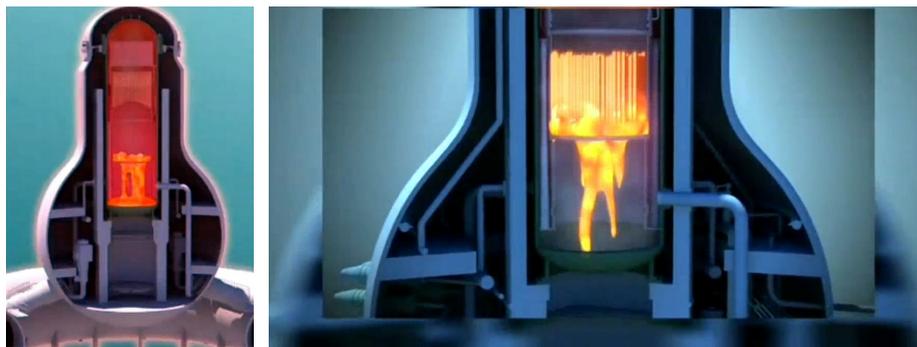
Figure 42. Core meltdown modelling of unit 1.

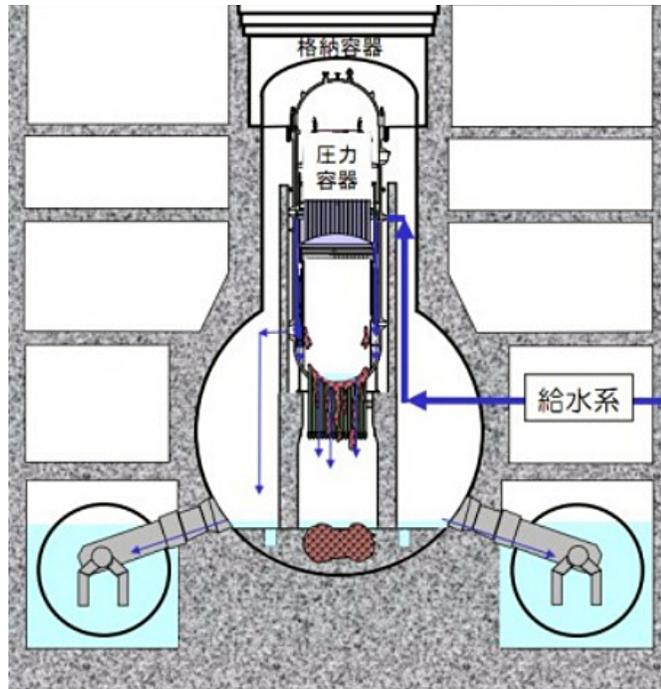
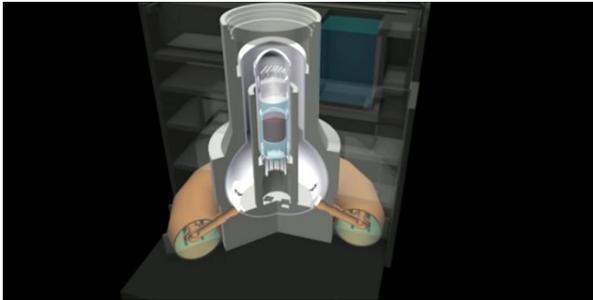
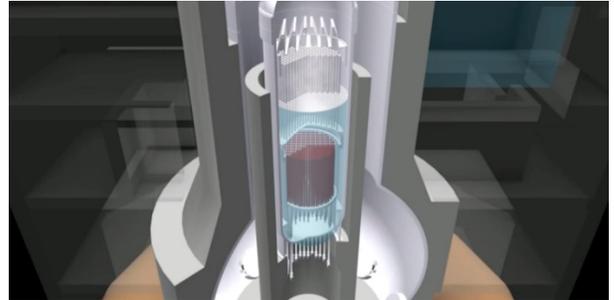
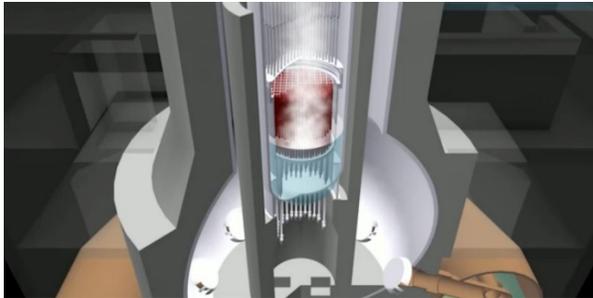
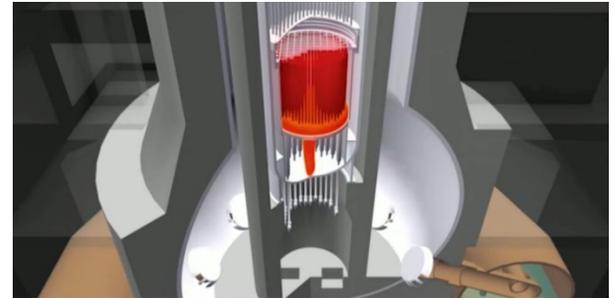
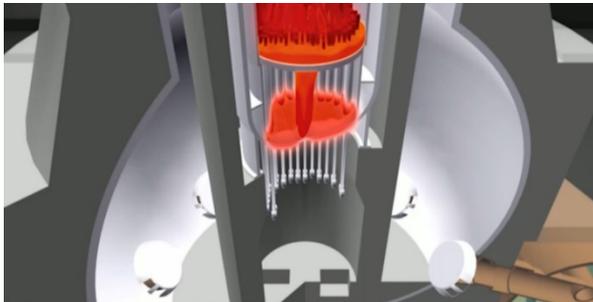
Figure 43. Molten corium material leaked through the control rods graphite seals into the dry well in the primary containment vessel. Dry well flooded through water injection from the top of the core. Source: Tepco.

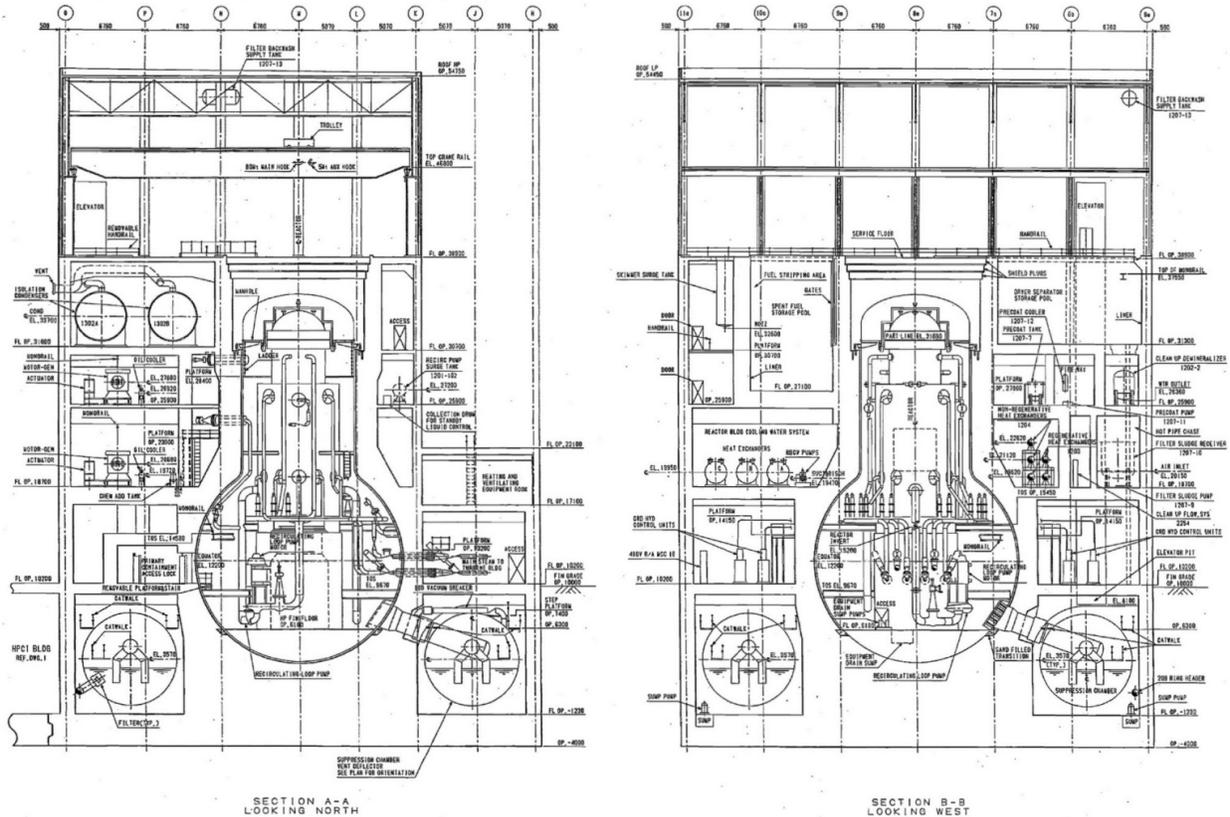
Figure 46. Perpendicular cutout through the containment structure showing the location of the storage batteries. The gate and other connections between the fuel storage pool and the top of the core may have sustained damage as a result of the earthquake and caused leakage of the pools' cooling water. Source: GE.

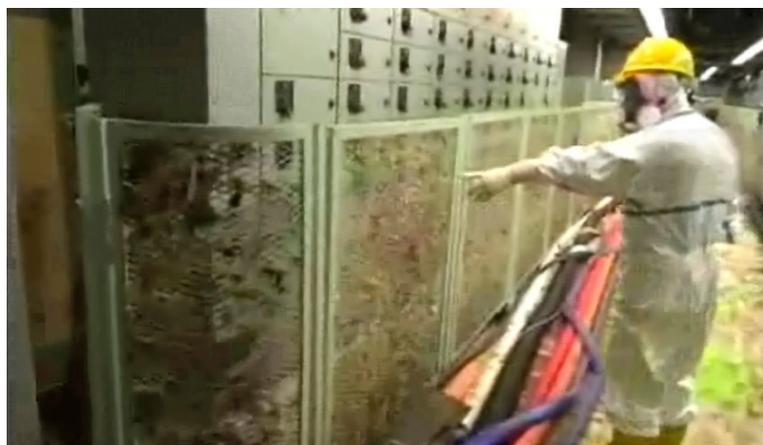
Figure 47. Tsunami water flooding of electrical switching components in basement of unit 1, May 6, 2011. Source: Tepco.

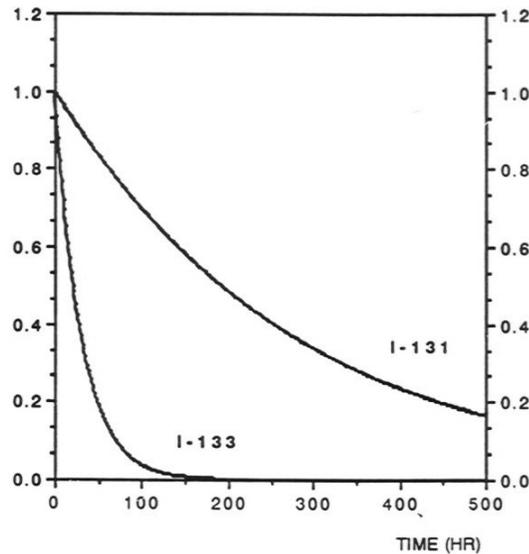
Figure 48. Decay curves of two short lived fission product isotopes, I<sup>131</sup> and I<sup>133</sup>.

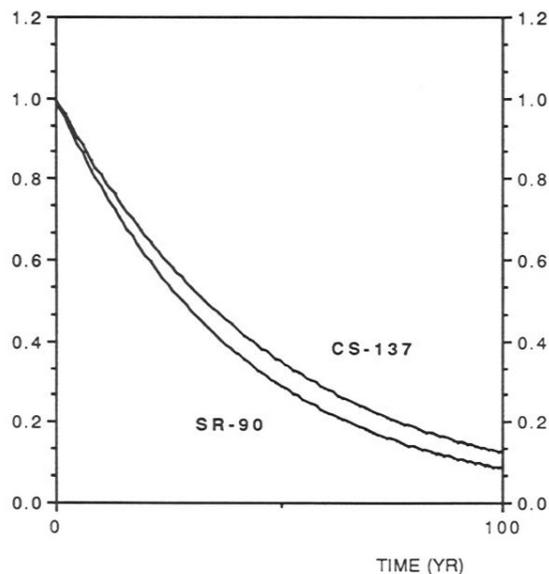
Figure 49. Decay curves of the two long lived fission product isotopes, Cs<sup>137</sup> and Sr<sup>90</sup>.

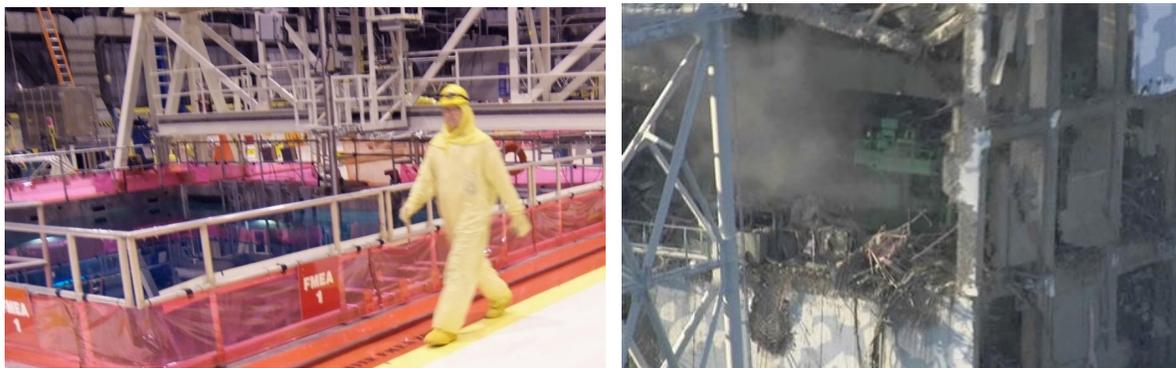
Figure 50. Spent fuel storage pools (top) showing fuel assembly being moved through gate between pool and reactor top. Steam emanating from fuel storage pool in unit 4 on March 15, 2011, under the loading crane showing at the center of the picture.

The fuel assemblies are stored in steel racks with boron added as a neutron absorber to prevent criticality. If the water leaks as a result of earthquake damage or cooling is discontinued, the water level would decrease through evaporation at a rate of 2 ft / day, eventually uncovering the fuel. The heat generation can cause the Zircaloy cladding to oxidize causing the volatile fission products to be released and even the zirconium to catch fire. The pouring of cold water on the hot cladding would generate thermal stresses in the cladding causing it to fail. To avoid causing a partially-drained or dried-out pool, cooling must be maintained.

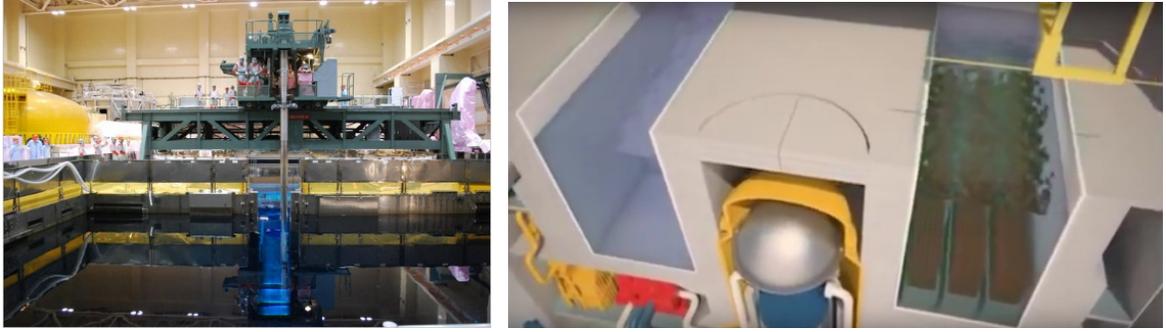
Figure 51. Refueling operation into fuel storage pool. Yellow object is the removed core dome.

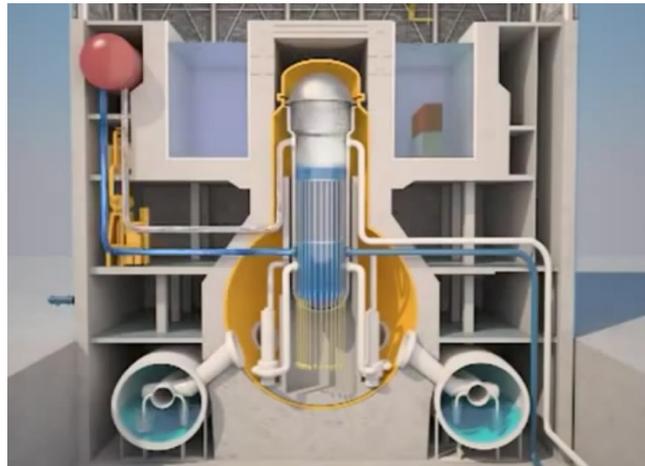
Figure 52. Unit 1 had a steam drum that could have provided natural circulation cooling for up to ten hours to a heat exchanger. Initially, the operators isolated the heat exchanger due to excessive cooling according to operating procedures before the tsunami hit. As flooding of the basement occurred, affecting the electrical supplies, the operators were unable to reactivate the cooling system. Unit 1 core was the first to melt-down. Hydrogen explosion occurred upon venting of containment structure. Source: Institut de Radioprotection et de Sûreté Nucléaire (IRSN).

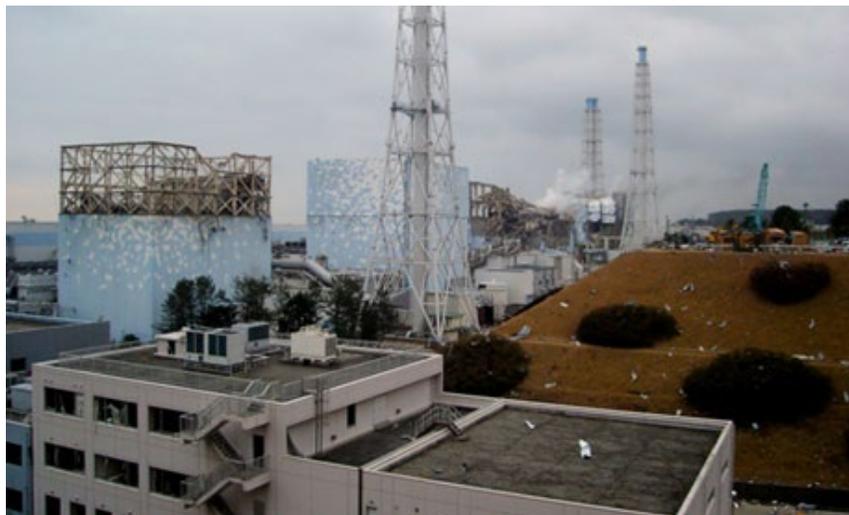
Figure 53. Damage to the upper structure of the Fukushima Daiichi unit 1, and undamaged structure of unit 2. Source: Tepco.

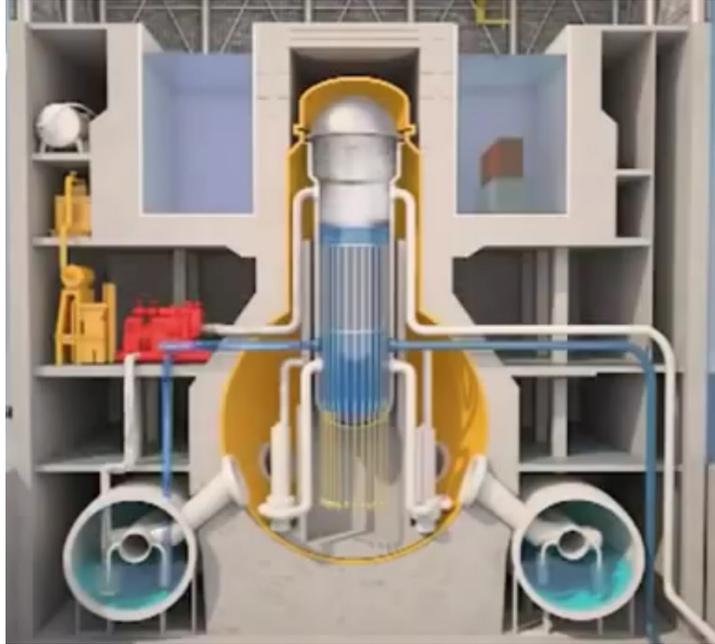
Figure 54. Units 2 and 3 had decay-heat cooling provided by steam-driven turbo-pumps rejecting the decay heat into the pressure suppression pool. They operated for 24 hours until batteries providing power to the control valves were depleted or flooded. Both units underwent hydrogen explosions. Source: Institut de Radioprotection et de Sûreté Nucléaire (IRSN).

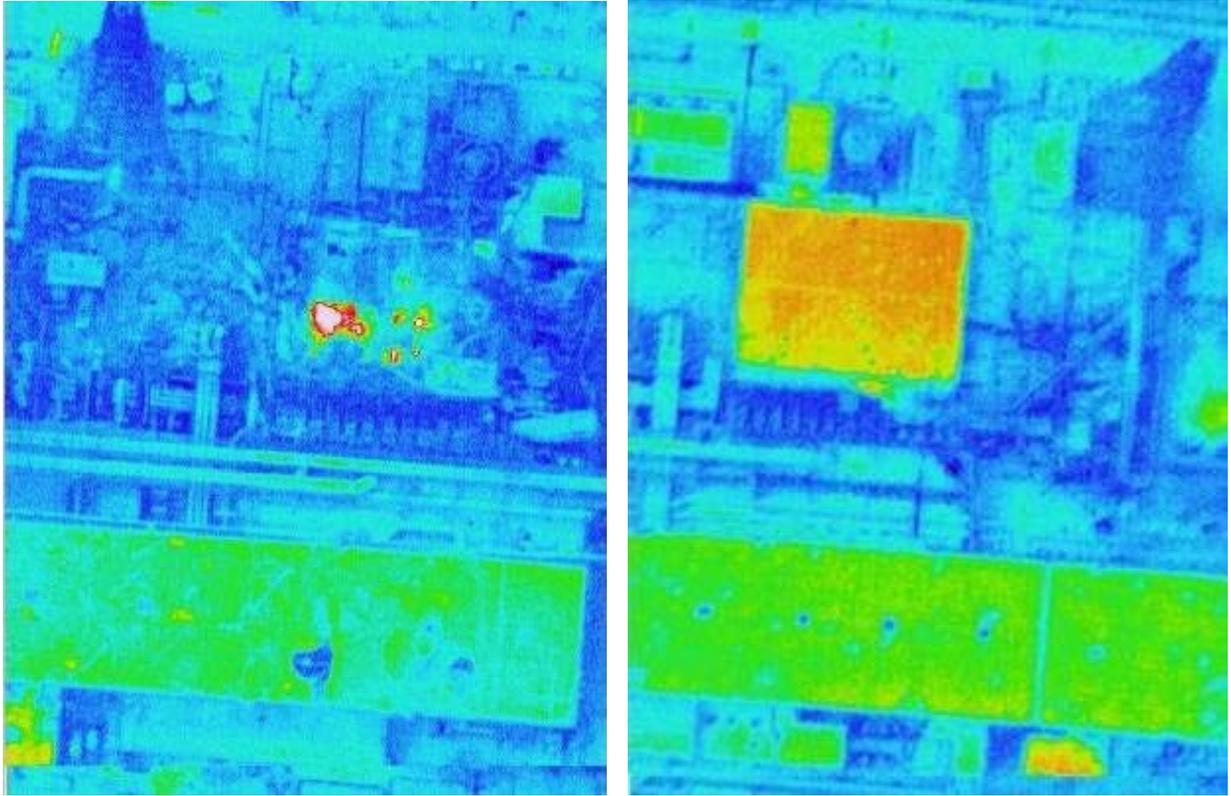
Figure 55. Infrared signatures of Fukushima units 1 and 2 (right) suggesting a temperature of 262 °F in unit 2 and of units 3 and 4 (left) suggesting a lower temperature of 144 °F on March 21, 2011 in reactor building and turbine hall caused by accumulated unvented steam. A heat plume at the bottom of the reactor building of unit 2 suggests steam leakage from the undamaged building structure. A heat signature exists in unit 1 to the far right. Unit 4 does not exhibit a heat signature. Highly localized heat signature in unit 3 may suggest a possible ejection of the concrete shield plug by the observed hydrogen or possibly steam explosion. Atmospheric pressure measurements at units 2 and 3, but not unit 1, suggest containment breach by April 10, 2011. Source: Tepco.

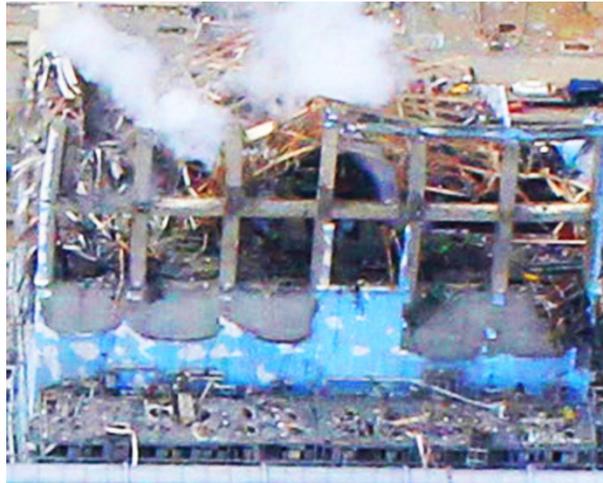
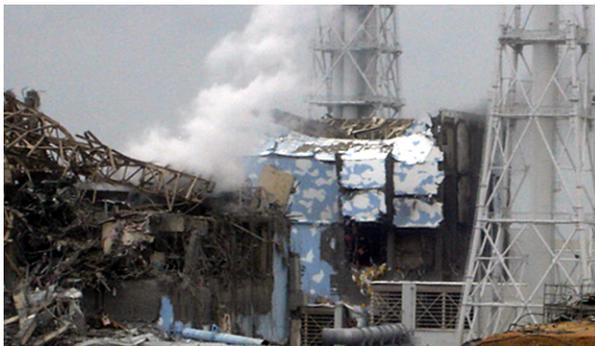
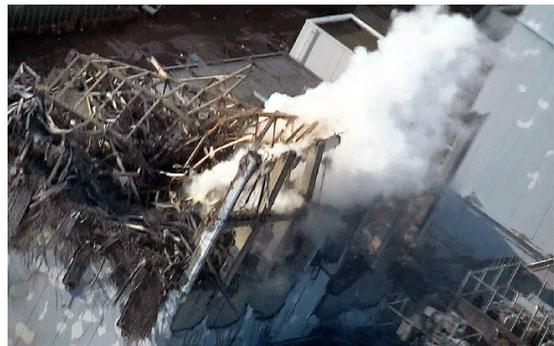
Figure 56. Fukushima Daiichi Unit 3. Steam emission on March 21, 2011 evolved into black smoke. A possible hydrogen or steam explosion tore out the upper part of the containment building structure. The blow-out-panels are missing, with remaining steel and concrete beams. The reactor containment vessel is reported to remain intact, even though the nuclear fuel storage pool and the reactor refueling deck would be exposed to the elements. Steam and dark smoke emanating from possible burning of the  $UO_2$  fuel, concrete rubble, or boron carbide  $B_4C$  embedded in the Al of the Boral shielding material if it is used in the fuel storage pool as spacer between the fuel assemblies. Source: Tokyo Electric Power Company.

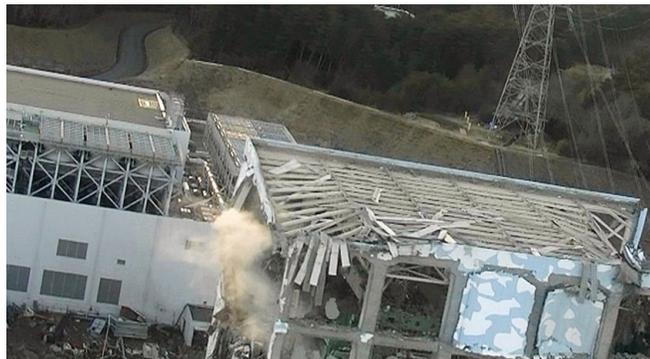
Figure 57. Fukushima Daiichi unit 4 on March 16, 17, 2011 showing steam emanating from fuel storage pool. Source: Japan Self Defense Force.

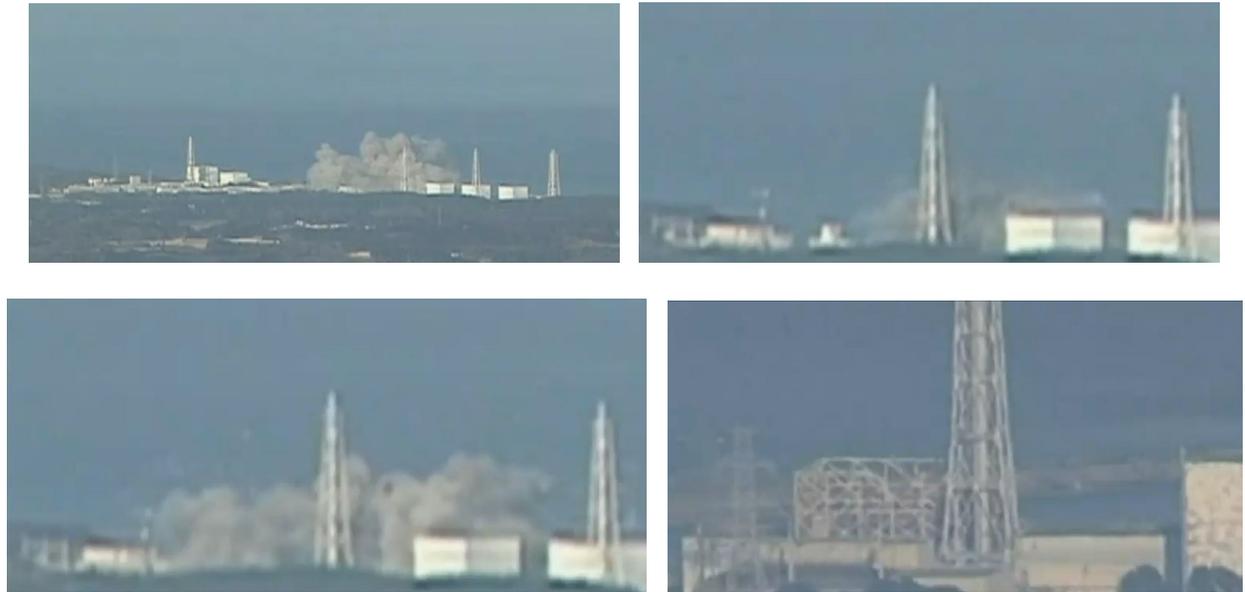
Figure 58. Fukushima Daiichi unit 1 Boiling Water Reactor, BWR nuclear power plant lateral horizontally propagating hydrogen explosion, initiated by depressurization and steam venting, sequence of events. March 12, 2011.

In the process of venting steam to reduce the pressure in the containment system, a stipulated hydrogen explosion was reported at the Fukushima unit 1 on March 13, 2011 at the Daiichi site with associated fuel damage, containment structure damage, partial core meltdown and fission products release. Small amounts of radioactivity were vented, the reactor had 400 fuel assemblies loaded in its core, and the storage fuel pool had 292. The rubble from the roof covered the reactor's loading deck and fell into the fuel storage pool.

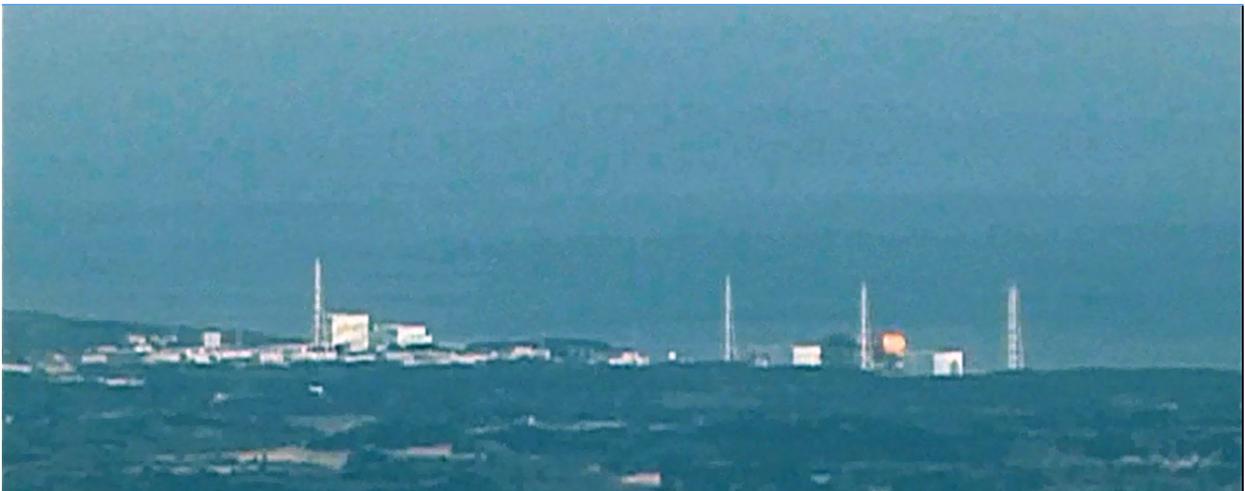
Figure 59. Lateral horizontally propagating hydrogen explosion at second chimney from the right preceded the vertical suspected steam explosion at unit 3.

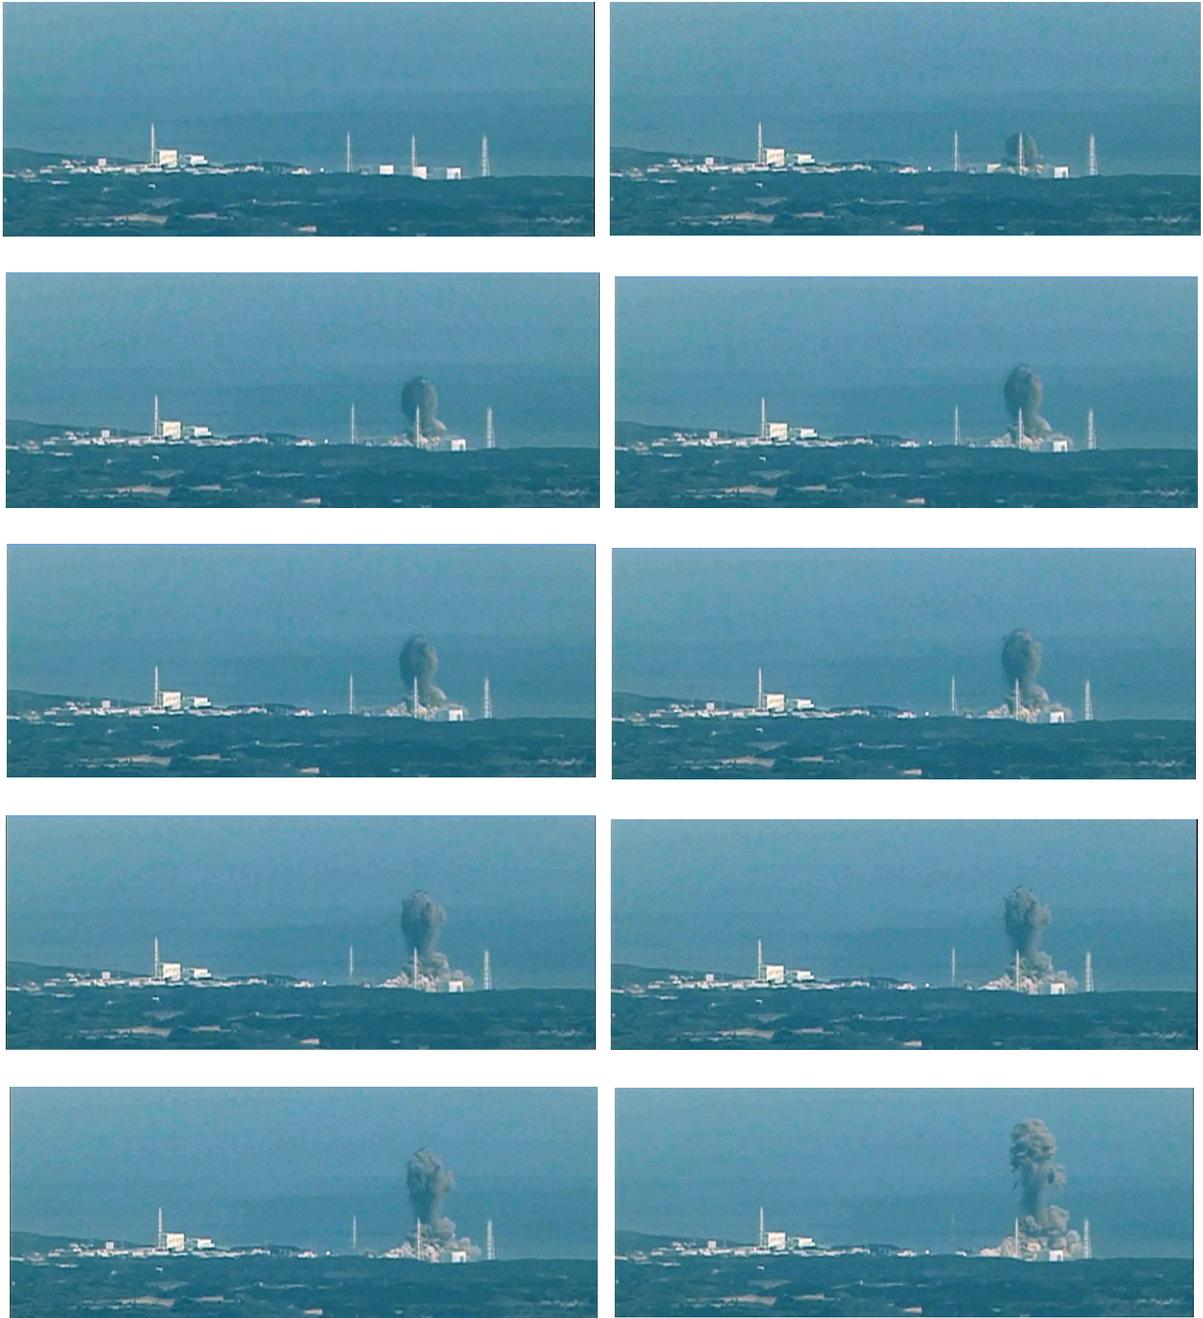
Figure 60. Sequence of vertical steam explosion following the horizontal hydrogen explosion at unit 3.

A more energetic presumed hydrogen explosion associated with steam depressurization followed at the unit 3 on March 14, 2011 with a fire and may have led to reactor vessel and pressure suppression pool damage. This unit uses a Mixed Oxide, MOX fuel mixture of 93 percent of UO<sub>2</sub>

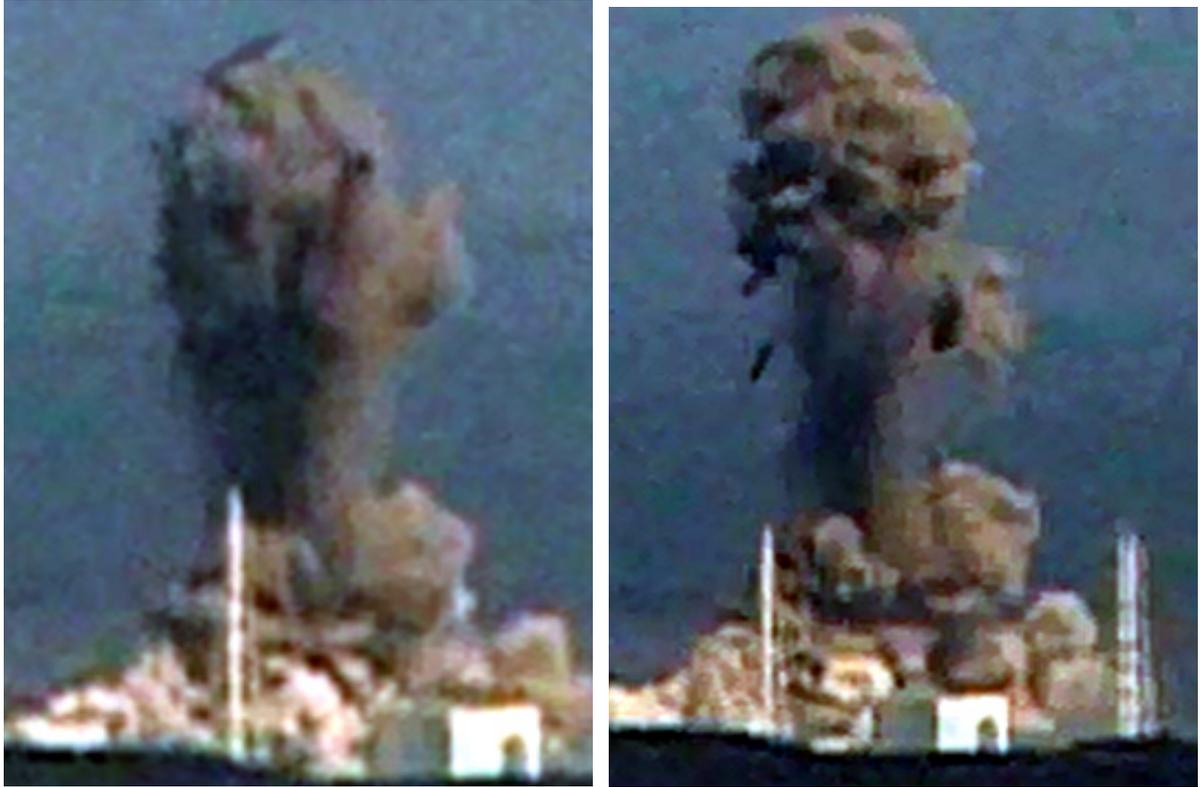
Figure 61. Highly energetic vertically propagating hydrogen or possibly steam explosion at the Fukushima Daichi unit 3 BWR on March 14, 2011 was followed by a fire and reactor fuel damage. Heavy debris possibly composed of the concrete shield plug or crane components was vertically ejected and is seen falling back down in the photograph. No damage to the reactor vessel can be inferred from the absence of the reactor's top plug in the ejecta. It bears some analogy to the complex aerodynamics of an "exploding vortex ring." The USS Ronald Reagan aircraft carrier and its battle group retreated away from the fallout cloud from33<sup>3</sup> uni<sup>t</sup> 3. Sources: NTV / NNN, Japan.

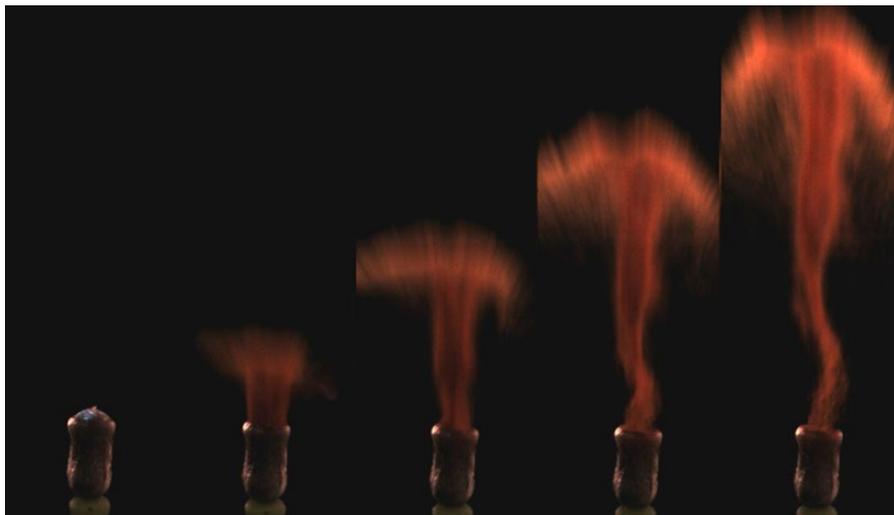
Figure 62. Exploding vortices suggest a steam explosion occurrence at unit 3.

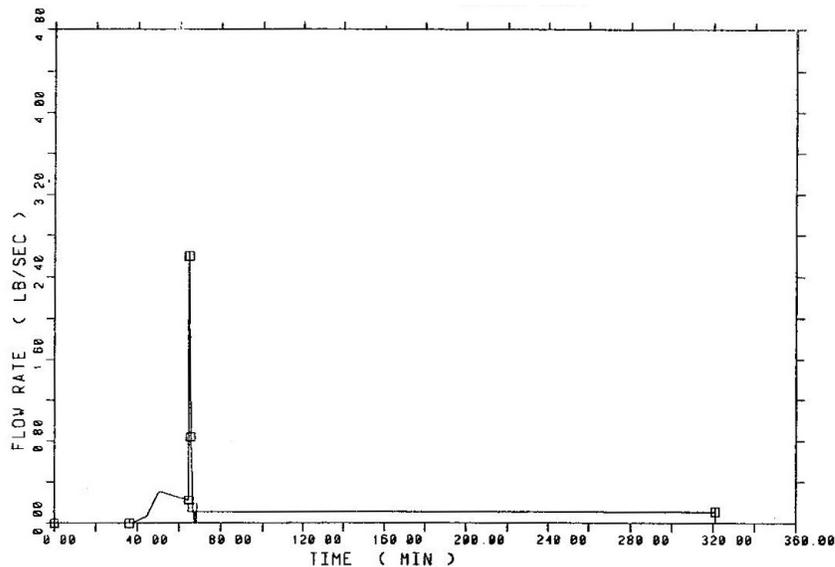
Figure 63. Hydrogen release rate was correlated with a pressure pulse inside the containment structure in the Three-Mile Island Accident. The hydrogen pulse did no discernible damage to the containment structure.

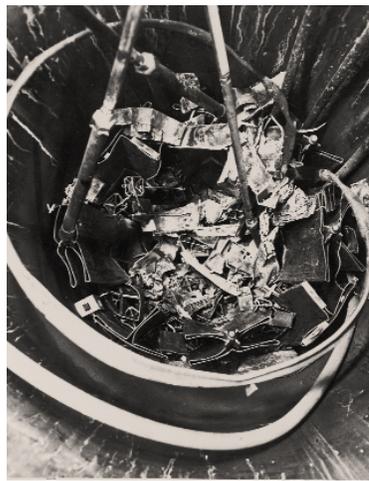
Figure 64. Damaged core resulting from steam explosion caused by a criticality accident in the military Small Low power reactor experiment SL-1 BWR. A worker inadvertently yanked out a control rod beyond the set limit during a maintenance procedure. The core became supercritical, boiled off the steam causing a steam explosion. The drying of the moderator stopped the fission reaction, even though the decay heat generation would have persisted for a while.

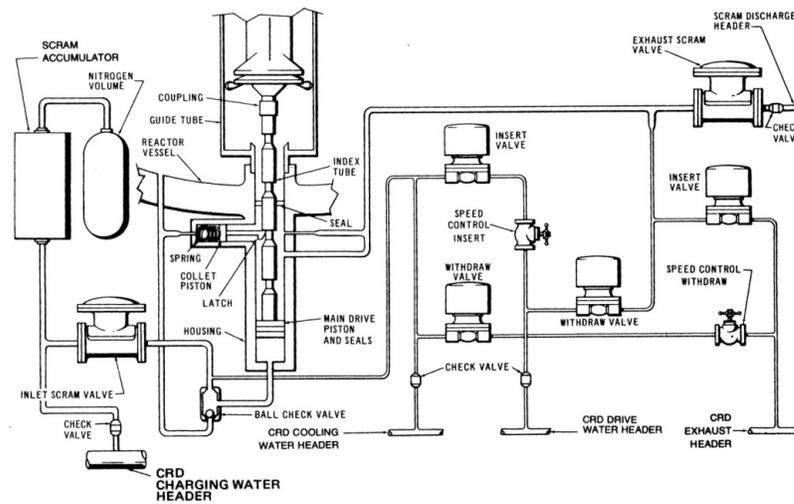
Figure 65. BWR control rod drive mechanism at the bottom of a BWR reactor vessel showing the control rod graphite seals location [2].

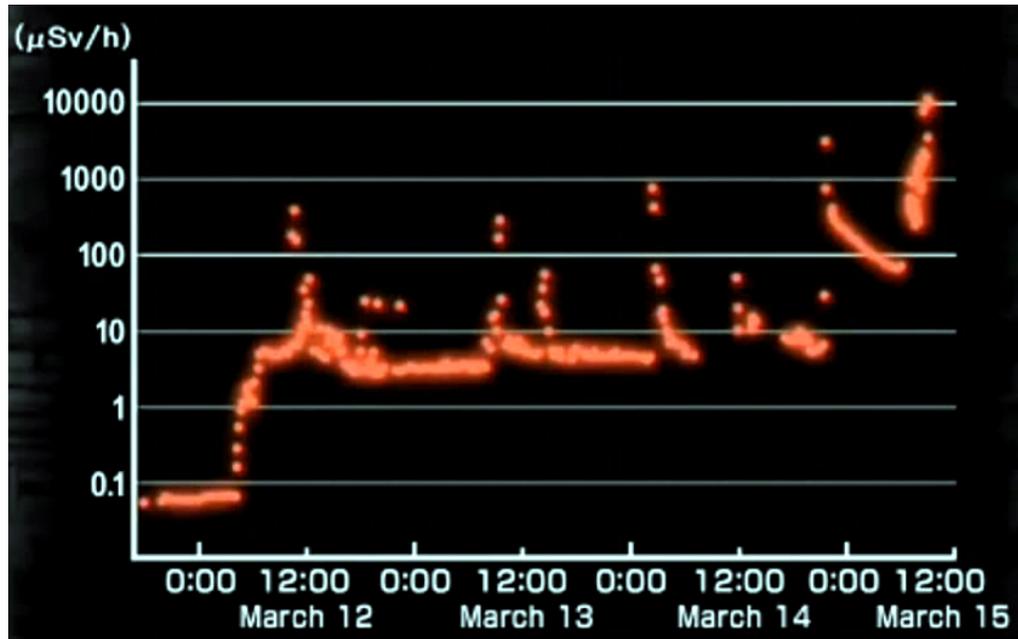
Figure 66. Dose equivalent rate at main gate of Fukushima Daiichi plants.

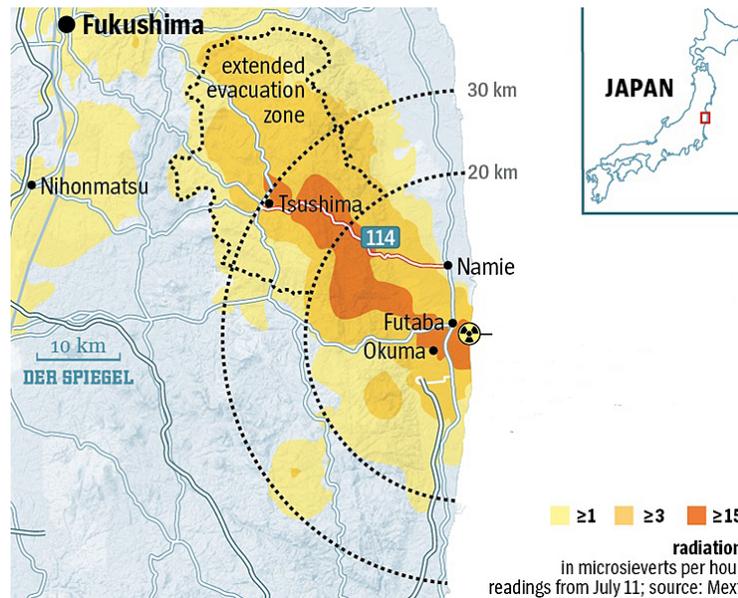
Figure 67. Evacuation zones around Fukushima. Source: Der Spiegel.

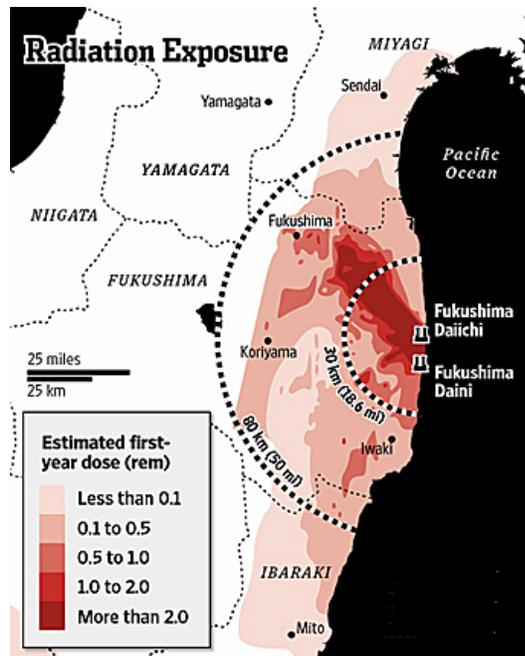
Figure 68. Dose equivalent contours.

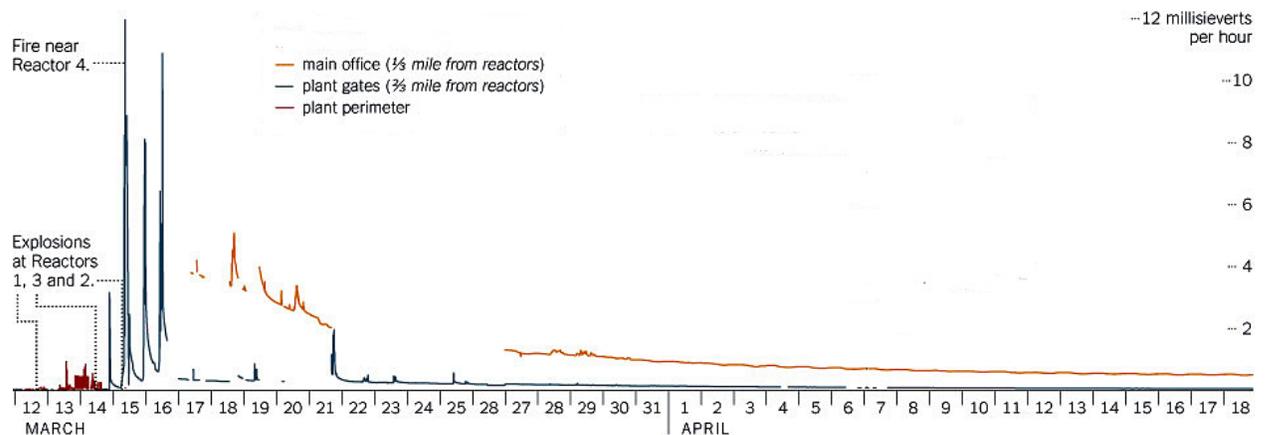
Figure 69. Effective dose rate measurements at main office, plant gates and plant perimeter.  
Source: Tepco, NY Times.

Monitoring vehicles collected air samples and measured the activity density of the radionuclides of concern at the western gate of the Fukushima Daiichi site. The samples were analyzed at the Fukushima Daini plant site using a Germanium solid-state counter for a measuring time of 500 s. Iodine<sup>131</sup> reached just 45 percent of the statutory activity density level for workers engaged in tasks associated with radiation.

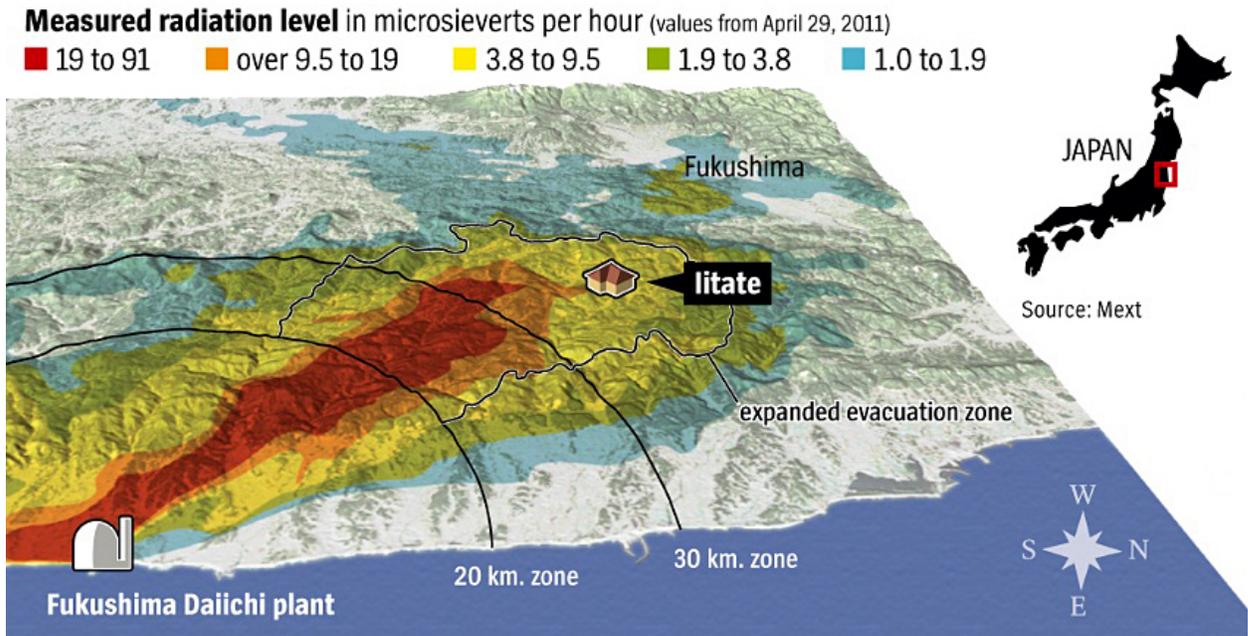
Figure 70. Dose equivalent rate around Fukushima. Source: Der Spiegel.

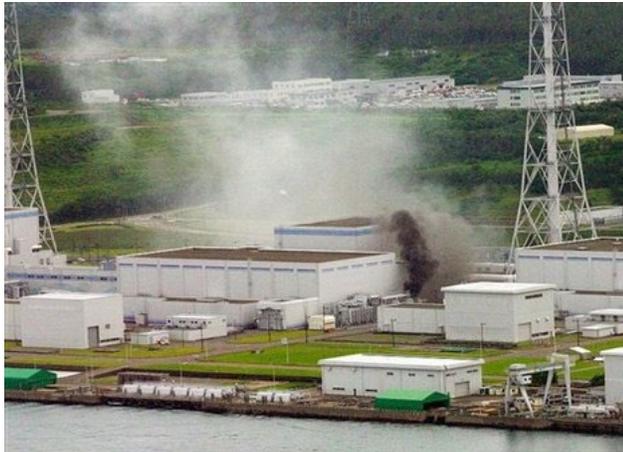
Figure 71. Burning electrical transformer resulting from the coupled earthquake and tsunami event, March 11, 2011. Source: Japan Coast Guard.
