# FUKUSHIMA EARTHQUAKE AND TSUNAMI STATION BLACKOUT ACCIDENT

© M. Ragheb  
12/4/2021

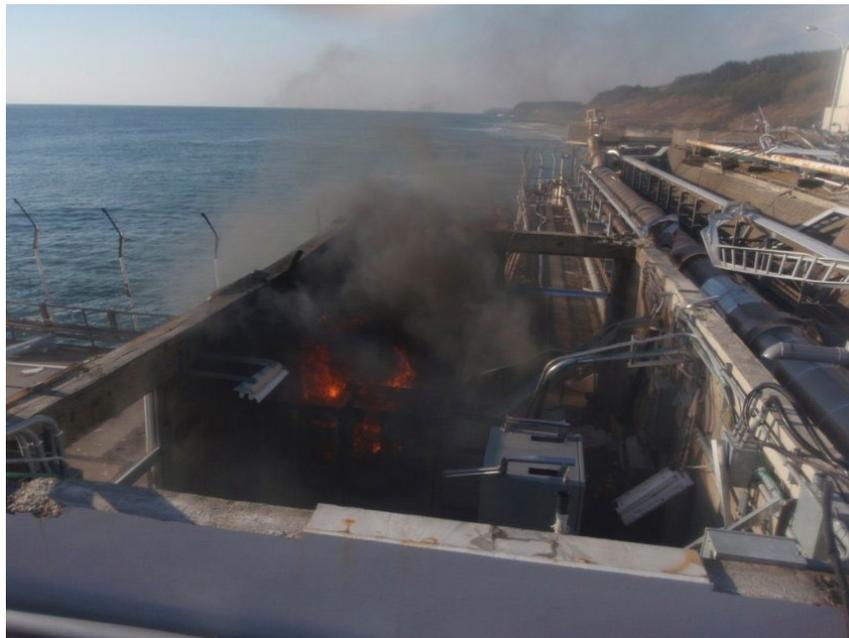
Figure 72. Fire in a battery bank initiated by a 6.3 scale aftershock on April 12, 2011. Source: Reuters.

Another 6.3 scale aftershock on April 12, 2011, initiated a fire in a battery bank that was quickly extinguished.

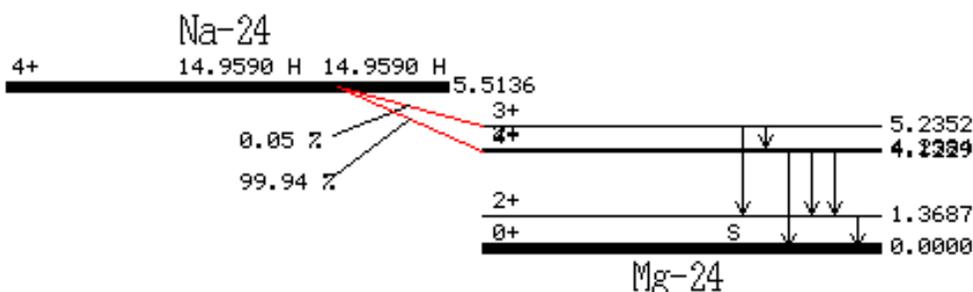
Figure 73. Decay diagram of Na<sup>24</sup>.

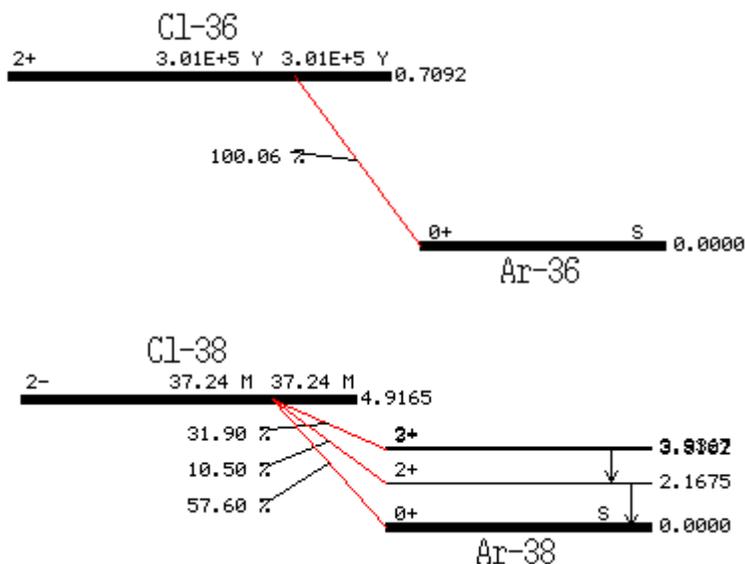
Figure 74. Decay diagrams of the Cl<sup>36</sup> and Cl<sup>38</sup> isotopes.

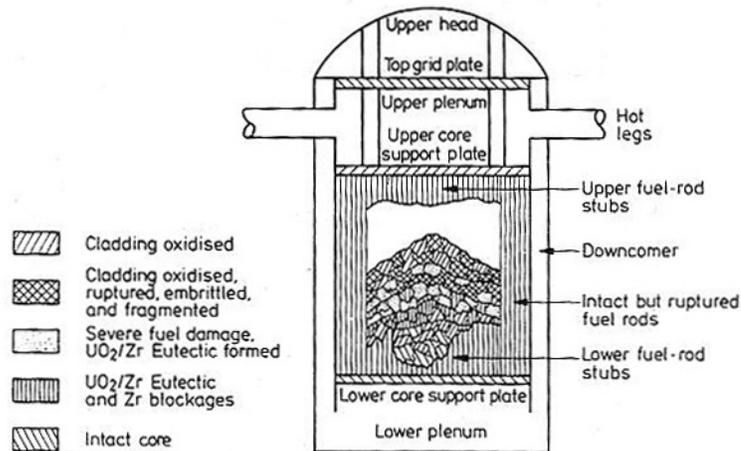
Figure 75. Debris bed resulting from the core damage in the Three Miles Island accident.

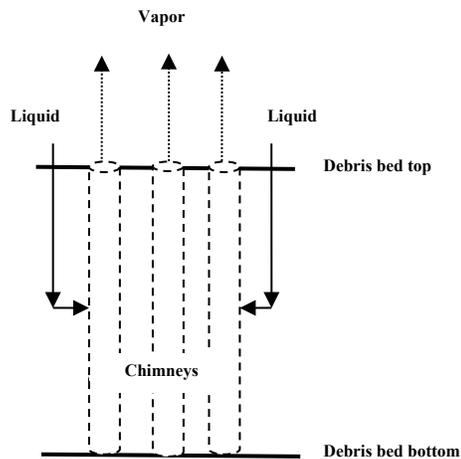
Figure 76. Debris bed chimneys cooling.

In the case of the existence of a shallow bed of immersed particles at the bottom of the containment, “chimneys” form much like in the case of those forming in rice when cooking. The formed steam escapes through the chimneys. The liquid is pulled through capillary action through the particulates layer in between the chimneys. This efficient method of cooling can only exist under a very limited set of conditions.

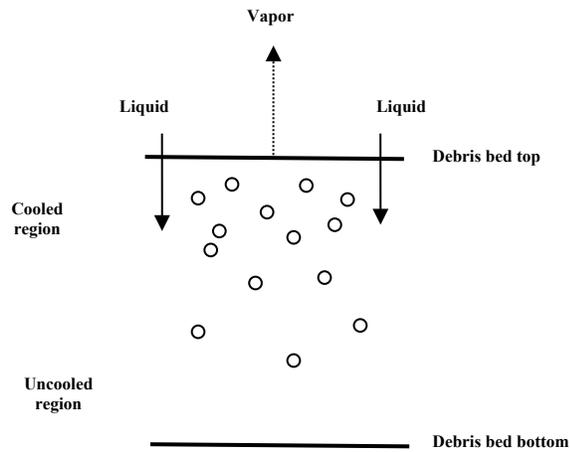
Figure 77. Closed bed debris bed cooling.

However, if the fuel and the control rods were already fully damaged and forming a debris bed, alternate cooling approaches can be considered. Porous non-neutron moderating materials such as sand or gravel or iron pebbles to reduce neutron moderation and prevent criticality in the formed debris bed could be attempted, in addition to using boron or lithium dissolved in water as a neutron absorber. The observed rising steam plume from the Fukushima unit 3 implied the possibility of the existence of a debris bed being cooled by the evaporating water as steam.

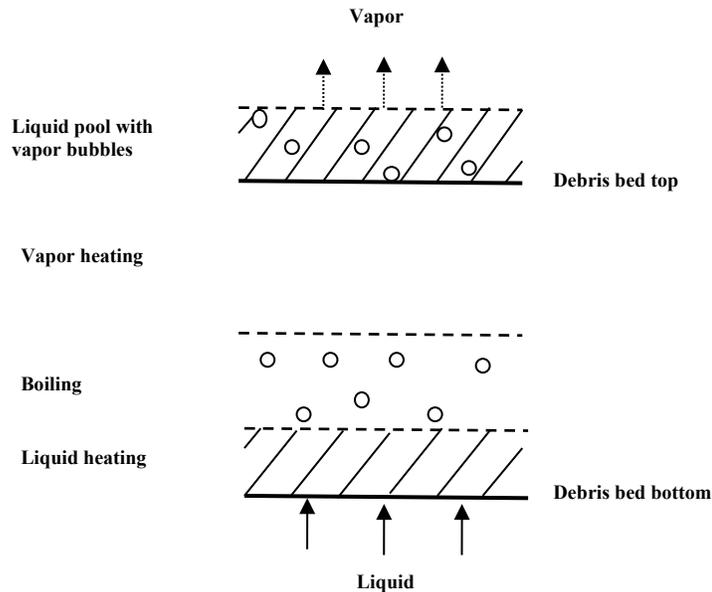
Figure 78. Multilayered once-through debris bed cooling.

This is the best possible situation where the cooling liquid reaches the bottom of the bed and flows upwards through it through the action of forced and natural convection, much like what occurs in a steam boiler.

The natural convection would be caused by the differential in density of the fluid within and outside the debris bed.

The decay heat generated within the fission products would bring the fluid coolant to its boiling point generating vapor bubbles. As the fluid moves through the bed, it is totally converted into vapor. At this stage, the temperature rises rapidly up the bed.

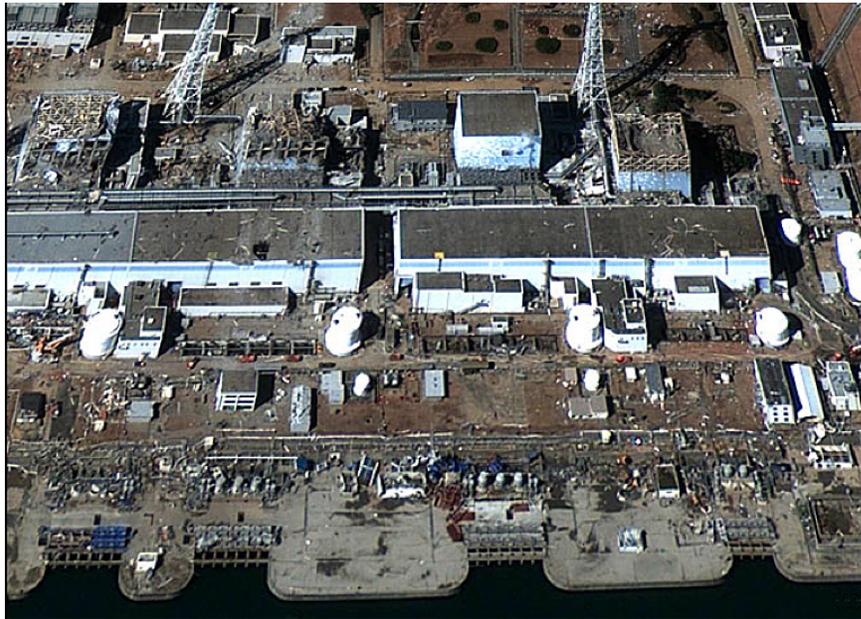
Figure 80. Aftermath of Fukushima Daiichi accident on March 18, 2011, one week after the accident. Rubble from hydrogen explosions in units 1, 3 and 4 and fire in unit 3 is spread over the site. Damage from earthquake and tsunami to the electrical systems apparent along the water front. Steam still emanating from unit 2. Source: Digital Globe.

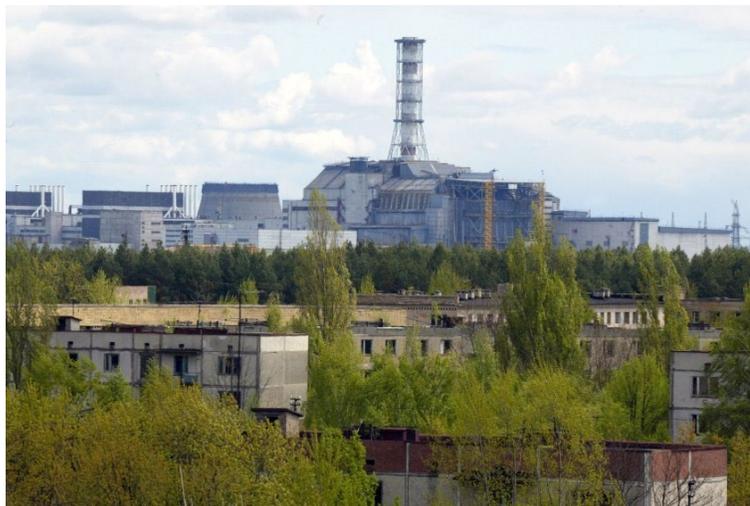
Figure 82. Encased damaged reactor at the Chernobyl site.

The damaged reactors at the Fukushima site would have to be prevented from leaking radioactivity to the environment through the effects of wind and rain by surrounding them initially with an enclosure like the one used at the Chernobyl site, until the decay of the radioactivity would allow them to be dismantled for ultimate disposal.

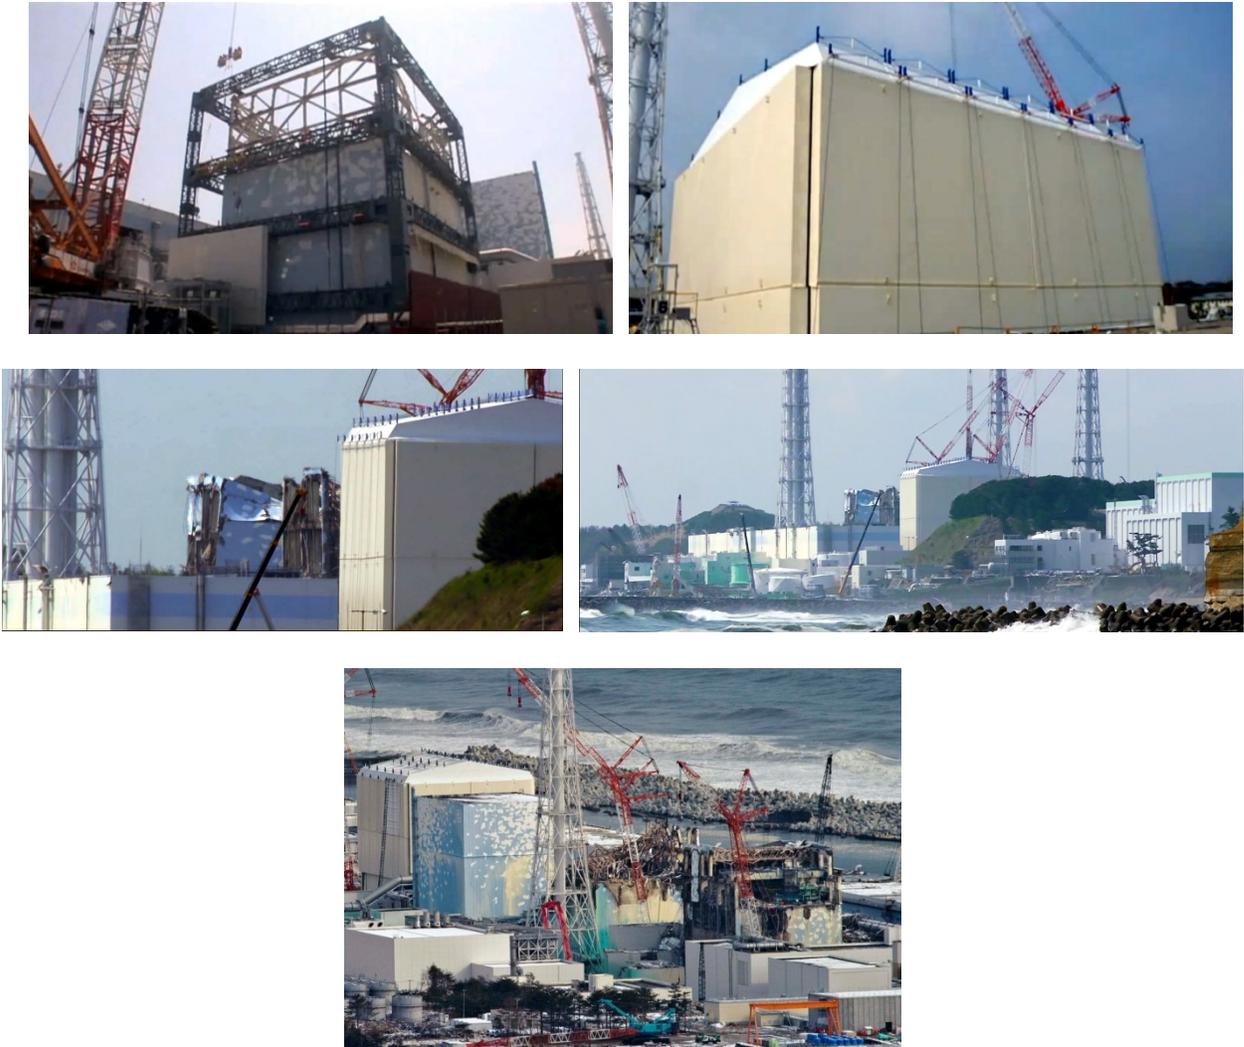
Figure 83. Cocoons encasing the damaged Fukushima reactors.

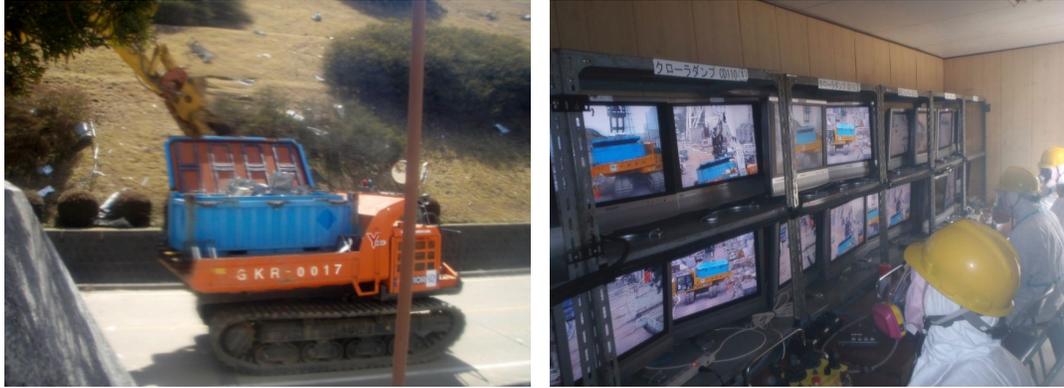
Figure 84. Removal of debris using remote control equipment and autonomous transporters. A useful design feature at the Fukushima site is an emergency command control center in an earthquake proof bunker with power supplies, radiation shielding thick walls, communication gear, food and water supplies and two air filtration systems. Source: Tepco.

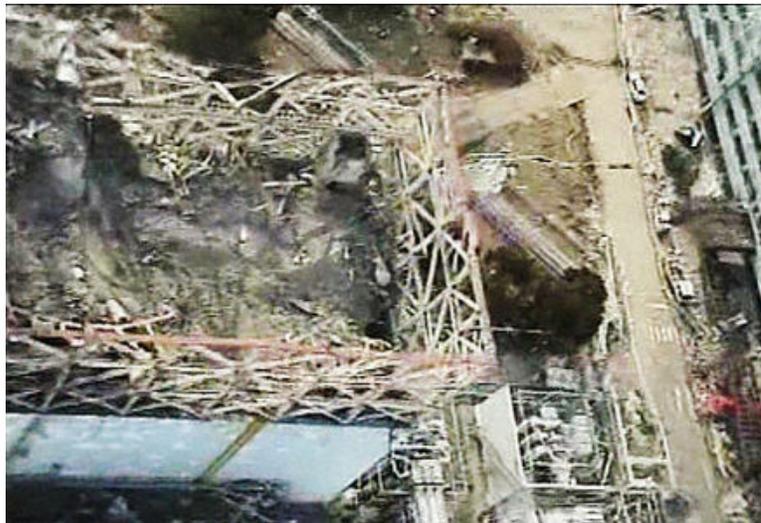
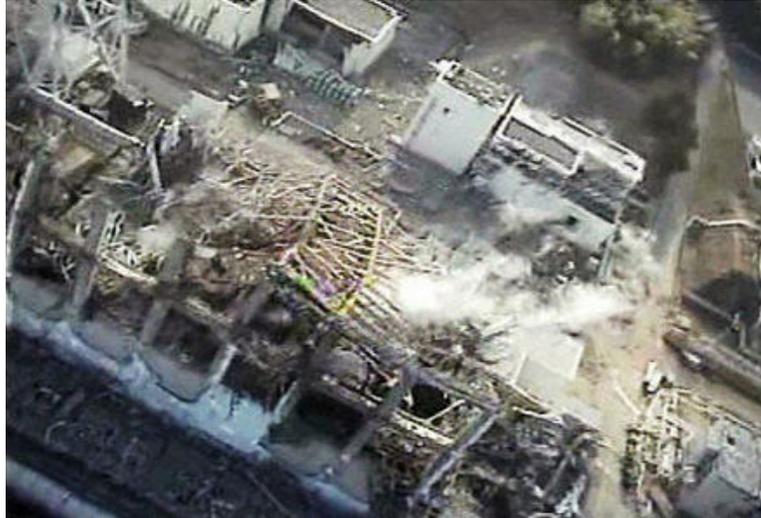
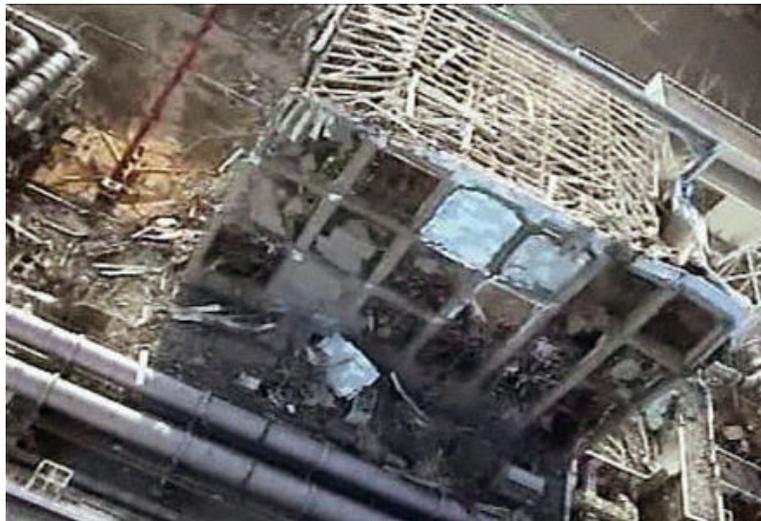
Figure 85. Unmanned Aerial Vehicle, UAV T-Hawk MAV by Honeywell pictures of tops of units 1 (top), 3 (middle) and 4 (bottom), as of April 10, 2011. Source: Tepco, Honeywell.

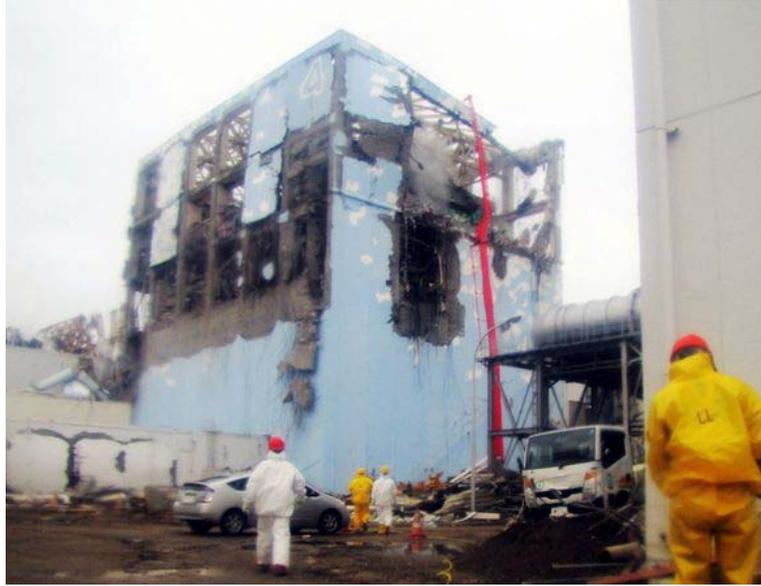
Figure 86. Damage below the fuel storage pool in unit 4 as seen from the ground on March 22, 2011. Water being pumped into the damaged spent fuel pool using a boom. Source: Tepco.

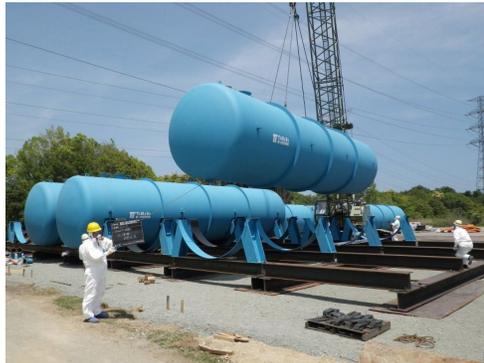
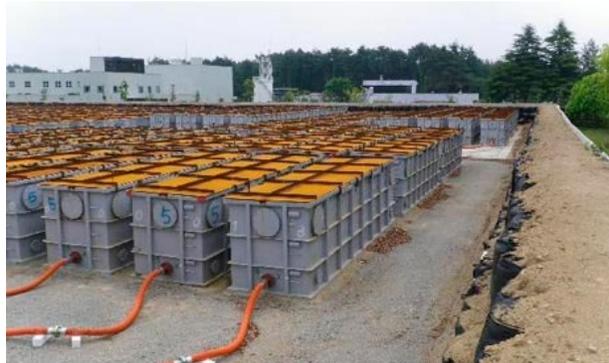
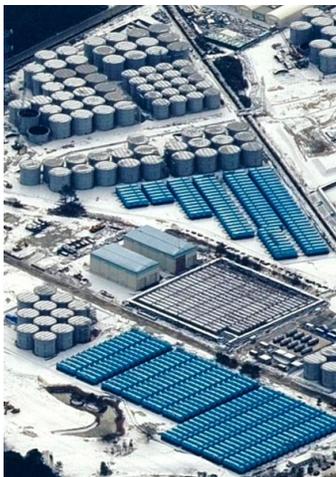
Figure 87. Storage tanks for sludge resulting from the water decontamination process and coolant storage tanks. Contaminants are removed except for tritium, which decays with a 12.3 year half-life. Source: Tepco, DPA.

Most of the water poured for cooling the reactors overflowed or leaked into basements, connecting tunnels and service trenches at the plant. The Tepco electrical utility with the help of Areva from France and Kurion from the USA installed a water decontamination system that uses ion exchange resins and Zeolite filters. By the end of the year it expects to have generated 2,000 m<sup>3</sup> of sludge separated from the water used to maintain cooling of the units.

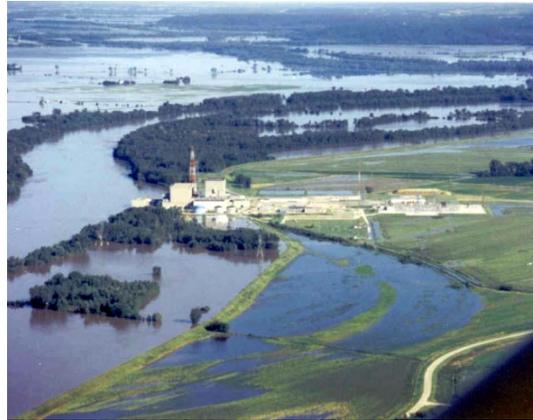
Figure 88. Cooper Station, Brownsville, Nebraska on the Missouri River flooding event, 1993.

The Nebraska Public District's Cooper Station, Brownsville, Nebraska on the Missouri River sustained a flooding event in July 1993 when upstream dikes and levees failed and suggested a shutdown of the plant. The below grade levels in the turbine hall and reactor building had water accumulation when the floor drain system backed up. The rising water level affected the electrical cabling and equipment including the Reactor Core Isolation Cooling (RCIC) pump room causing them to be shorted out.

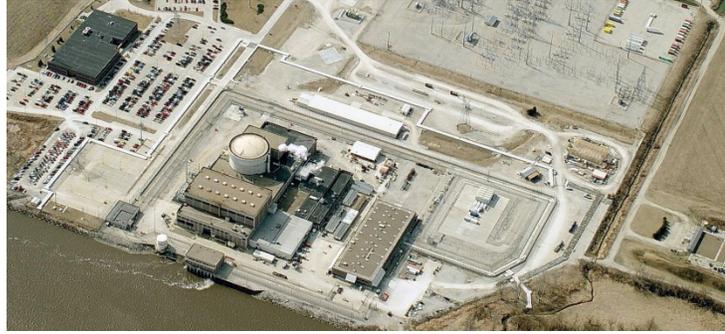
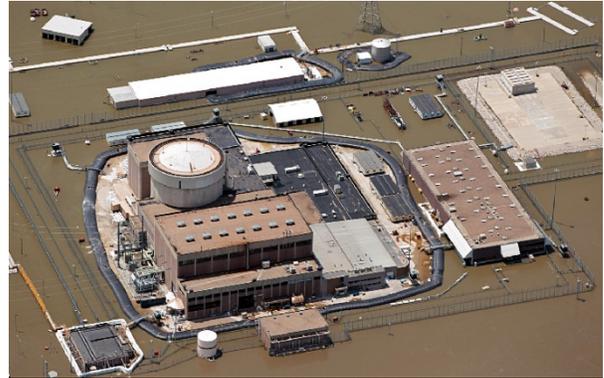
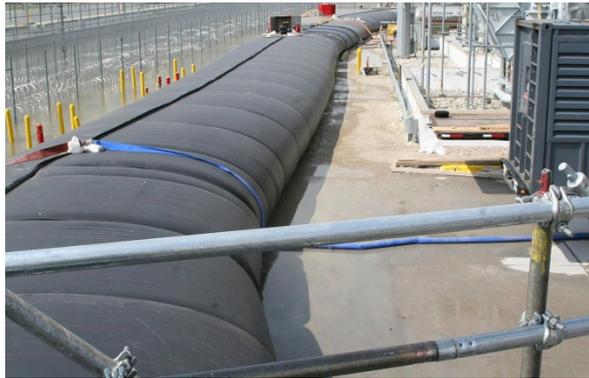
Figure 89. Fort Calhoun station, Blaine, Nebraska, 19 miles north of Omaha on the Missouri River is protected against flooding by a 2,000-ft long Aqua Dam berm from releases from the Gavins Point Dam, June 10, 2011. The berm raises the protection 6 ft above the 1,004 ft river level to the 1,010 ft Mean Sea Level, MSL. Source: OPPD.

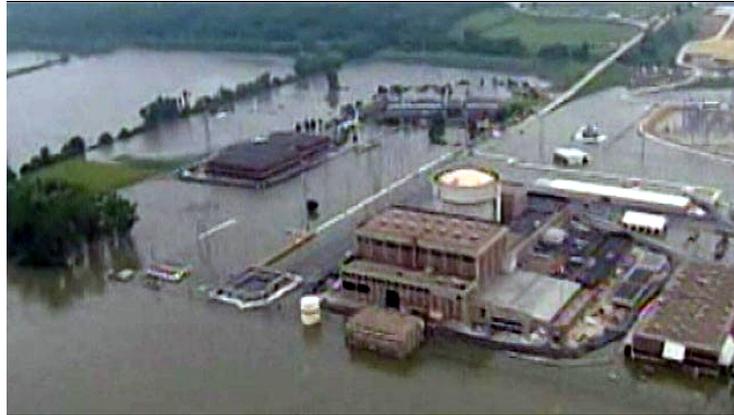
Figure 90. Fort Calhoun's Aqua dam, June 26, 2011. Source: ABC News.

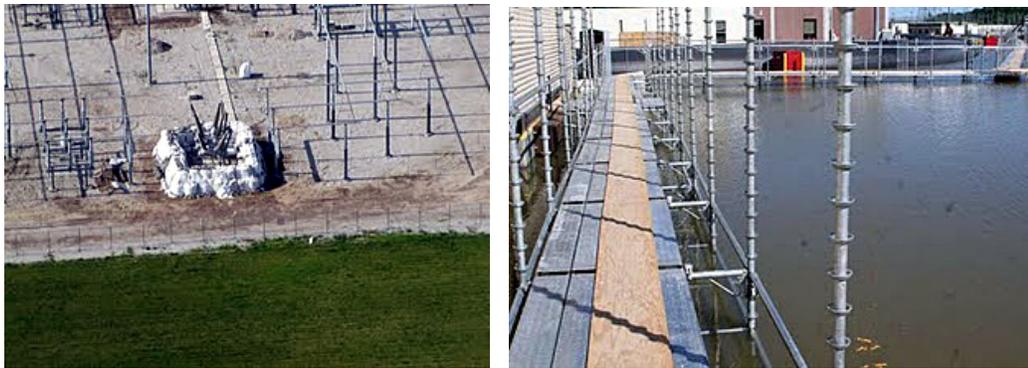
Figure 91. Circuit breaker 345 kV at transformer substation protected with sandbags and walking bridges around buildings were implemented against flooding at Fort Calhoun, Nebraska, June 13, 2011. Source: OPPD.

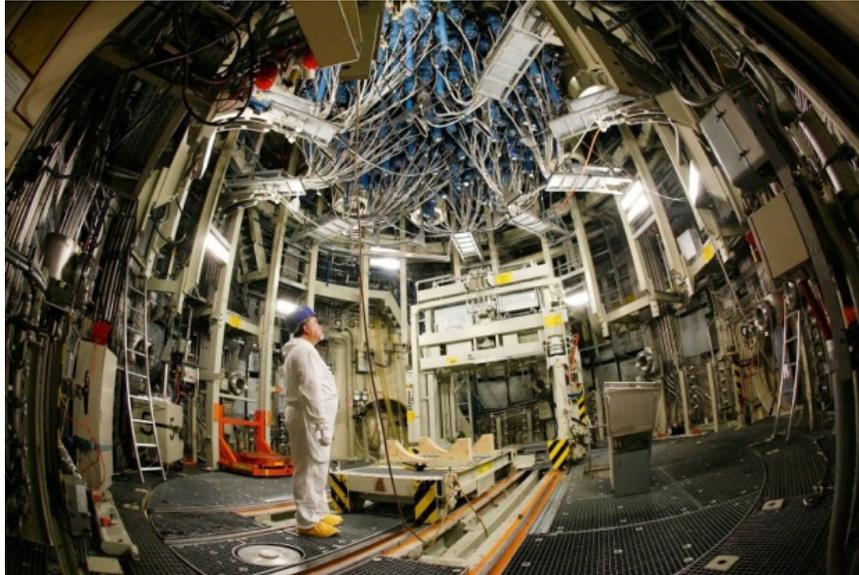
Figure 92. Control rod drives at the bottom of the Krümmel BWR reactor near Hamburg, Germany that went into operation in 1984.

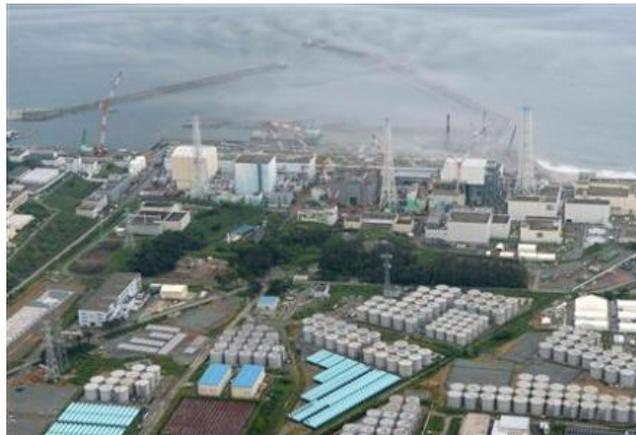
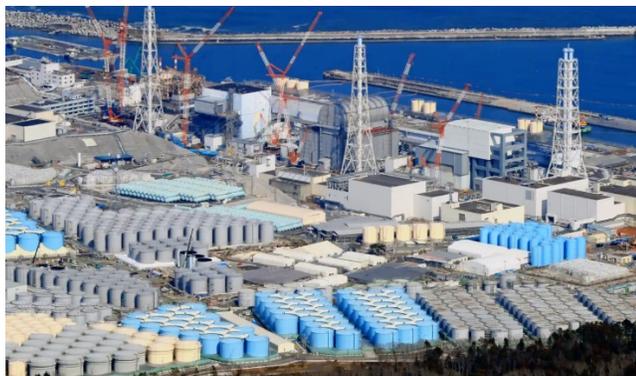
Figure 93. Liquid storage tanks at Fukushima. While great efforts have been made to sequester hot water in tank farms, the tanks leaked and the buildings were insecure. Leaking into the coastal zone soils are fission products  $Cs^{134}$  and  $Cs^{137}$ ,  $Sr^{90}$ ,  $I^{131}$  and  $I^{129}$ , along with various isotopes of T<sup>3</sup>, U and Pu. Water leaked and was diluted into the North Pacific Ocean at a rate that varied from 300-900 tons of water per day at an allowable content of 2.5 percent of the maximum permissible tritium concentration MPC, after filtering the solids content.

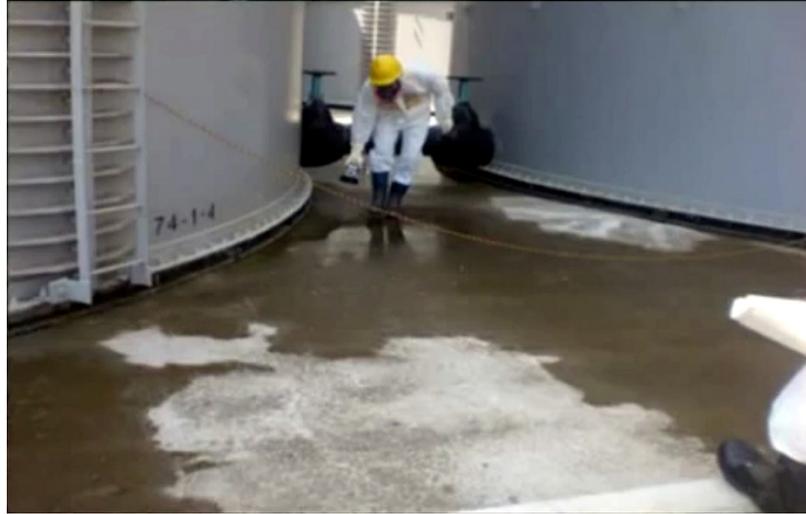
Figure 94. Leaking water storage tanks.

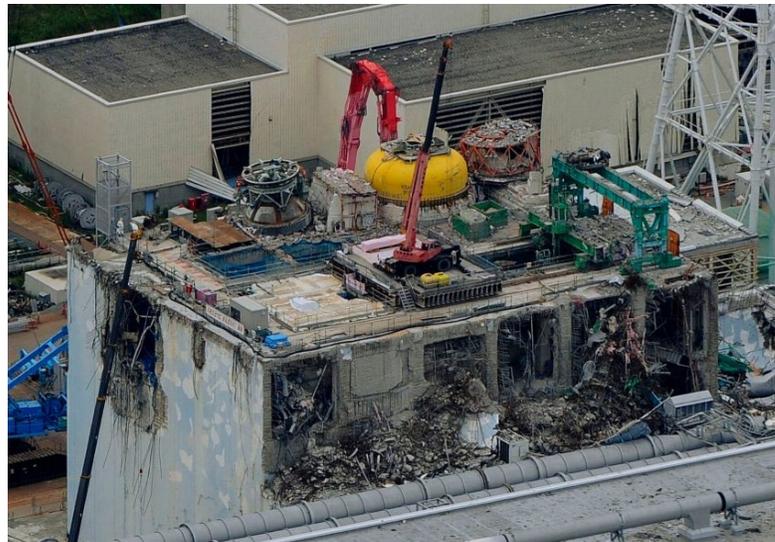
Figure 95. Debris removal at Fukushima unit 2.

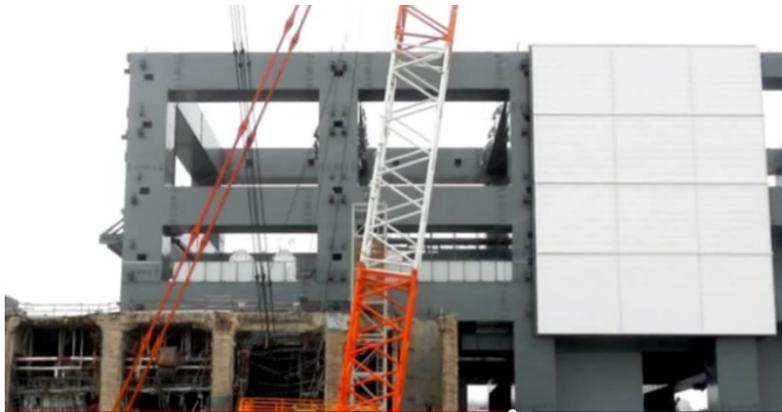
Figure 96. Adding support under unit 4 fuel pool.

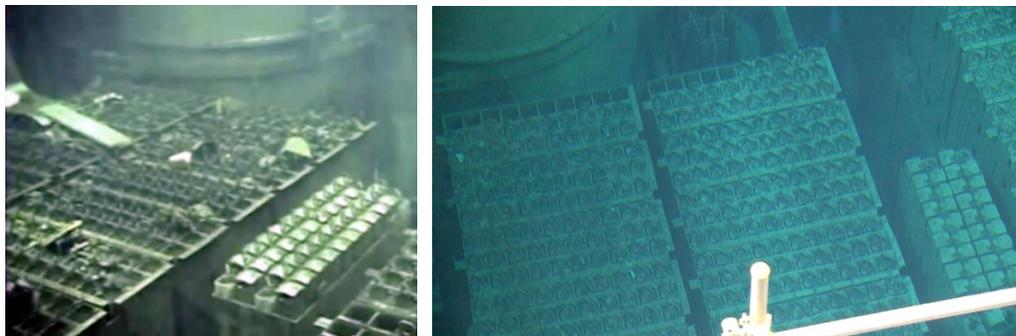
Figure 97. Debris removal in from unit 4 fuel storage pool.

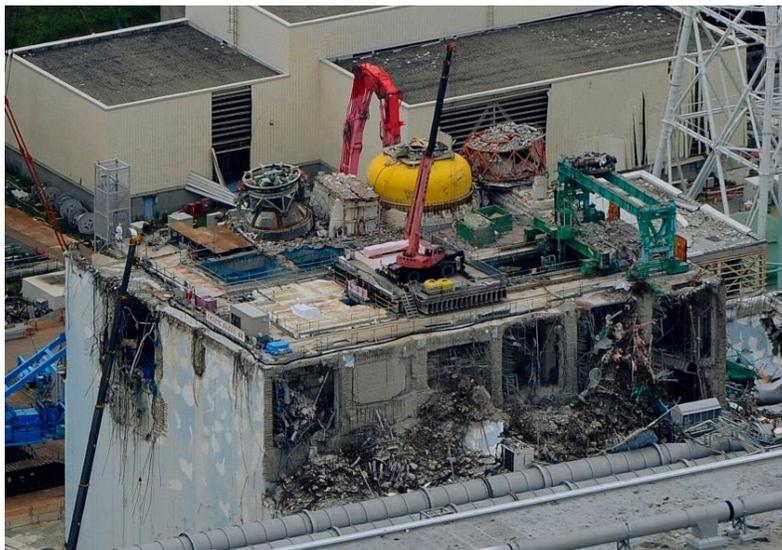
Figure 98. Debris and fuel elements removal from fuel storage pools at Fukushima.

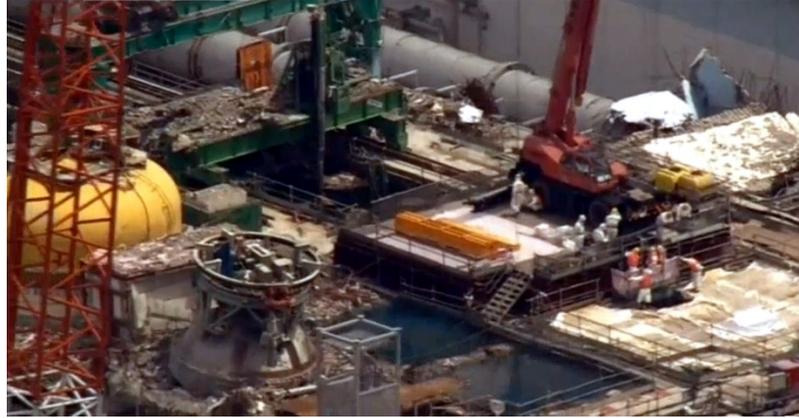
Figure 99. Extraction of fuel elements from fuel pool of unit 4.

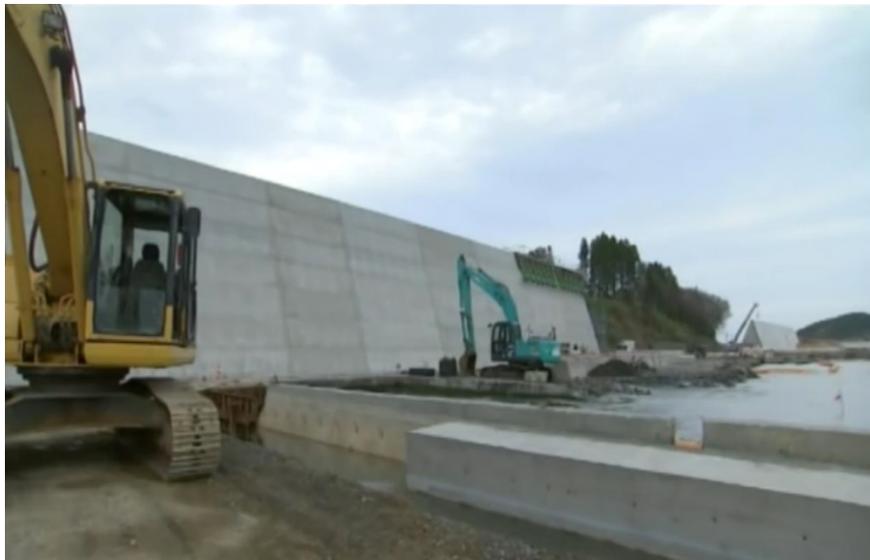
Figure 100. Concrete tsunami protection wall constructed along 400 km of the Japanese coastline.

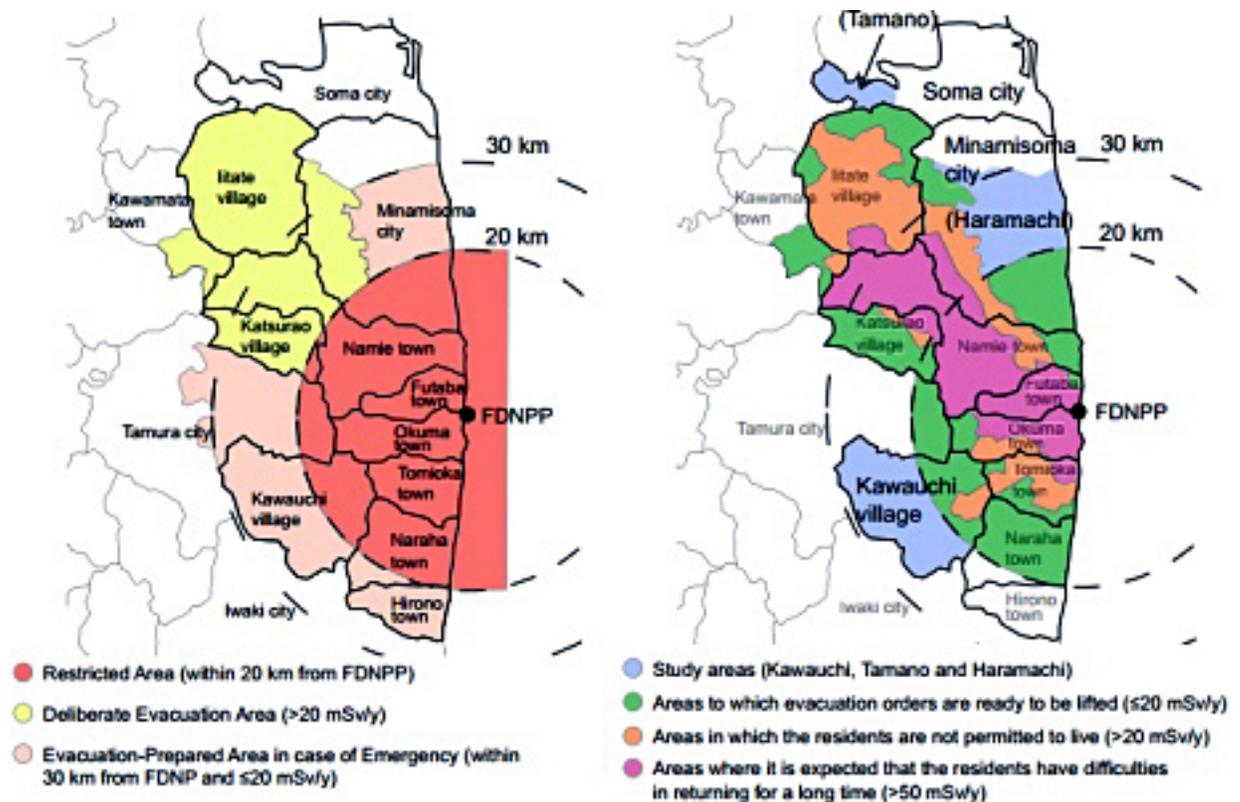
Figure 101. Radiation study zones. Source: Akio Kizumi et al., "Radiation dose rates now and in the future for the residents neighboring restricted areas of the Fukushima Daiichi Nuclear Power Plant," Kyoto University Graduate School of Medicine, Proceedings of the National Academy of Sciences of the United States of America (PNAS).

Most of the Fukushima-related radiation received by the study subjects was found to be from external sources from the deposited Cs<sup>137</sup>, referred to as "ground-shine" rather than diet or inhalation. The study found that in 2012, the mean annual radiation dose rate associated with the Fukushima event was 0.089 - 0.251 cSv (rem) per year – close to Japan's average annual per capita background radiation exposure of 0.200 cSv(rem) / yr or 200 mrem / yr.
